Inspection Report

Sample Report

Property Address:
1202 Missouri Ave
Oceanside Ca 92054

Nation Wide Inspections

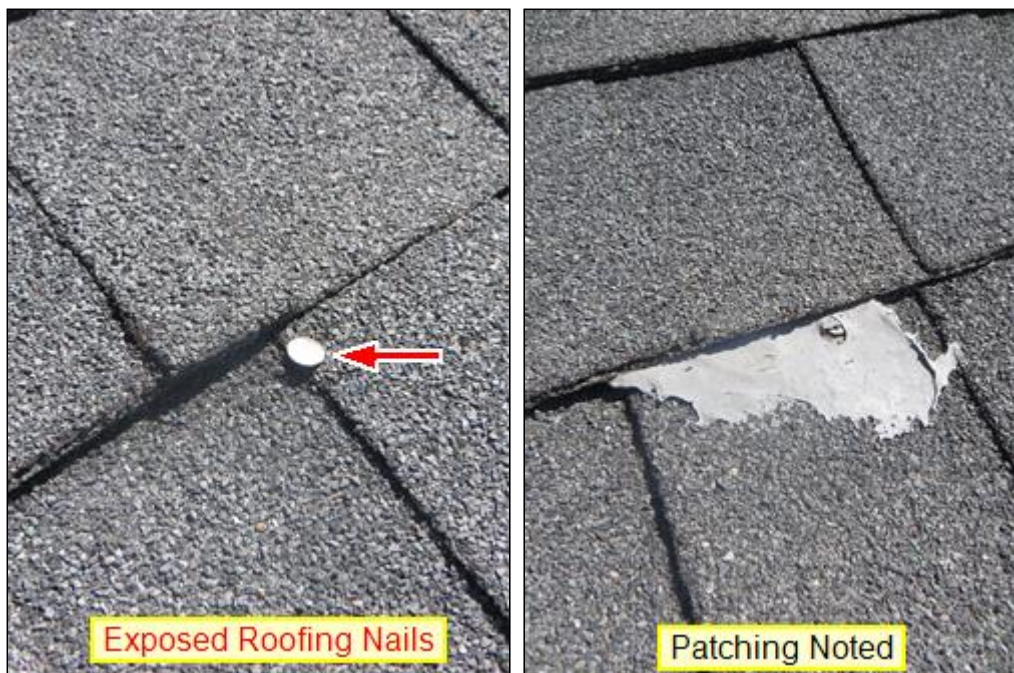
(2) **Exposed Nails at Field** . Roofing materials should not have exposed nails or staples; these fasteners should be covered by roofing material to decrease the chance of leaks. It was noted that there were several nail heads that were covered with Mastic however there were currently a few exposed nails found throughout the field of the roofs. Typically Three-Tab shingle are secured with 4 nails (unless installed in high wind areas where you may have 6). Nail placement is typically 1 inch from each of the sides (apx. two inches above the top of the keyway) and two inches above each keyway. In this application it does not appear that either the

standards of practice or the manufactures specifications were followed. **Improper roofing installation can lead to shortened roof life expectancy and leaks.** It is recommended that this roof be further evaluated by a licensed roofing contractor and be repaired as needed.

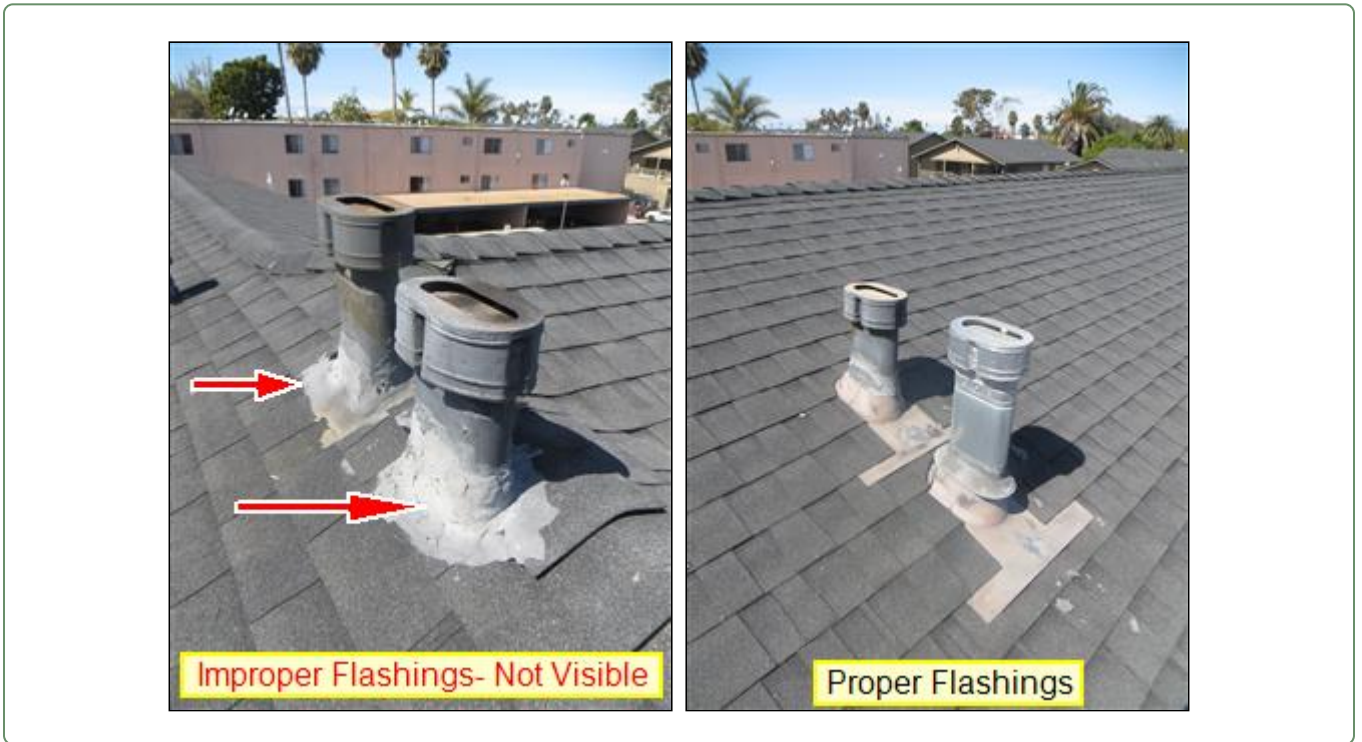
(2) **Flashings Not Visible.** There were some flashings that were not visible at the time of the inspection. **This could indicate that there are no flashings at the roof penetrations, or that they were done incorrectly.** Missing or incorrect flashing greatly increases the probably of roof leaks. It is recommended that incorrect, damaged or missing flashings be repaired by a licensed roofing contractor.

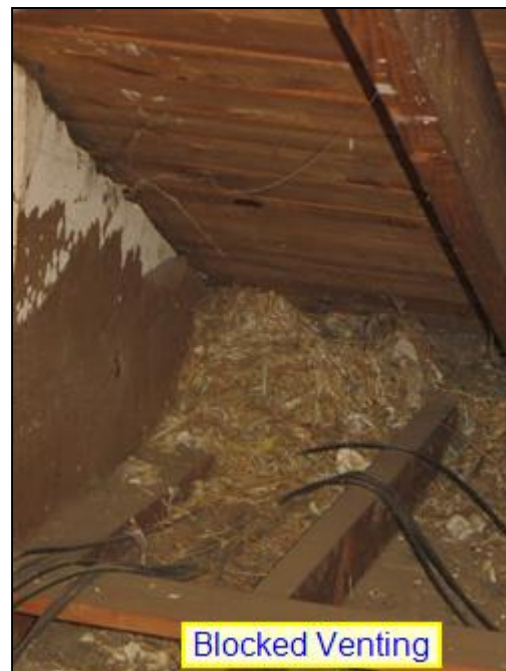
**Eave Vents Blocked.** The attic is supplied with eave vents for ventilation. Although there is currently nothing physically wrong with the venting system, the vents have been covered in the attic by pigeon nests at some locations limiting the ability to effectively vent. Insufficient ventilation, can not only cause the building to not efficiently heat and cool; but it also can decrease the life expectancy of the roof. **Recommend that the nests and debris in the attic be removed from the vents to allow for proper ventilation.**

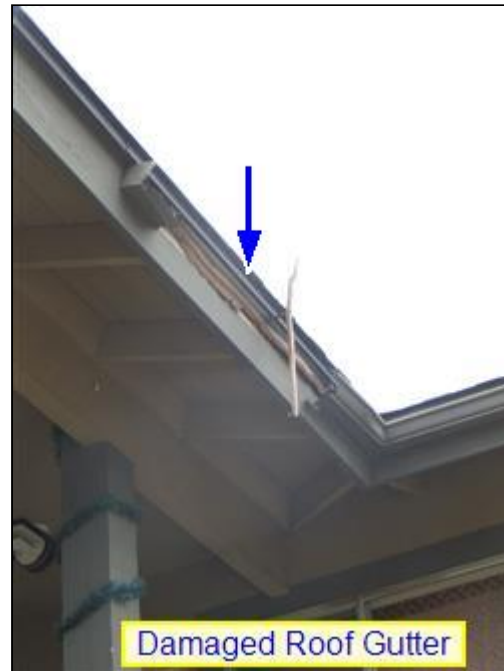
(1) **Deteriorated Roof Drainage.** The gutter system is rusted and deteriorated in various areas of the buildings. This system is inadequate and in need of repair or replacement. It is recommended that the gutter system be repaired as needed by a licensed contractor or qualified specialist.

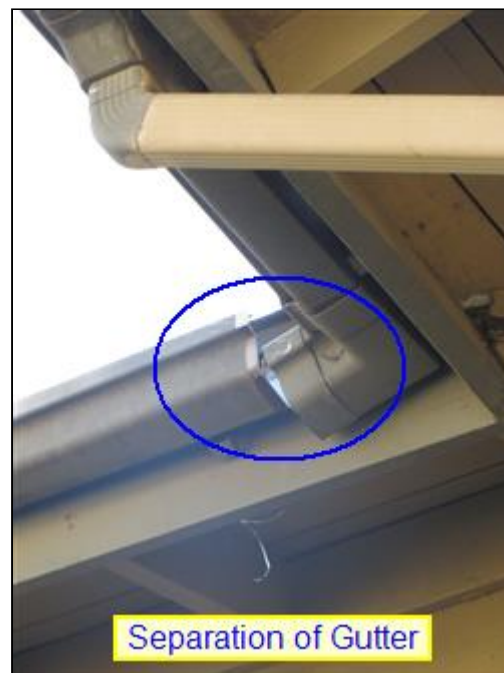
(2) **Gutter Needs Repair.** There were sections of the gutter system that were disconnected or pulling from the building. It is recommended that these be repaired to allow the gutters to function properly, and allow the water to drain away from the house and foundation.

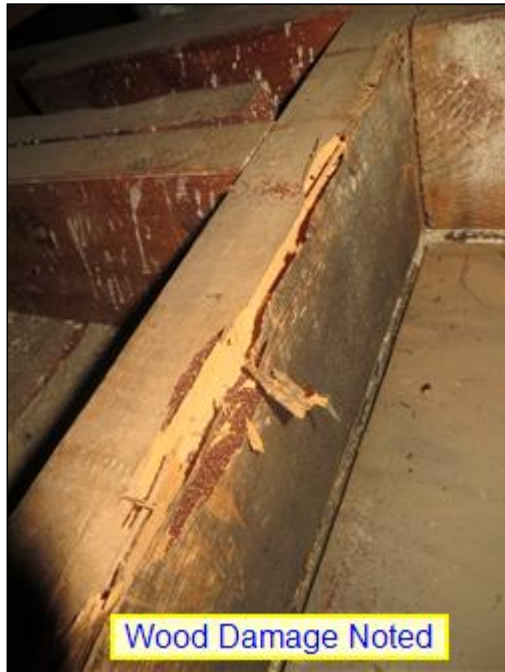
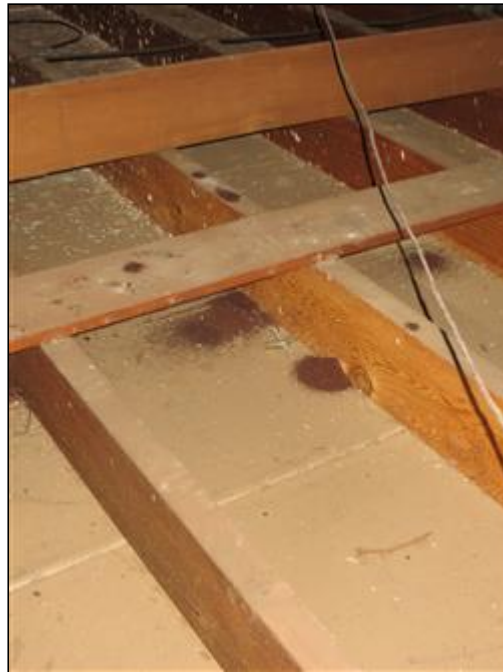
(2) **Wood Damage**. There were several areas of wood damage noted in the attic spaces of each of the buildings (two of the buildings were not entered or inspected). There was damage to some of the wood framing and ceiling joists at several locations. It is recommended that you have a termite report conducted and you read through the report for more information about this damage and the corrections and repairs recommended.

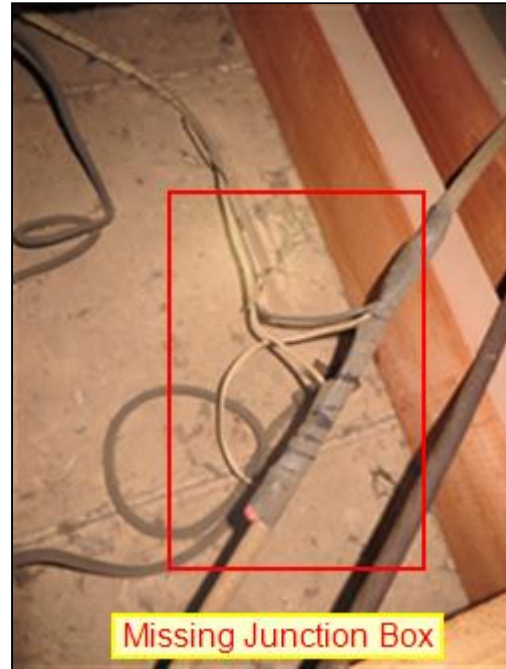
**Missing Electrical Boxes.** All wire connections need to be concealed within proper listed electrical boxes. Currently there are wire connections not contained with junction boxes. Junction boxes are used to conceal wire connections, protecting them from damage and decreasing the risk of fire. **Recommend installation of outlet boxes on all exposed wire connections by licensed electrician.**

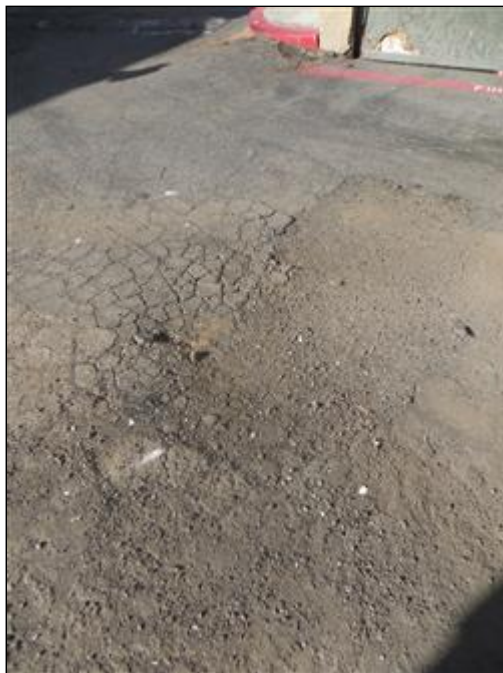
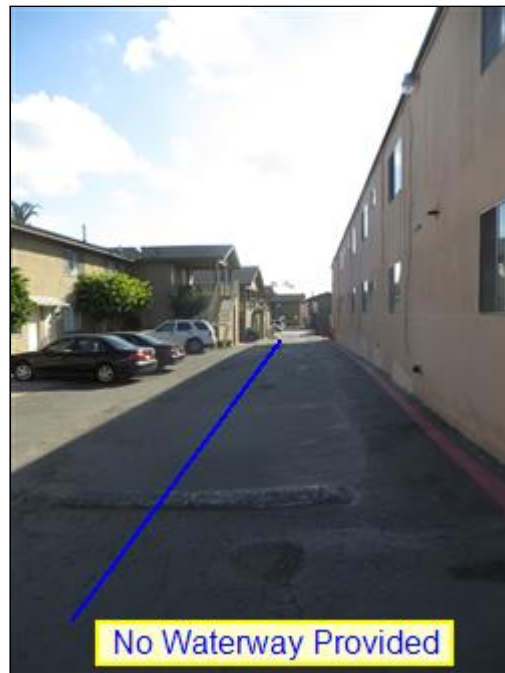
**Erosion and Damage of Asphalt.** The driveways at the front of the buildings were worn and deteriorated at multiple locations. It was noted that there were sections of the driveway that did not have adequate drainage or a proper directional slope, allowing water to puddle or run in multiple paths. There was no designated drainage running down the driveway, and there was only one visible storm drain at the base of the driveway. The driveways need patching at several locations and re-sealing. **It is recommended that the driveway be further evaluated and repaired as needed by a licensed contractor.**

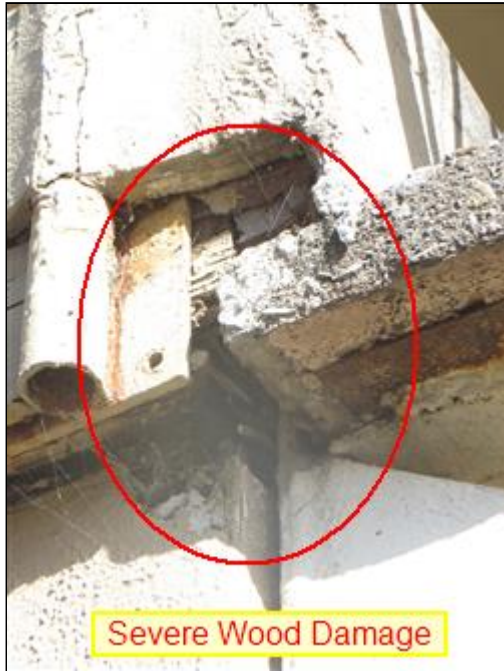
📍 (3) **Wood Damage- Further Evaluation Needed.** The landings at several of the stairs had worn decking and damaged wood. Because the interior structural elements were not able to be inspected and the condition determined it is recommended that these areas be further evaluated. It was noted that there was evidence of water intrusion at some of these locations as well as serious wood damage at the stair connection. **Due to the severe visible wood damage, it is recommended that the interior locations of these landings be further evaluated.** It is recommended that these areas be further evaluated and repaired as needed by a licensed contractor.

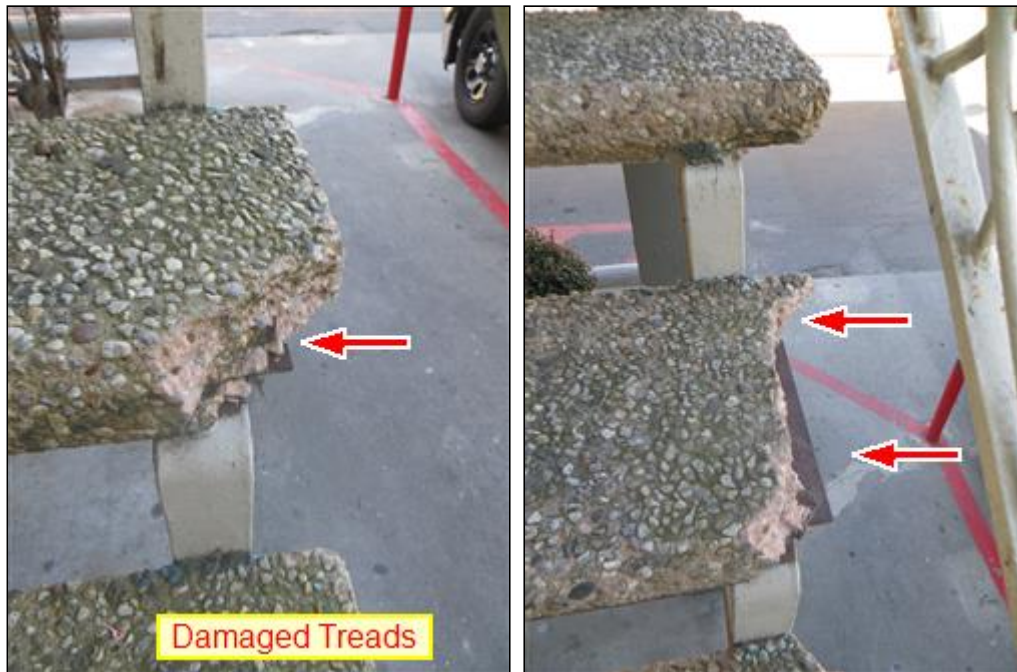
(6) **Damaged Stair Treads.** There were several loose and damaged treads at the front stairs of the buildings. **It is recommended for safety purposes that all damaged areas be further evaluated and repaired or replaced as needed by a licensed contractor.**

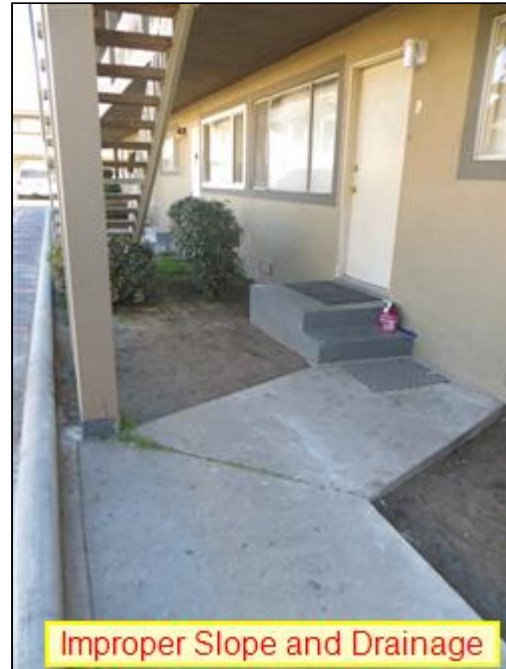
(3) **Improper Drainage.** There are areas around the building where the drainage is poor. There were no visible surface drains noted at most of these locations. It is important that all water shed away from the building and the foundation. It was noted that there were serious drainage, moisture and venting issues at the underside of most of these buildings. It is recommended that swales, french drains or other means of drainage be provided to keep water away from the buildings and foundations.

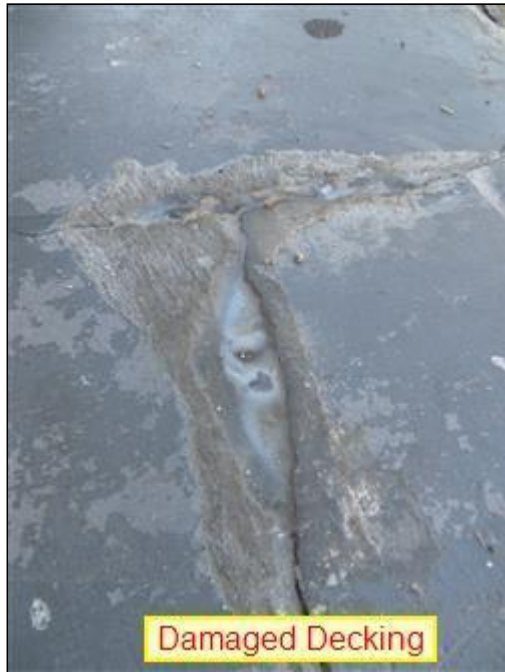
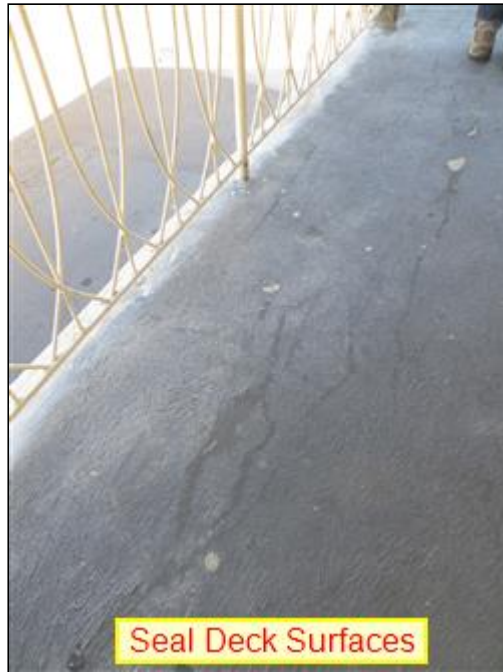
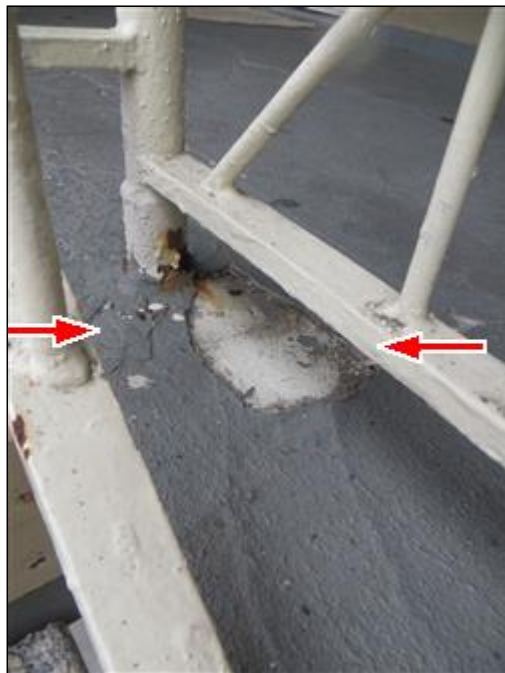
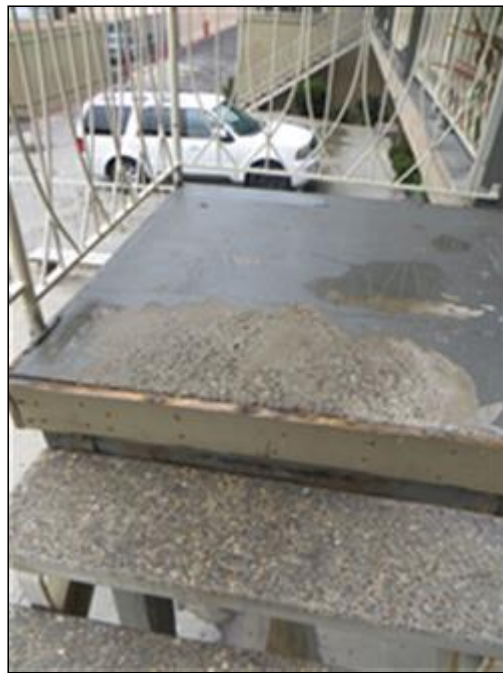
Seal Balcony/ Deck Surfaces . The front balconies and walkways have penetrations and damage to the surfaces. This can allow for water penetration. It is important that the surface of this deck be kept water tight in inhibit water intrusion. There was evidence of water intrusion noted at the underside of some of the landings as well as severe wood damage. It is recommended that the surface of the exterior walkways/ balconies be further inspected and repaired as needed by a licensed contractor.

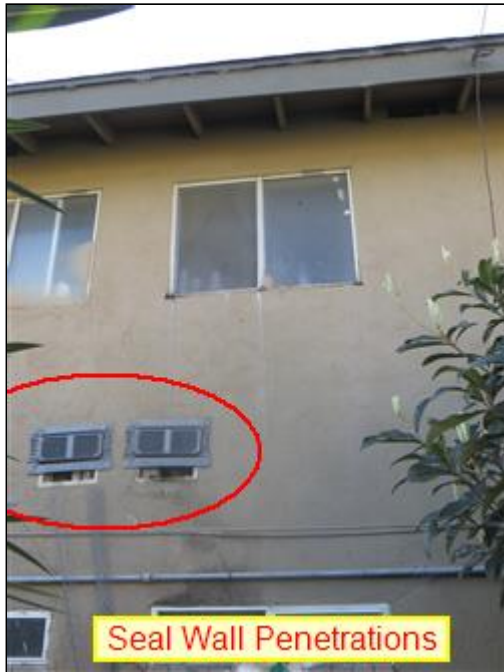
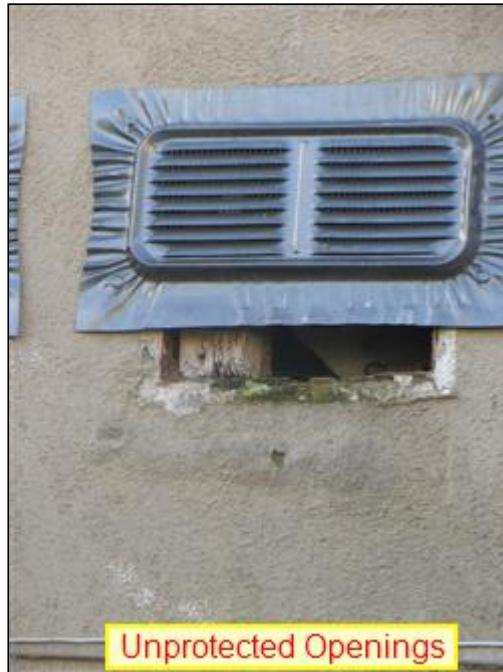
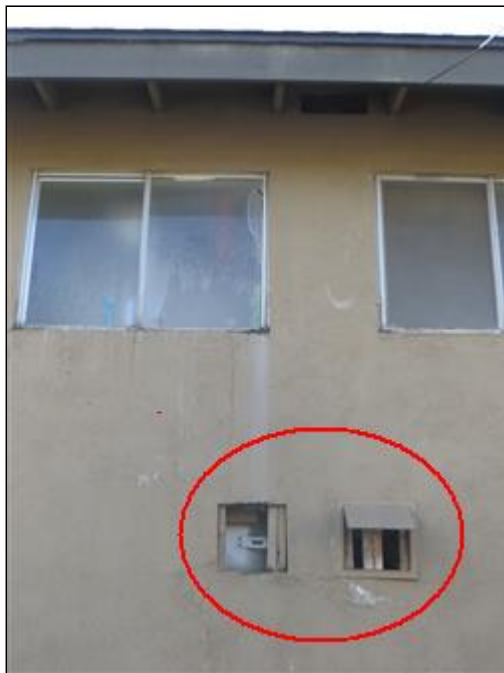
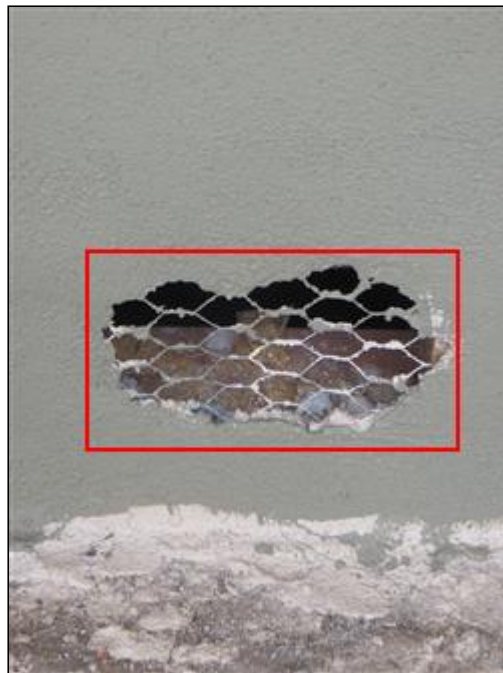
(2) **Unprotected Openings** . There were some penetrations noted at the exterior walls of the second and 4th (west) buildings. Also there were no visible flashings at the wood patching at the underside of the replaced bathroom windows. **These penetrations do not appear to be properly sealed or flashed. This can allow for water intrusion and animal infestation.** It was noted that there was internal wood damage at these locations as well as evidence of moisture. **It is recommended that these areas be patched or sealed as needed by a licensed contractor.**

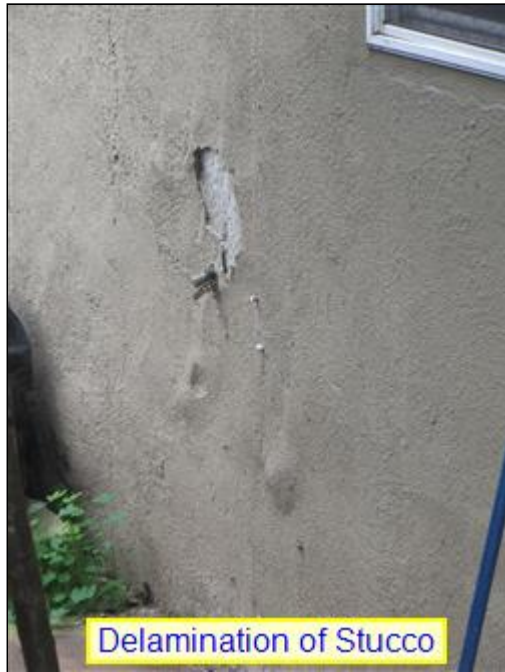
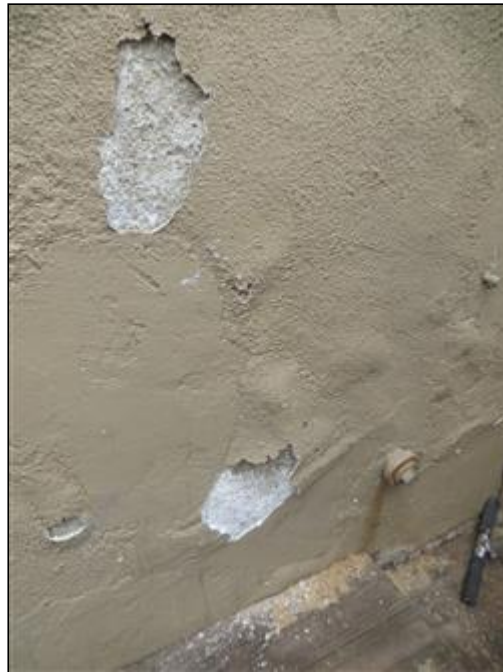
(5) **Delamination of Stucco.** There was some delamination of stucco noted at the exterior of the 2nd 3rd and 4th building. The stucco is beginning to delaminate at the exterior of the buildings. Although there are many causes of delamination, most often, it is due to excess moisture wicking into the stucco, and causing it to fail. **This is a cosmetic fix but, but efforts should be made to keep the area around the building and foundation dry.**

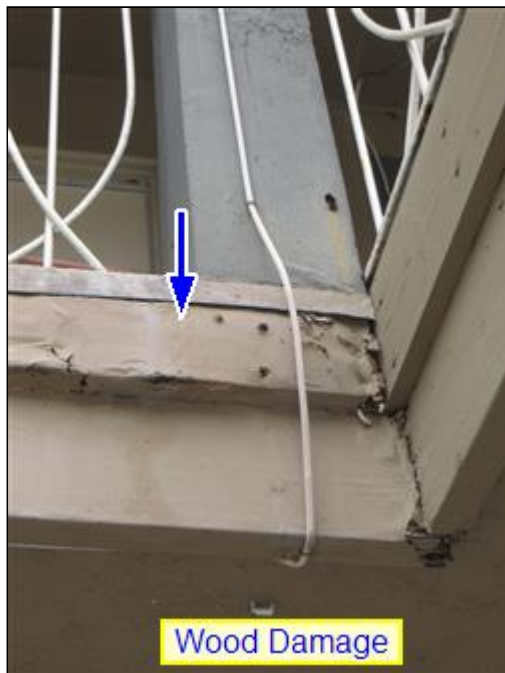
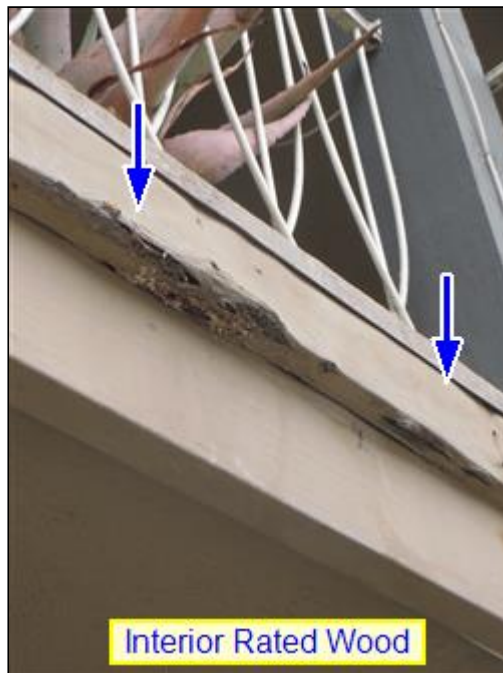
(7) **Interior Wood at Exterior.** There were some areas of trim work that were installed with interior rated wood. Interior wood is not designed for exterior use. It was noted that the wood at these locations has become swollen and damaged. This was noted at the underside of the balcony flashing at the second building. It is recommended that these areas be further evaluated and repaired as needed by a licensed contractor.

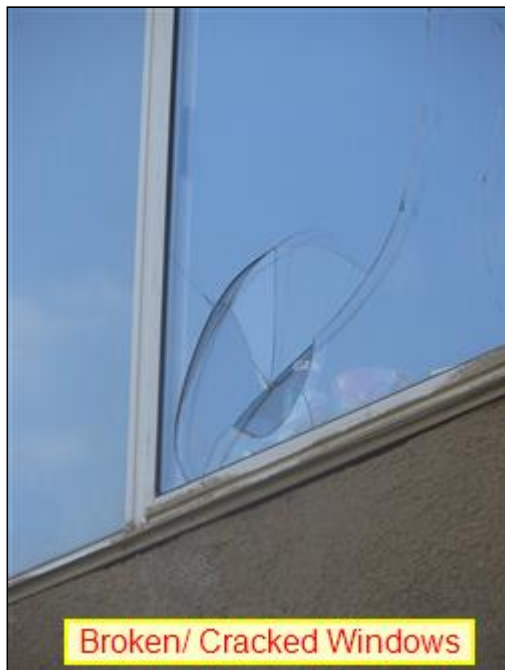
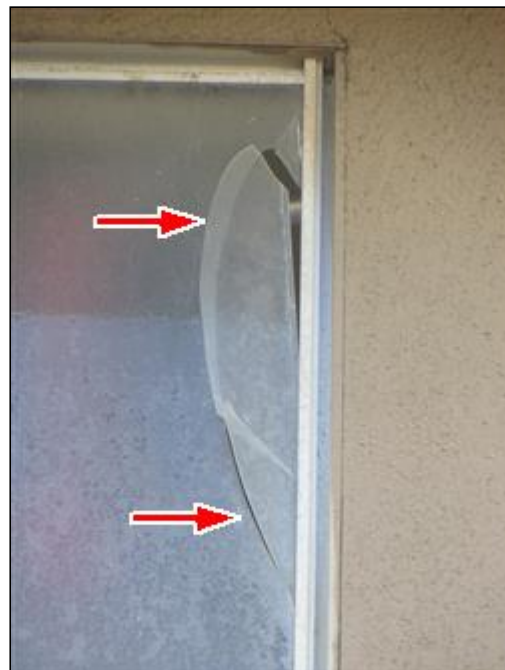
(3) **Broken Windows.** There are multiple window(s) that are broken or are missing and need replacement. **See the INTERIOR sections of each unit for specific locations of these windows.** **Due to the extreme hazard that this creates, it is recommended that this window be replaces ASAP by a licensed contractor.**

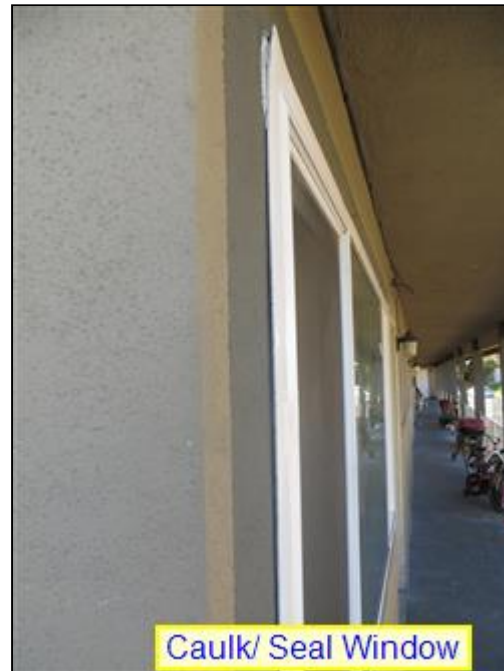
(4) **Caulk Windows.** There was a replaced window at the front of unit #1 that was not properly sealed and caulked. It is recommended that a new bead of caulking be provided around the windows.

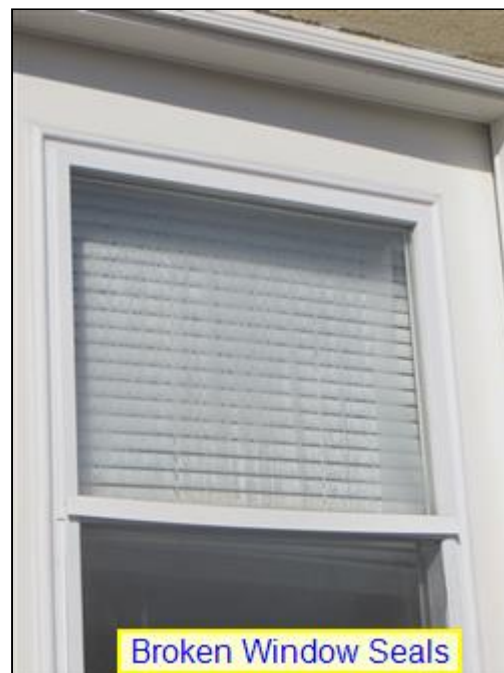
(5) **Broken Window Seals.** There were a few windows at the rear of the first building that have damaged seal(s) and there appears to be condensation within the window panes. Typically this is an indication that the seals have expired and the low-e gases have escaped. **Currently these windows no longer are energy efficient.** Due to climatic and weather conditions, some windows may not show signs indicating that there are issues present. We cannot always determine if seals are broken and will not be held liable for broken window seals. Currently it appears that there are at least 2 windows that appear to have damaged seals. It is recommended that all of the windows be further evaluated for potential damage and repaired as needed by a licensed contractor or specialist.

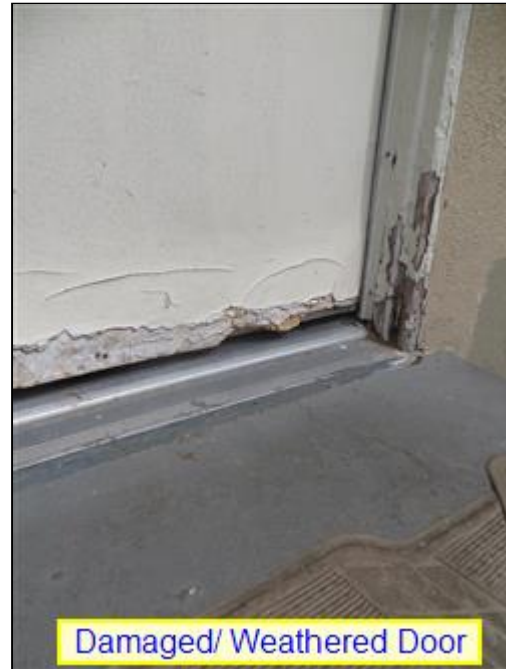
There are several door(s) at the front of the buildings that are worn or damaged. Finishing/ painting the wood will help preserve the wood increasing the life expectancy. **It is recommended that all weathered doors be painted or sealed by a qualified person.**

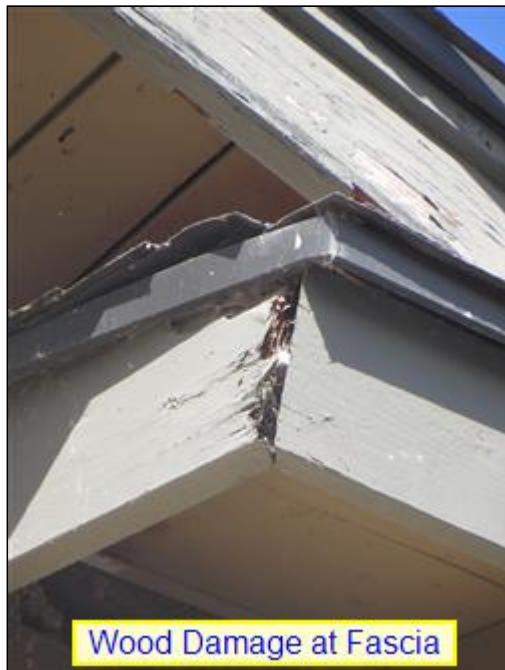
**Wood Damage.** There was some extensive wood damage noted at several areas of eaves and fascia of the buildings. **It is recommended that a termite report be conducted and that all reports about damaged materials be read.** All damaged wood should be properly repaired or replaced as needed according the the report by a licensed contractor.

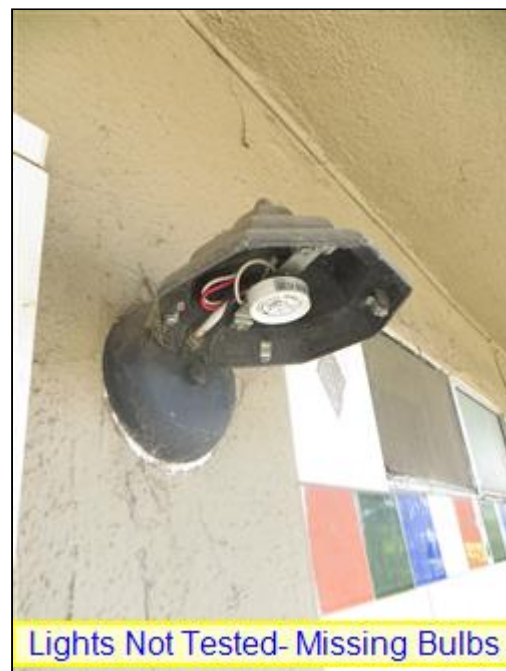
(3) **INOP Light... Bulb?** One of the exterior light fixtures did not operate when fixture was turned on. This could be because the fixture bulbs need replacement, OR there could be an electrical problem with the fixture. Recommend changing lights bulbs to determine the problem and replace as needed.

Recommend inserting light bulbs to determine if a greater problem exists.

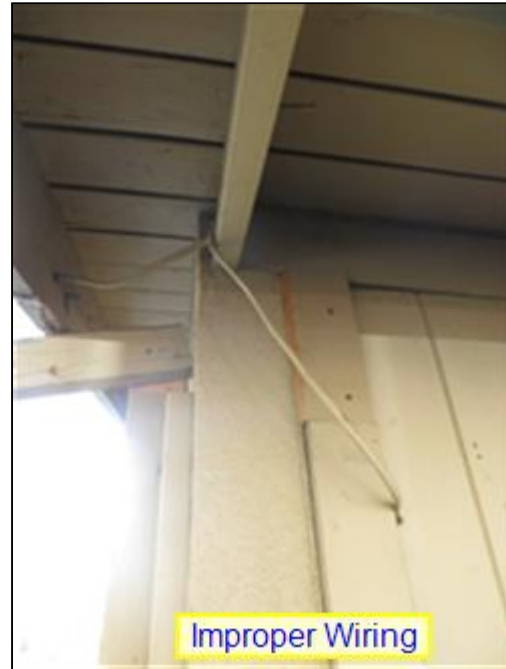
The use of Romex or NM-B wiring at the underside of the eaves is not permitted. Romex is not permitted in wet or damp locations. It is recommended that all Romex wiring at these locations be further evaluated and changed to an appropriate material by a licensed electrician.

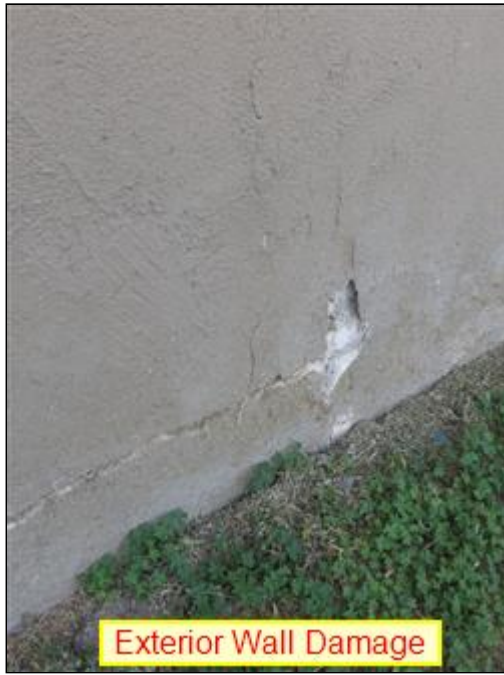
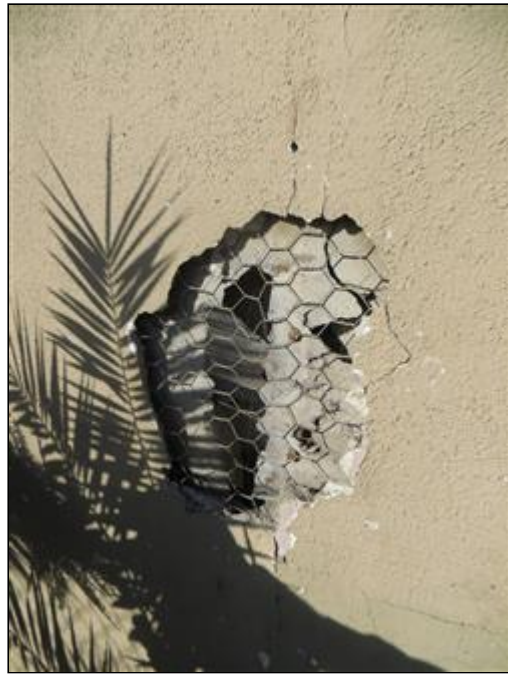
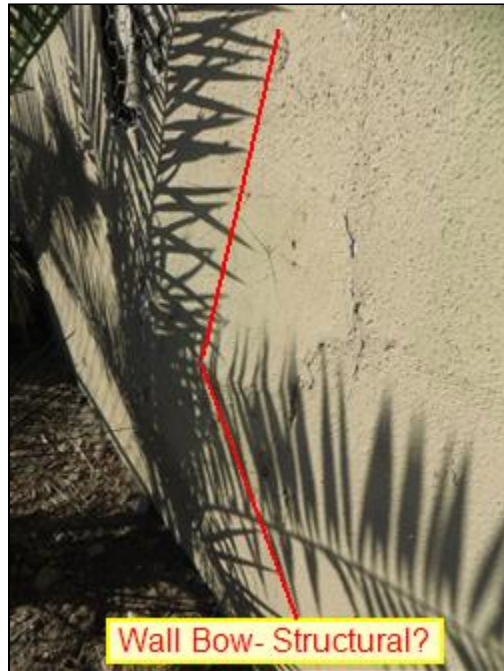
(2) **Exterior Wall Damage.** There is some damage to the exterior rear wall of the right (east) parking garages. The rear wall is bowing out with stucco damage and exposed paper and lathing. It appears that the structure of the wall has been damaged at this location. **Access to the interior of the garages and this location was not accessible and not able to be viewed or inspected.** The garages were locked. **It is recommended that this area be further evaluated and repaired as needed by a licensed contractor.**

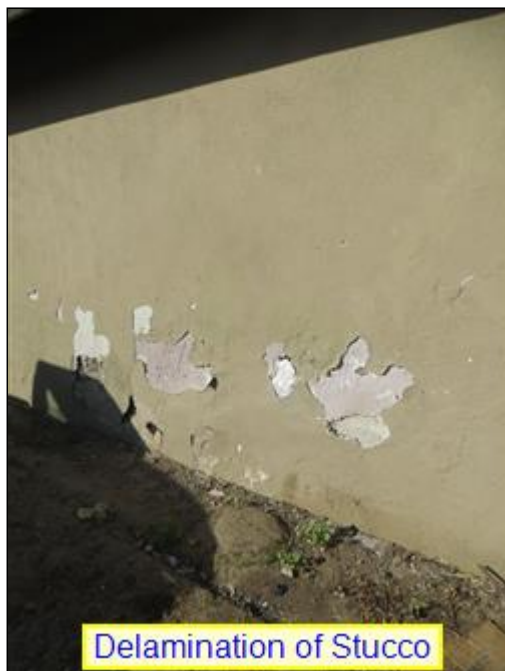
(4) **Delamination of Stucco.** There was some delamination of stucco noted at the exterior walls of the parking garages. The stucco is beginning to delaminate at the exterior of the buildings. Although there are many causes of delamination, most often, it is due to excess moisture wicking into the stucco, and causing it to fail. **This is a cosmetic fix but, but efforts should be made to keep the area around the building and foundation dry.**

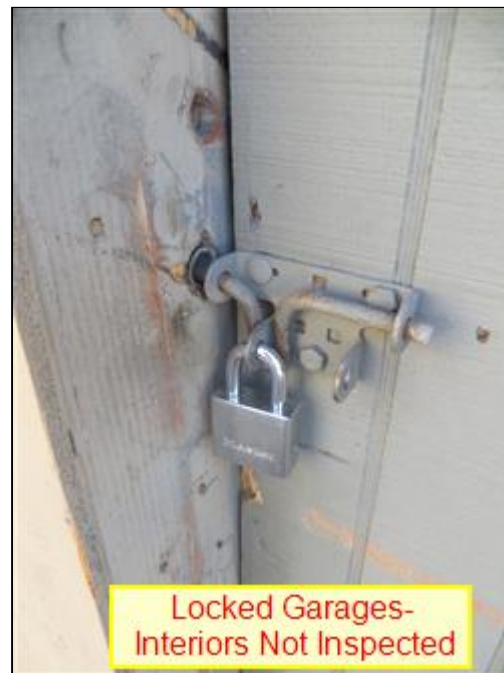
**Locked Garages- Interiors Not Inspected.** The garages to the units were locked and the interiors were not able to be viewed or inspected. **It is important to ensure that there are no penetrations in the fire rated walls and ceilings at these locations.** Penetrations at these locations can allow for carbon monoxide and fire to spread into the adjoining units. It is recommended that the garaged be further evaluated and that any penetrations at these locations be repaired as needed by a licensed contractor.

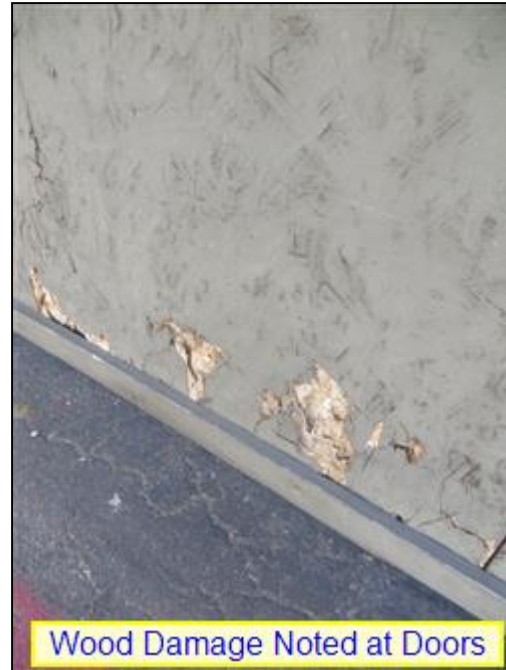
**Wood Damage.** There was some wood damaged noted at the garage doors of some of the units. Some of the wood was replaced with OSB, which is not rated for exterior use without proper protection. This is noted for your information and can be repaired at your convenience.

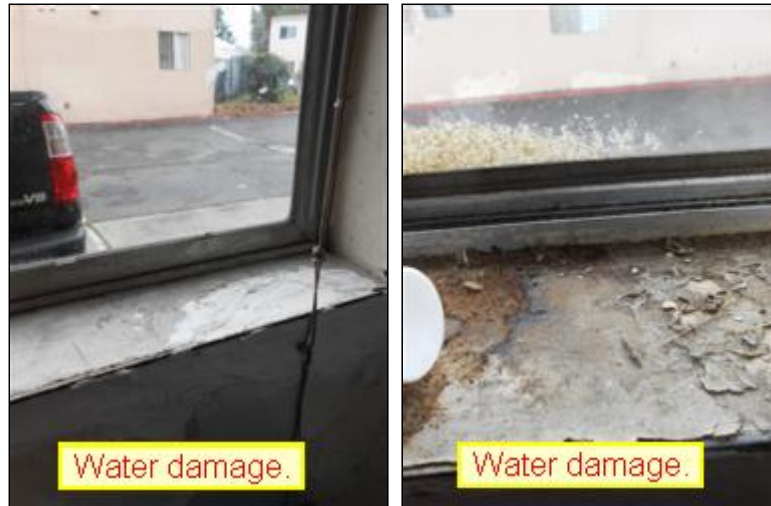
(2) **Water Damage at Sill.** There was some water damage noted on the window sill in the living room and bedroom windows. It could not be determined at time of inspection if this damaged occurred to a leak caused by a faulty window system, or by the window being left open during a rain. It is recommended that this be further inspected and that all water damaged materials be repaired or replaced by a licensed contractor to help ensure against the possibility of growth and further damage.

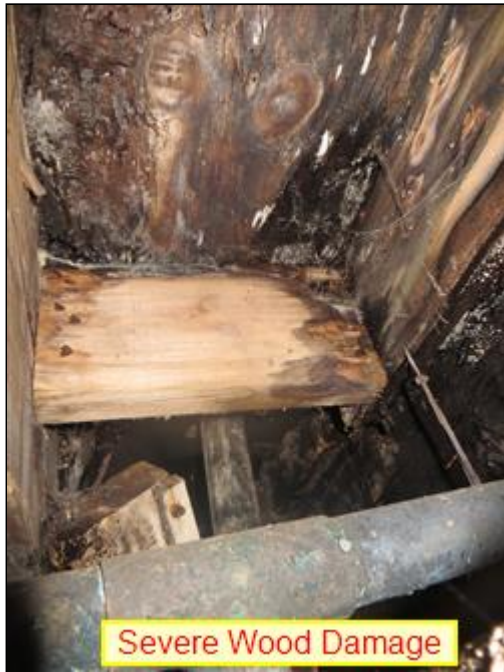
Severe Wood Damage

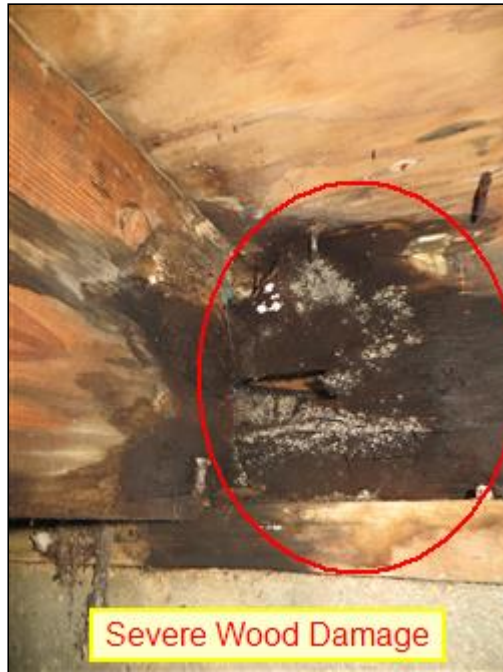
Severe Wood Damage

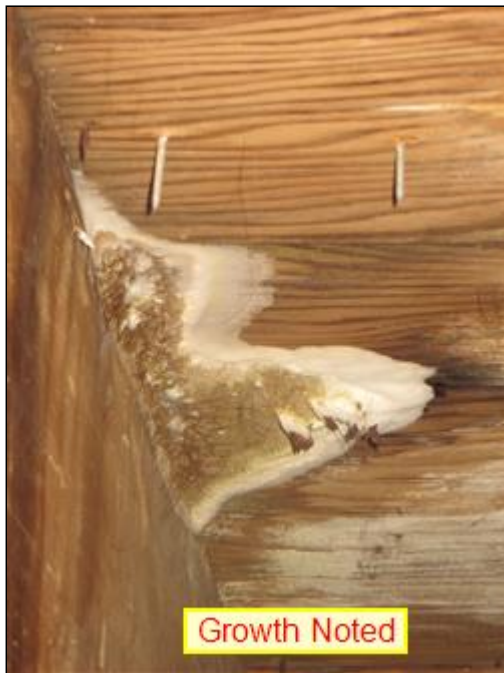
Growth Noted

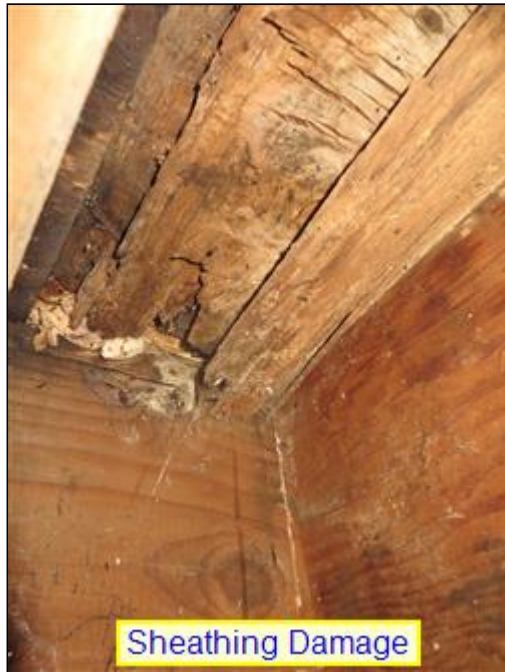
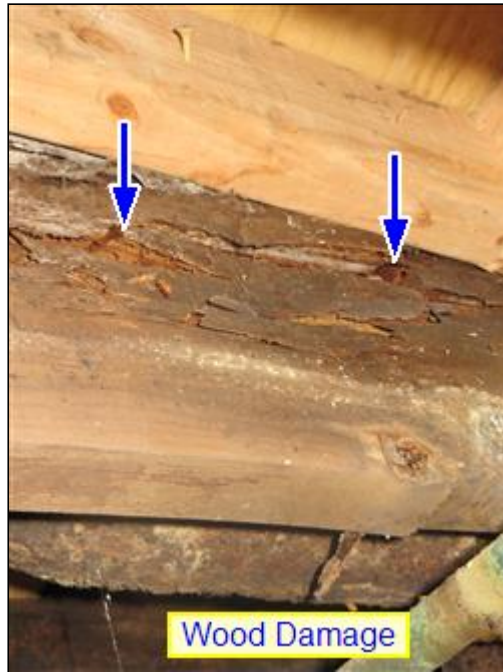
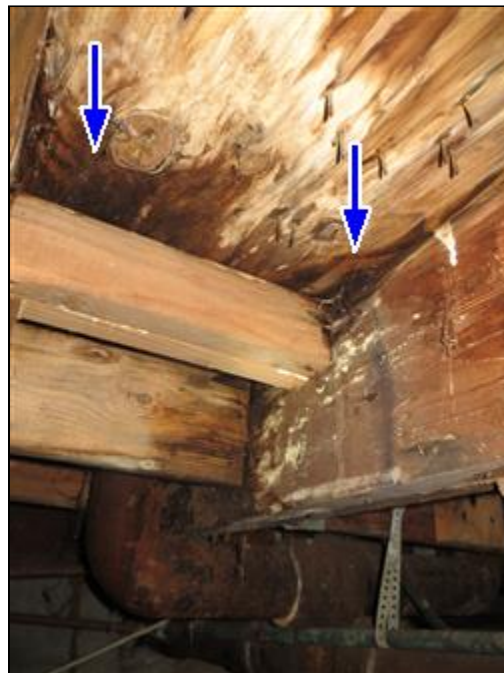
(2) **Wood Damage Noted.** There was some wood damage to the flooring framing members and sheathing at the underside of the house. It is recommended that a termite specialist be called out for further analysis and that all damaged wood be repaired or replaced by a licensed contractor.

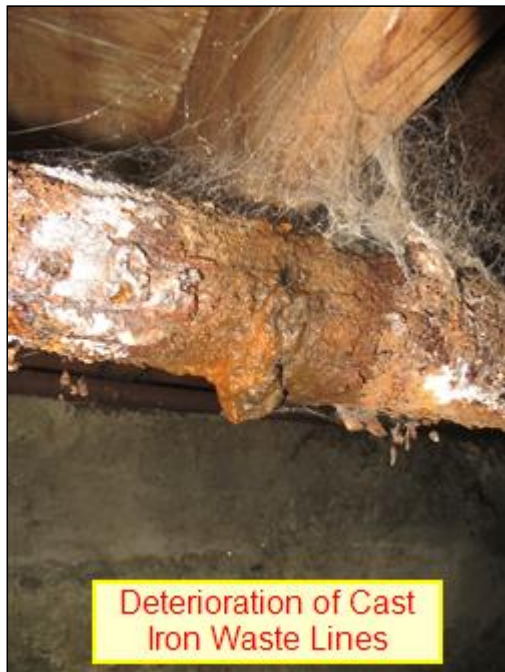
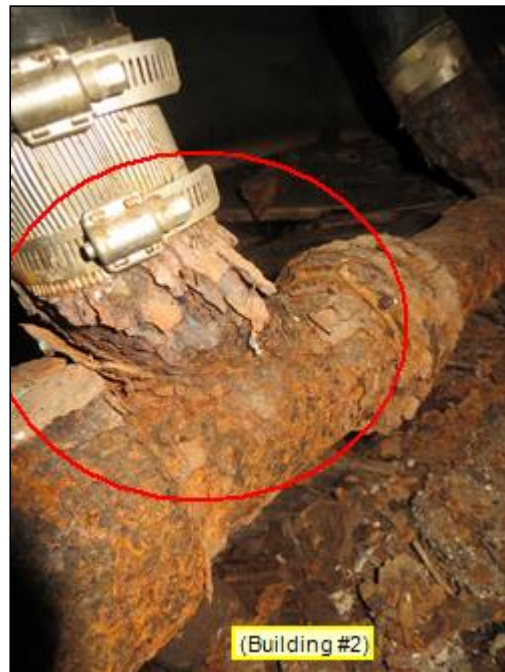
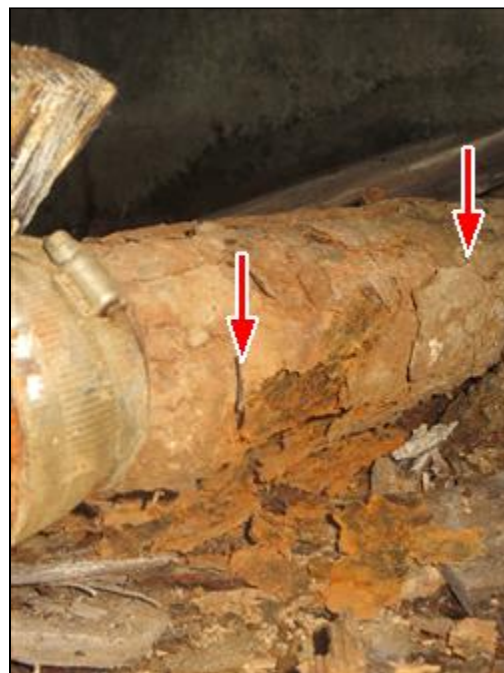
🏠 (3) **Cast Iron Leaks Noted Under House.** There are a few active leaks at the underside of the buildings. These leaks occur in the crawlspaces of the first and second buildings. **There were several areas which suggest that the toilets are not properly seated and are actively leaking.** It is recommended that these be further evaluated and corrected as needed by a licensed plumber.

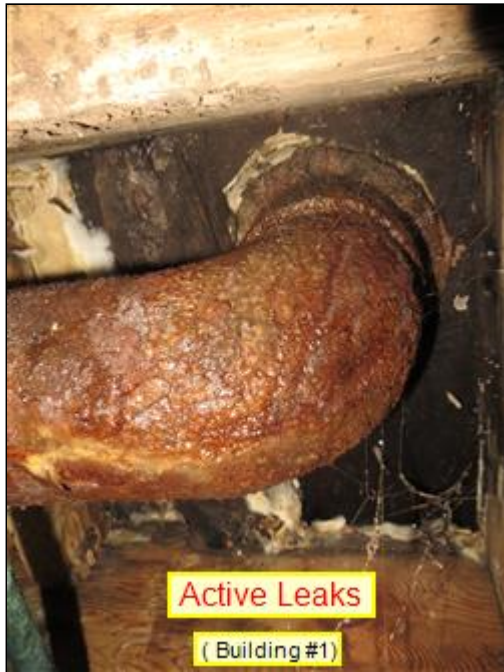
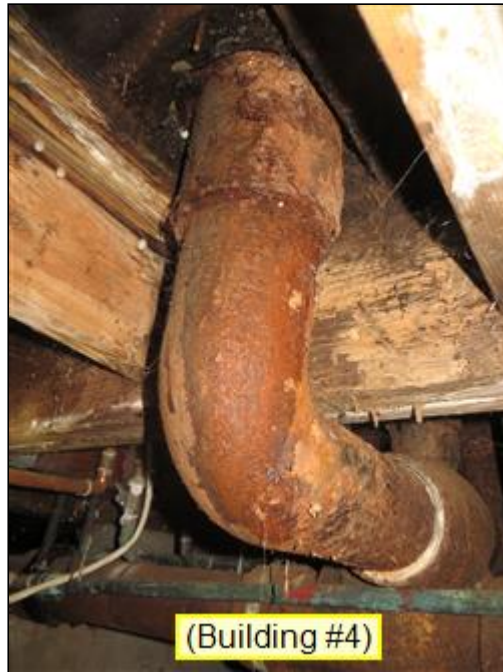
📍 (4) **Active Leaks Under Bathrooms.** There were several active leaks at the underside of the bathrooms of both building #1 and #2. It is recommended that the waste system be further inspected, evaluated and repaired as needed by a licensed plumber.
