Inspection Report

Property Address: 18145 Old Crow Rd San Diego Ca 92116

Nation Wide Inspections

Date: 10/18/2012	Time: 10:31 AM	Report ID : J101812A
Property: 18145 Old Crow Rd San Diego Ca 92116	Customer: Sample Report	Real Estate Professional:

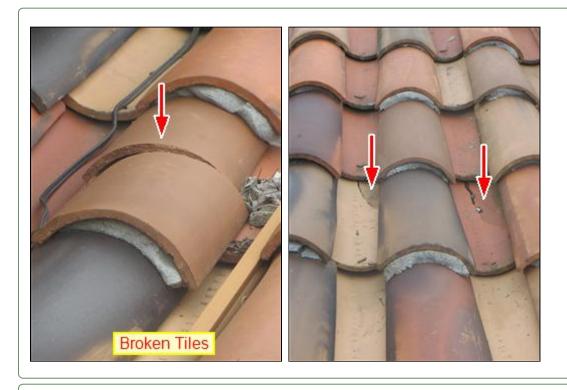
- (3) Damaged Tiles. There are a few cracked and or broken tiles on roof. Although it is not the tiles that "waterproof" a roof, it is the paper; the tiles are there to protect the paper from UV and other forms of damage. Not fixing these broken tiles increases the chance of damage to paper and increasing the risk of leaks. At time of inspection there were no signs of active roof leaks. Recommend replacing broken tiles.

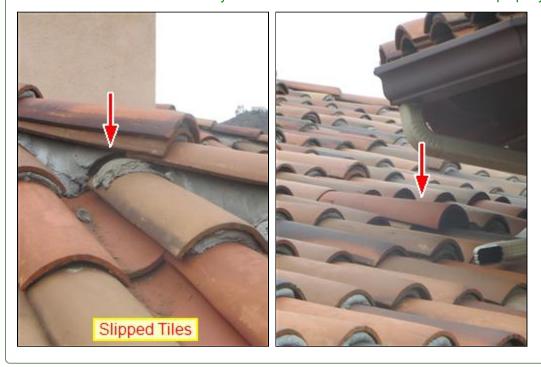
(4) Slipped Tile(s). There was a tile at the rear of the roof that appears to have slipped. Although it is not the tiles that "waterproof" a roof, it is the paper; the tiles are there to protect the paper from UV and other forms of damage. Not fixing unsecured or shifting tiles increases the chance of damage to paper and increasing the risk of leaks. At time of inspection there were no signs of active roof leaks. Recommend that the roof be further evaluated by licensed contractor and that all loose tiles be properly secured.

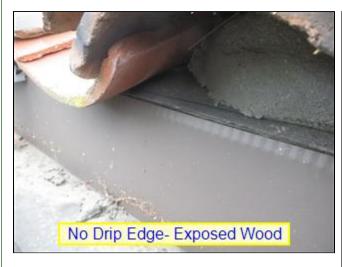
No Drip Edge Flashing. The roof is not equipped with a Drip edge: A non-corrosive, non-staining material used along the eaves and rakes to allow water run-off to drip clear of underlying construction and protect the wood from getting wet and rotting. Currently water is getting between the gutter and the starter board. It is recommended that a drip edge be applied be a licensed roofer or qualified person.

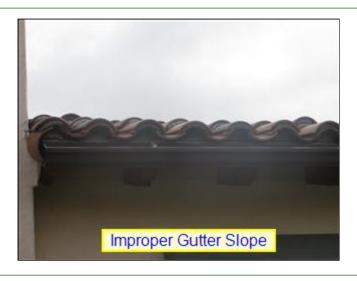
Improper Gutter Slope. There are sections of the gutter troughs that do not have the proper slope towards the downspouts. This was noted at the rear left side of the house. It is recommend that the slope of the gutters be adjusted to allow the water to flow freely towards the downspouts.

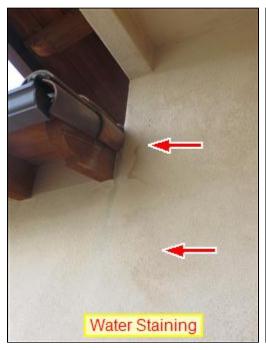
(2) Water Staining with Possible Water Intrusion. There was some water staining noted at two areas at the rear of the house. It appears that water is getting to the exterior stucco at these locations. Because the the tile roof, the flashings at these areas were not able to be inspected. The attic areas were not accessible at these locations and were not able to be viewed for evidence of possible water staining. There was some minor bowing of the interior wall/ceiling connection at the dining area. It was not able to be determined if this was caused by water intrusion. It was noted that the ceilings and walls of the house were recently painted and no stains were visible. It is recommended that these areas be further evaluated by a licensed roofing contractor to ensure the flashing is proper and there is not water intrusion at the inner walls of these locations.

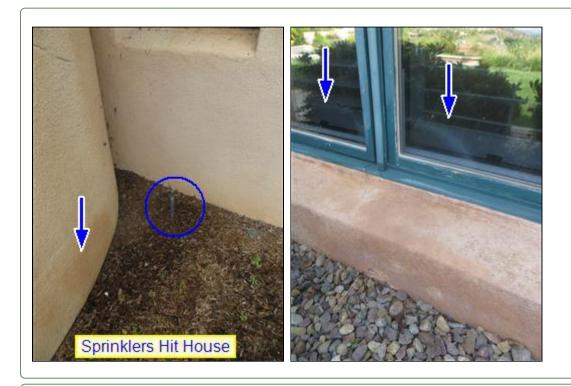
(3) Sprinklers Hit House. There were a few areas of stucco discoloration. It appears the the exterior sprinklers are hitting the house at some locations. It is important to keep all water away from the house and foundation. Sprinklers that hit the house can cause the stucco to fail and delaminate. It is recommended that the sprinklers be adjusted or changed to drip irrigation.

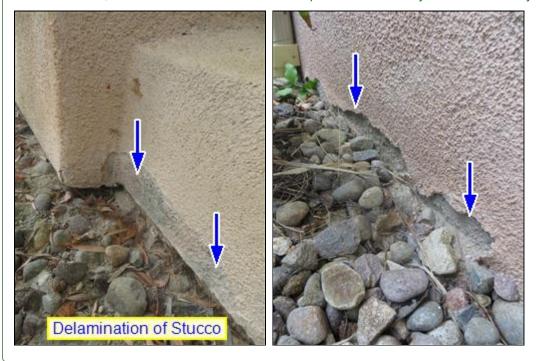
(4) Delamination of Stucco. There was some delamination of stucco noted at the exterior of the house. The stucco is beginning to delaminate at several areas of the home. Although there are many causes of delamination, most often, it is is due to excess moisture wicking into the stucco, and causing it to fail. This is a cosmetic fix but, but efforts should be made to keep the area around your foundation dry.

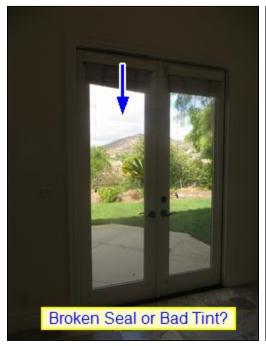
(1) Tint Damage. There was some damage to some of the window tinting at some of the doors. The tinting at the French door (off the family room by the kitchen) gave the window a foggy appearance. It could not be determined if the seal at this window was damaged or if this was caused by the tint. It is recommended that this be further evaluated and repaired as needed.

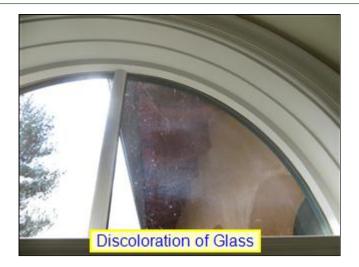
(1) Discoloration of Glass. The window(s) at the left side of the home have some discoloration within the glass. There was no condensation within the panes and it could not be determined if the seals for this window were still in good working order. It is possible that this is an indication that the seals have expired and the low-e gases have escaped. This is noted for your information and can be replaced if so desired.

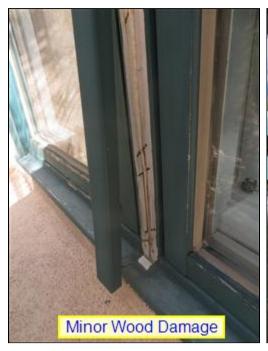
(2) Minor Wood Damage. There was some minor wood damage noted at a few of the windows. There are areas that are apparently being watered by the sprinklers. This is causing the paint to fail and the wood to deteriorate. Currently there is only minor damage at these locations. It is recommended that the sprinklers be properly adjusted or replaced with a drip system and that the damaged wood be repaired and properly painted to help preserve the life of the wood.

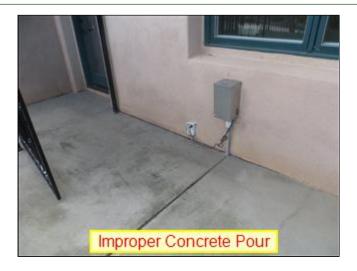
- (1) **NOTE:** It was noted that surface drains were present. Surface drains are noted but are not tested for proper working order. It is recommended that all drains be tested and kept clear of debris to ensure proper working order.
- (2) Improper Concrete Pour. The concrete at the rear and right side of the home have been improperly poured and currently covers or comes to the base of the weep screed. Weep screeds are a metal flashing at the wall base designed to allow the wall to breathe and water to drain from within the wall. Covering these areas increases the chances of moisture related problems within the wall. It is recommended that there be a 2 inch clearance between the weep screed and the concrete.

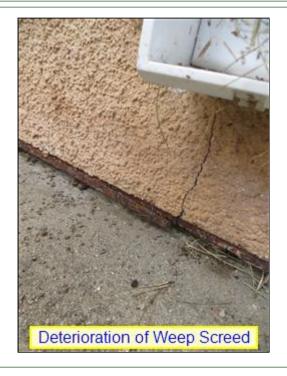
- (4) Deterioration of Weep Screed. There was some minor deterioration of the weep screed at the right side of the home. Weep screed is a metal flashing at the wall base designed to allow water to drain from the wall. Covering this area increases the chances of moisture problems within the wall. It is recommended that all soil levels remain a minimum of four inches below this point, and that sprinklers be adjusted as to not water the house.

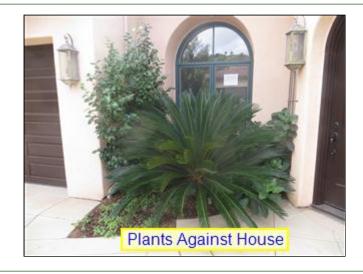
- (5) Improper Slope. There was an area at the right side of the home where the grade, slopes toward the house or does not have a directional slope. It was noted that this area has an improperly poured slab which covers the weep screed and which also slopes towards the house. There were no visible surface drains noted at this location. It is recommended that a swale, french drain or other means of drainage be provided to keep water away from house and foundation.
- (6) Plants Against House. There are areas where the shrubs or tree limbs come into contact with the roof line or the walls of the building. It is recommended that all shrubbery and trees be cut away from the house to create a clear space of about 12 inches. This will help to minimize potential moisture and pest related problems.

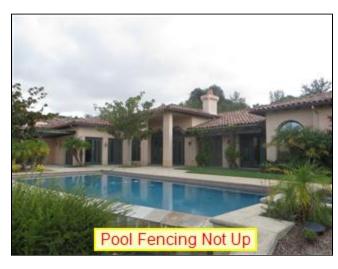
(1) NO POOL FENCE. It is highly recommended, especially with children, that a fence be installed around the pool area. This fence should be a minimum of 48 inches high, with a max opening of 4 inches between lateral bars, and no more than 2 inches from the ground. Access to the pool should be by an outward swinging, self closing gate, with a latch out of a child's reach. All house doors leading to the pool area should have a child proof lock as well as an audible alarm. For more information and specifics on pool fencing, visit: Pool Safety (It was noted that a retractable fence was stored by the pool equipment). It was not determined at the time of the inspection if all sections were present, or if there were any problems with the provided fence. It is recommended that the fence be verified as being in working order before the close of escrow.

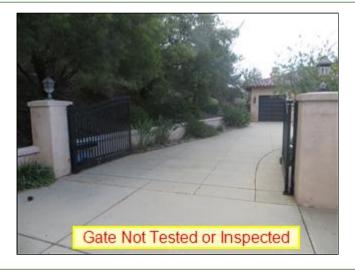
(2) Not Inspected- The Driveway gate was not tested or inspected. There was currently no remote to test this feature. It is recommended that this be further evaluated by a qualified professional.

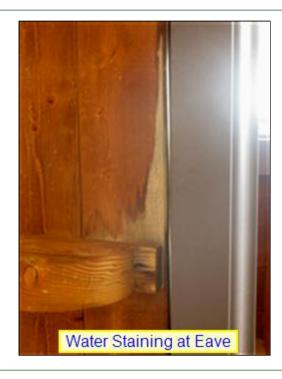
Water Staining at Underside of Eaves. There was some water staining noted at the underside of the eaves at two locations. These were noted at the right side of the house, and at the main rear patio area. It is recommended that these areas be properly flashed to help ensure the starter boards do not become damaged.

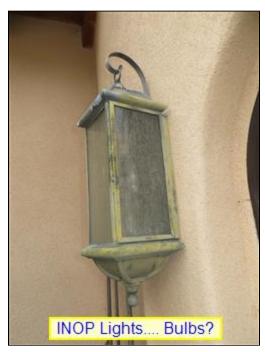
(2) INOP Lights.... Bulb? Some of the exterior light fixtures did not operate when fixtures were turned on. This could be because the fixture bulbs need replacement, OR there could be an electrical problem with the fixture. Recommend changing lights bulbs to determine the problem and replace as needed.

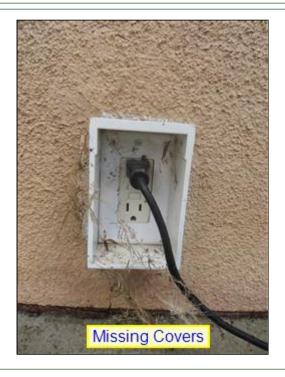
(3) Missing weather cover. All electrical outlets outside should have protective weather covers provided. For safety reasons all outlets and switches should have secure covers to reduce the chance of damage and electric shock.

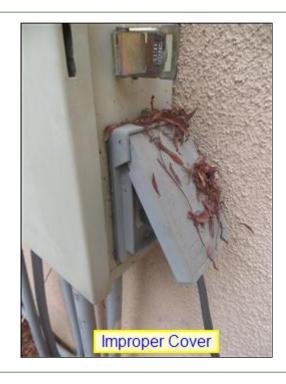
(4) Improper Outlet Cover. This outlet requires a permanent fixture use cover for this type application. Exterior outlets are equipped with a weather cover for the protection of the outlet. This type outlet cover is designed for temporary use appliances (i.e. electric lawn mowers, radios etc.) Appliances for permanent use (i.e. Fountains, sprinkler timers, or outdoor lighting) require a different cover, designed to seal weather out of the entire fixture when plug is inserted. Recommend purchase and installation of correct weatherproof electrical cover.

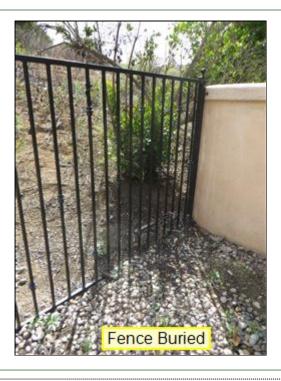
Property is not part of the inspection and were not all viewed for damage or issues. However it was noted that there were several areas of rod iron fencing that were buried. This will cause deterioration and premature failure of the metal. It is recommended that the soil at these areas be leveled so there is no earth contact.

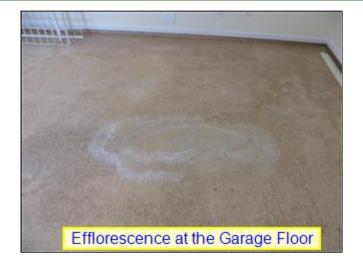
(1) Efflorescence at the Garage Floor. There was some mild pitting of the garage floor noted. Efflorescence is a (powder-like substance) of calcium/ and salt which deposit at the exterior of the block as water evaporates. In new construction this may occur through hydration as the block or brick cures. On concrete, this usually indicates that moisture is in contact with the masonry. Typically in these instances, efflorescence is not a structural concern, but more of an aesthetic issue. This is noted for your information and should be observed over time. Reducing the amount of watering may help limit this.

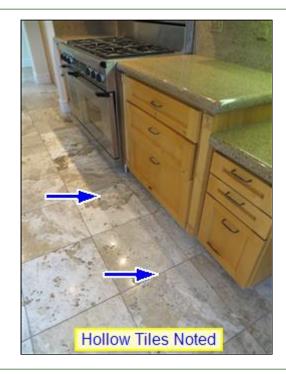
Hollow Tiles. Some of the tiles in the kitchen were laid with a minimal thin set at the underside of the tile. According to ANSI tiles should laid with a minimal of 90 percent coverage. If proper coverage has not been met this may result in the tiles to prematurely crack or lift, and become loose. This is noted for your information and repairs may be needed in the future.

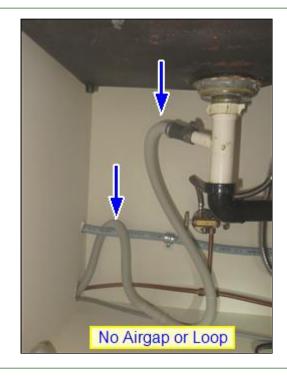
No Air-gap or High Loop. There is presently no airgap or high loop at the waste line for the left dishwasher. Air gap devices prohibit sewer water from backing into the dishwasher through the possibility of siphonage. When water backs up, due to a plumbing clog, the air gap devise installed for your dishwasher will dispense water at the sink. Recommend the purchase of an air gap device or the install of a high loop.

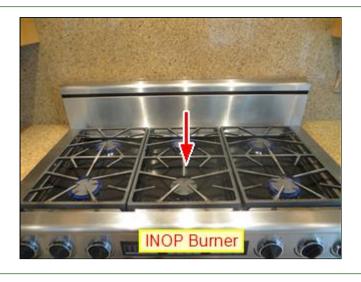
INOP Burner. One of the burners did not properly operate at time of Inspection. This may be able to be repaired with a simple cleaning, or may need to have parts replaced. It is recommended that this be further inspected by a licensed repairman.

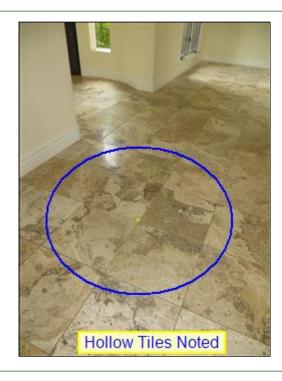
Hollow Tiles. Some of the tiles at the entryway, were either laid with insufficient thinset, or have 'popped'. These areas were noted as having a hollow sound when tapped. According to ANSI tiles should laid with a minimum of 90 percent coverage. If proper coverage has not been met this may result in the tiles to prematurely crack or lift, and become loose. It is important that excessive weight not be placed on these areas, doing so may cause these tiles to break. This is noted for your information and repairs may be needed in the future.

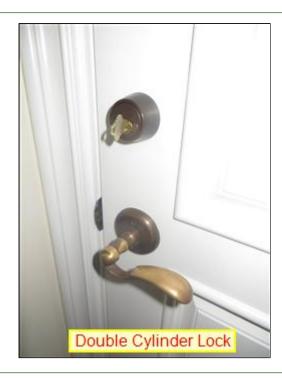
Double Cylinder Lock. The door to the garage is equipped with a lock which requires a key to unlock the door from the inside of the house. These are often found on doors with windows in them, because of the fear of someone breaking the glass and unlocking the door. However these pose as a safety risk, if the key is not provided in the door when the door needs to be used in the event of an emergency. Because of this factor, it is recommended that this lock be changed to a single cylinder lock type by a qualified person.

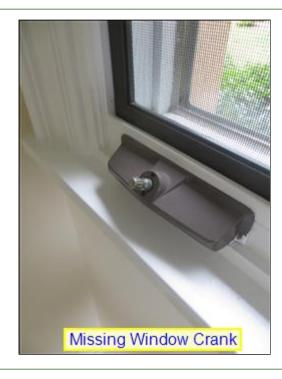
Missing Window Crank. The jalousie window crank in bedroom #1 was missing at time of inspection. It is recommended that this be replaced by a qualified person to allow the window to properly function.

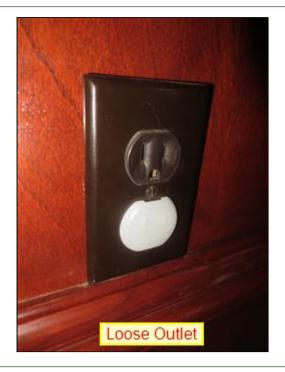
(1) Loose Outlet(s). There was a(n) loose at the wall connection in the study. Loose outlets can pull the wires from the back of the receptacle causing the wires to arch or cause electric shock. For safety reasons it is recommended that these outlets be properly secured.

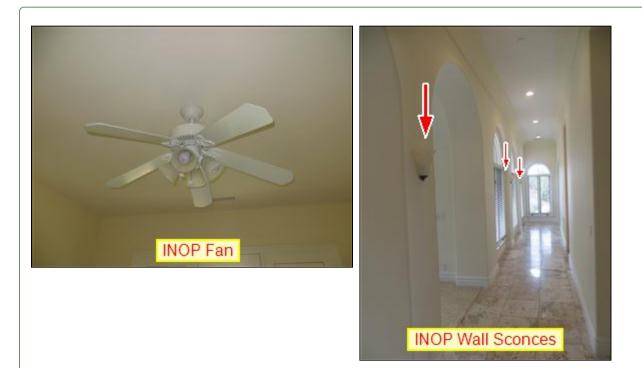
(2) INOP Fan. The ceiling fan in bedroom #3 did not function at the time of the inspection. The cause of this could not be determined. It is recommended that this be repaired or replaced at your convenience.

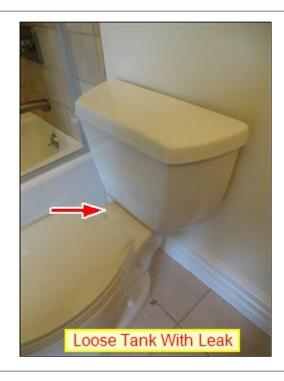
Loose Tank with Leak. The toilet tank at the back of the toilet is loose and should be tightened. Currently this toilet leaked at the tank connection. (WARNING) Over tightening will cause the porcelain to crack and the need for replacement of the toilet/ tank.

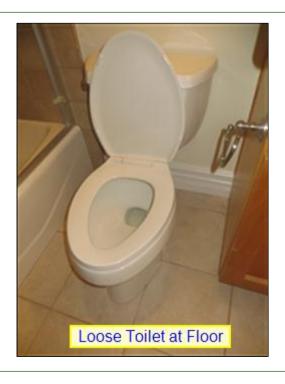
The toilet fixture in this bathroom is loose at the floor. This could cause the wax ring to become dislodged and your toilet to leak water onto the floor. It is recommended that this toilet have the wax ring replaced and the toilet secured to the floor (to ensure a proper seal), and caulking be applied to the base of the toilet. (WARNING) Over tightening will cause the porcelain to crack and the need for replacement of the toilet.

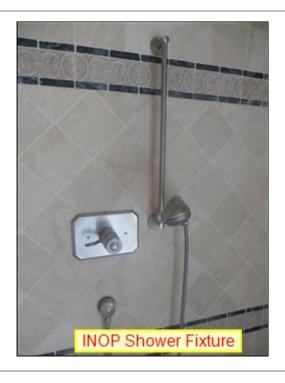
INOP Shower Fixture. The left shower fixture did not work at the time of the inspection. The cause of this was not determined at the time of the inspection. It is recommended that a licensed plumber be called out for further analysis and repair as needed.

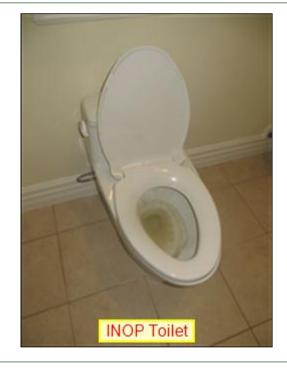
Improper Flush. The toilet in this bathroom did not have a proper flush. The water swirled around but not all of the water was flushed, leaving debris in the toilet after the flush. It is recommended that this be further evaluated and repaired by a licensed plumber.

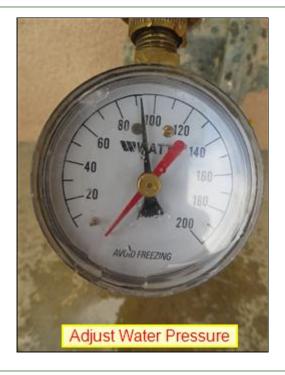
Water pressure at time of test was noted at being 92 PSI. It is required that when the water pressure exceeds 80lbs, a water pressure regulator be installed due to heightened risk of plumbing malfunction due to pressure. This unit has a regulator installed, but apparently needs adjustment or replacement. Recommend adjusting/ or purchase of new regulator, so water pressure is between 50lbs-80lbs when valve is fully open.

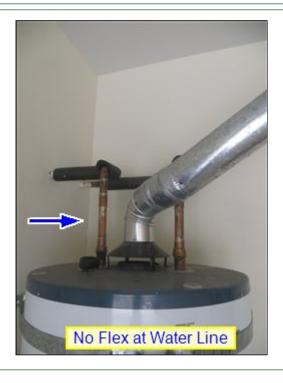
(2) No Flex Water Line. The copper piping extending from the top of the 75 Gallon water heater should have a flexible copper line and be provided with a heat loop or trap. This heater currently has rigid copper tubing and no heat trap or loop. It is recommended that this is corrected by a licensed plumber.

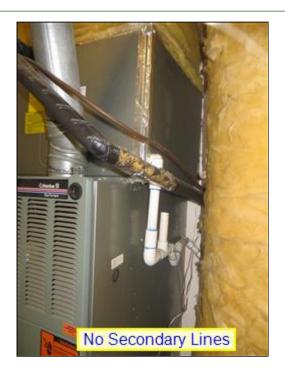
Air conditioning units create water as a byproduct. This water is carried out of your house via two methods. The first is carried through the primary condensate line located by the PVC pipe. These lines drain to the exterior of the house. The secondary line is currently incomplete. Should your primary line become blocked or clogged, water will discharge through the secondary line, and will flood this area. There are several alternative methods to alleviate this issue. It is recommended you contact an HVAC specialist to determine which is the most efficient, and effective way of dealing with this.

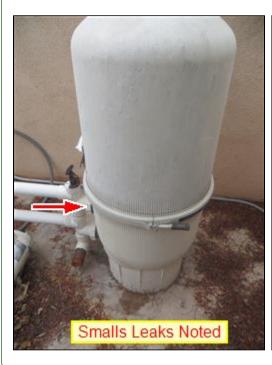
Leak Noted at Plumbing Lines. There were several small leaks at the pool plumbing. These were noted at the filter seal, the back flow device and and the back-pressure valves. It is recommended that these be repaired as needed by a licensed plumber or qualified pool professional.

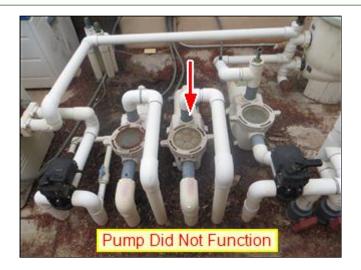
INOP Pump. The second or middle pump in the series did not function. No water went through this system. The valves for the pumps were not turned, it is possible that the valves were adjusted to not allow water to flow to this pump. It is recommended that this be further evaluated and repaired as needed by a licensed pool specialist.

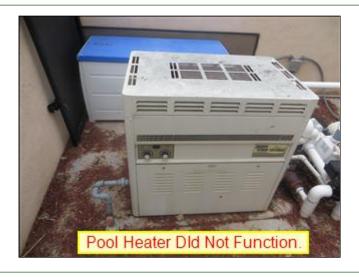
The pool heater did not turn on in either the service mode, or the manual mode. It was also tried from the master keypad in the master bedroom. The cause of this could not be determined. It was noted that there was an error message. It is not known if this code indicates the problem with the heater for this unit. It is recommended that this be further evaluated by a licensed specialist.

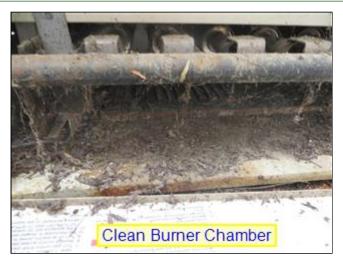
(2) Clean Burner Chamber. There was a build-up of debris at both the vent and burner chamber of the heater. It is recommended that this be further evaluated and cleaned as needed.
