Inspection Report

Property Address:
1530 Sunburst Way # 287
San Marcos Ca 92078

Nation Wide Inspections

Date: 2/14/2013	Time: 04:00 PM	Report ID: J021413P
Property: 1530 Sunburst Way # 287 San Marcos Ca 92078	Customer: Daniel Yooniker	Real Estate Professional: Thad Ryan Ascent Realty (Union Station)

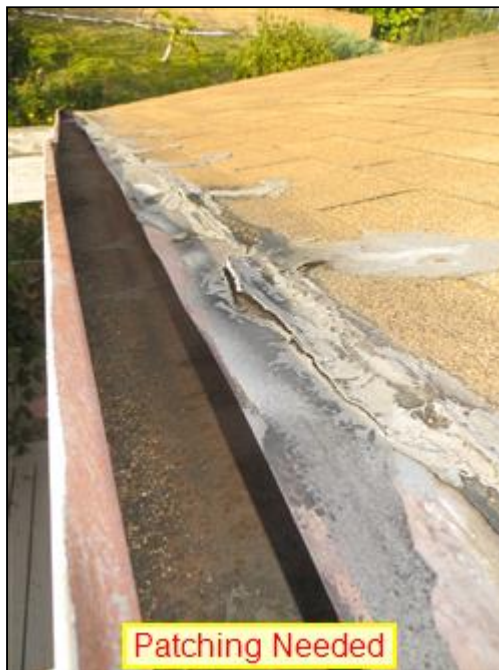
(3) **Patching Needed.** There were some areas around the edge of the home, that are in need of patching. These areas can allow water to enter the seams causing roof leaks. It is highly recommended that these areas be patched by a licensed roofing contractor.

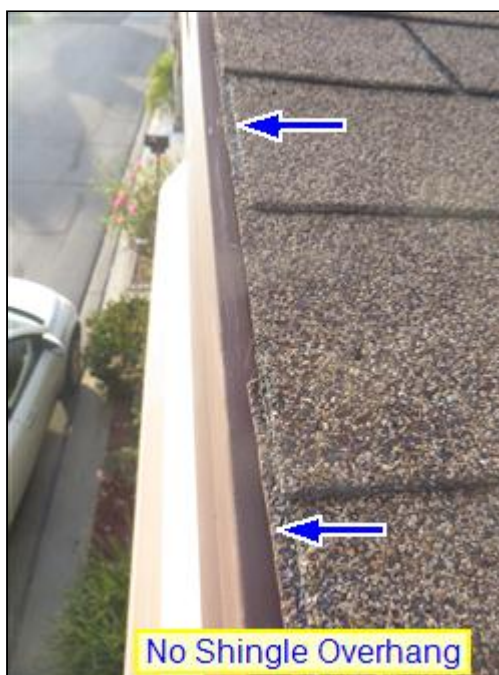
🏠 (4) **No Overhang at Rake.** Roof coverings should extend off the roof by a minimum of 1/4 inch. This was not observed in all area of the overhang. This is to allow the water to drip off the roof and not damage the fascia or eave boards. When roof is replaced, it is recommended that an drip edge be installed around perimeter of house.

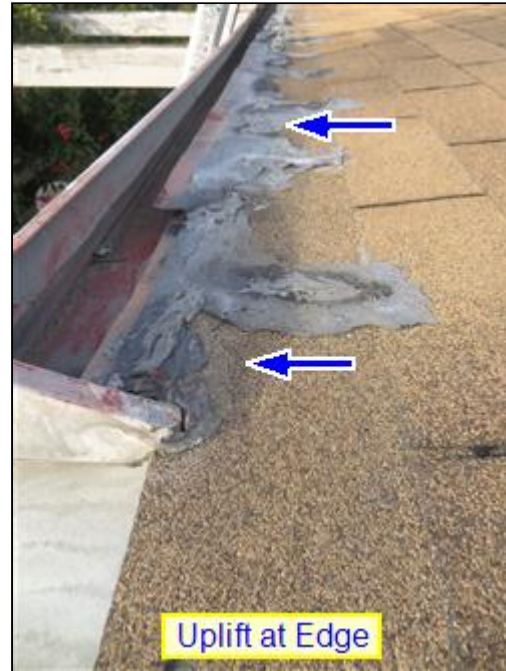
📍 (5) **Uplift at Edge.** There were some areas around the perimeter of the roof that have areas of uplift or a lip at the edge. This lip can inhibit water from properly draining, increasing the risk of water intrusion and damage. It is recommended that this area be further evaluated and repaired as needed by a licensed roofing contractor.

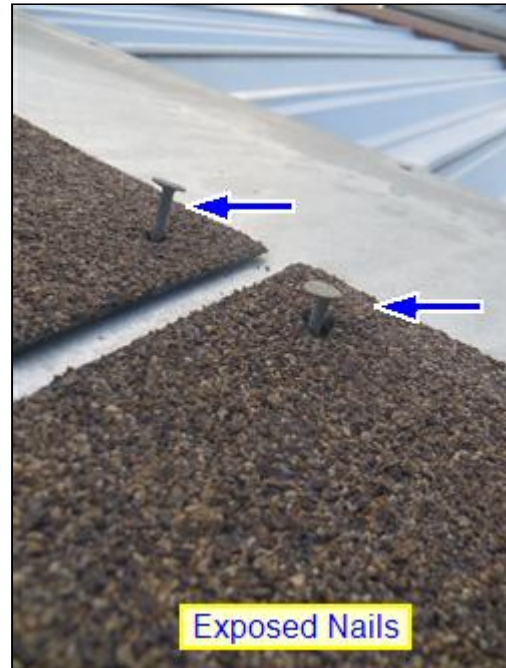
(6) **Exposed Nails.** There were a few areas where there were some exposed nails. All nails should be covered with roofing material or Mastic. It is recommended that these areas be further evaluated and be repaired as needed by a licensed contractor.

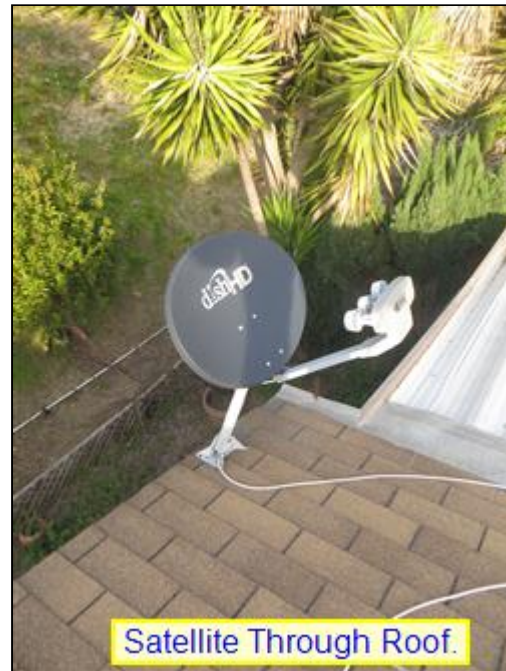
(7) **Satellite Through Roof.** The satellite dish on the roof was improperly installed and was bolted through the roofing material. This puts holes in your roof, increasing the risk of roof leaks. It is recommended that this dish be removed and the holes be properly repaired by a licensed contractor.

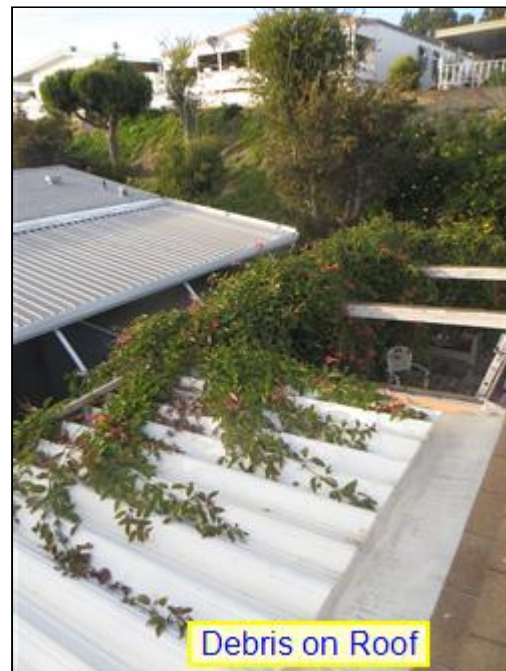
(8) **Debris On Roof.** There was some debris on the roof, over at the left side of the home. It is recommended that this roof be cleared of debris. Debris can create a dam like feature that can allow water to pool and increase the risk of roof leaks. It is recommended that this area be cleared of debris.

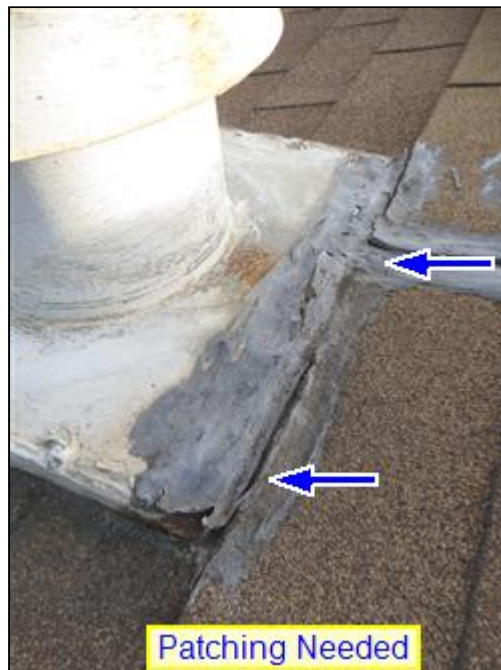
**Patching Needed.** There were some areas of flashings where the Mastic was worn and cracked. It is recommended that these areas be further evaluated and resealed as needed by a licensed roofing contractor.

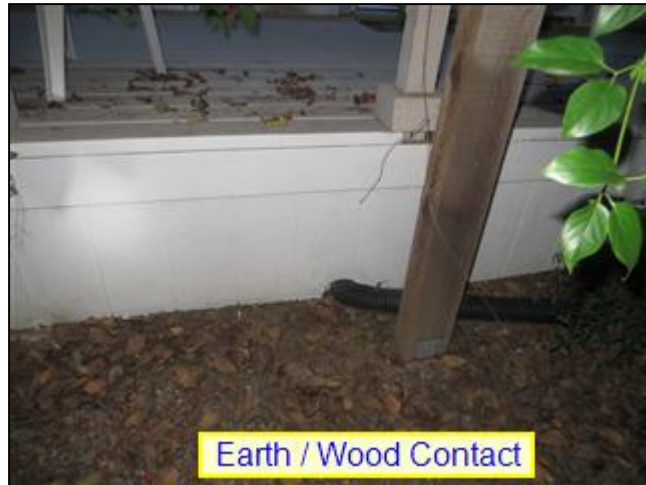
(1) **Earth/ Wood Contact.** Some of the wood siding has earth/ wood contact. All wood products, exposed to weather, should be at least six inches above the ground or be of pressure treated lumber. It is recommended that all damaged wood be repaired or replaced, and lumber that falls within six inches of the ground be provided with pressure treated lumber.

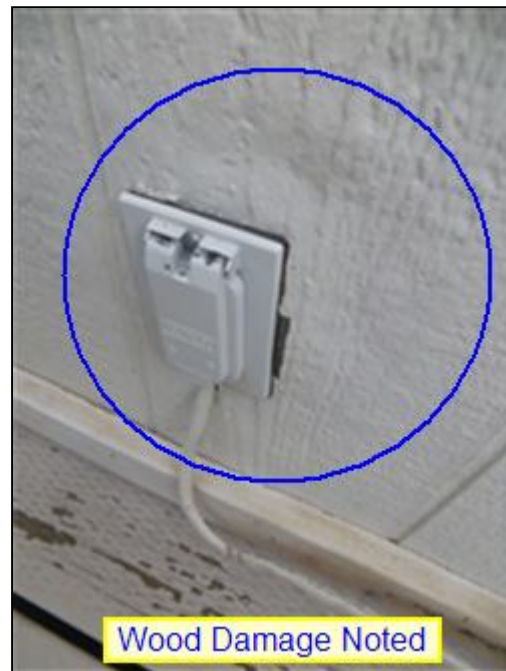
(2) **Wood Damage.** It was noted that there were a few areas of siding that have areas of damage. These were noted at the left side of the home. It appears that this damage has been caused by water intrusion. It is recommended that all damaged wood be repaired or replaced as needed by a licensed contractor.

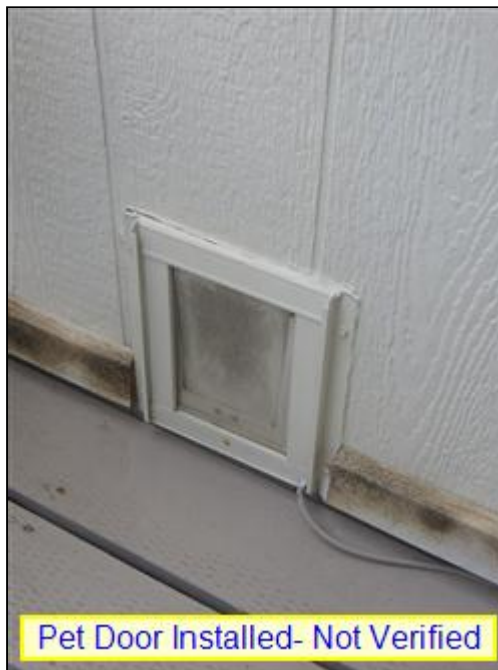
(3) **Pet Door Installed- Flashings Not Verified.** There was a pet door installed at the exterior wall of the house. The flashing at this location was not able to be verified. Flashing helps to inhibit water intrusion at wall penetrations. Not having flashings, or having improperly installed flashings can greatly increase the risk of moisture intrusion and damage. It is recommended that this area be further evaluated by a licensed contractor to ensure proper flashings have been installed and repaired if needed.

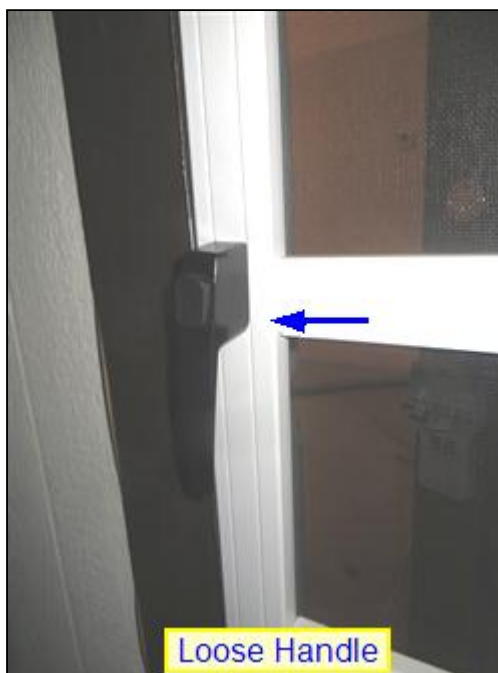
🏠 (1) **Loose Handle.** The screen door at the left side of the home was loose at the time of the inspection. It is recommended that this be repaired or secured to ensure proper working order.

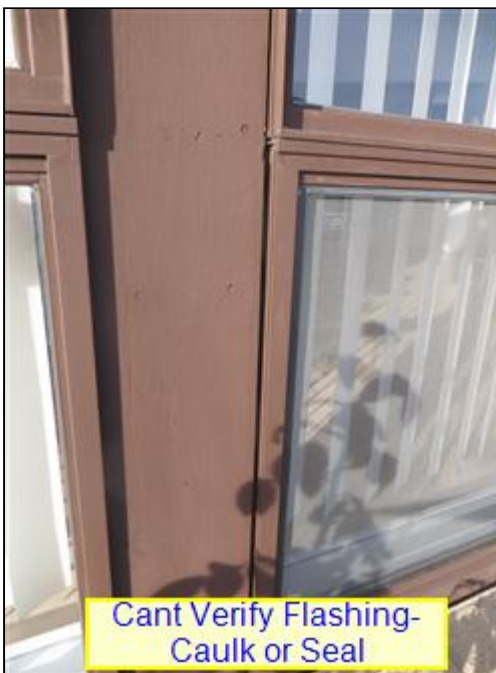
(3) **Caulk Windows**. There were some areas around the windows where the caulking has begun to crack or is missing. **It is recommended that a new bead of caulking be provided around the windows.**

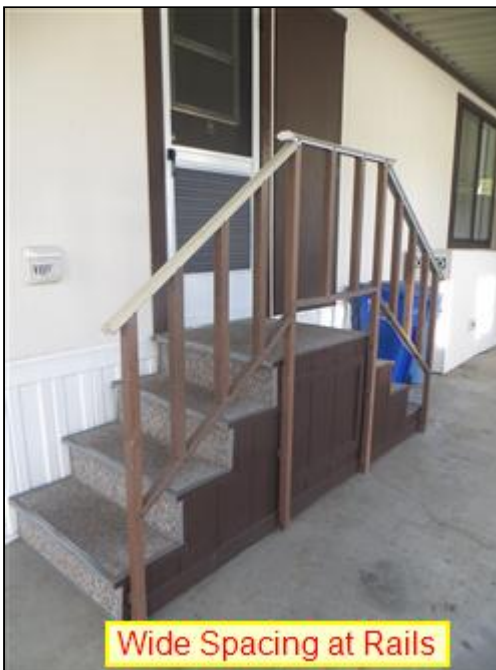
🏠 (1) **Wide Spacing at Rails** . The balusters at the deck and stair railings are currently spaced greater than 4 inches. Although this may have been standard at the time this was built, it is recommended for today's standards, that the spacing of these balusters be no greater than 4 inches. This is a safety measure to help ensure that a child cannot slip through this area. **It is recommended that you add a screen or more balusters at this location.**

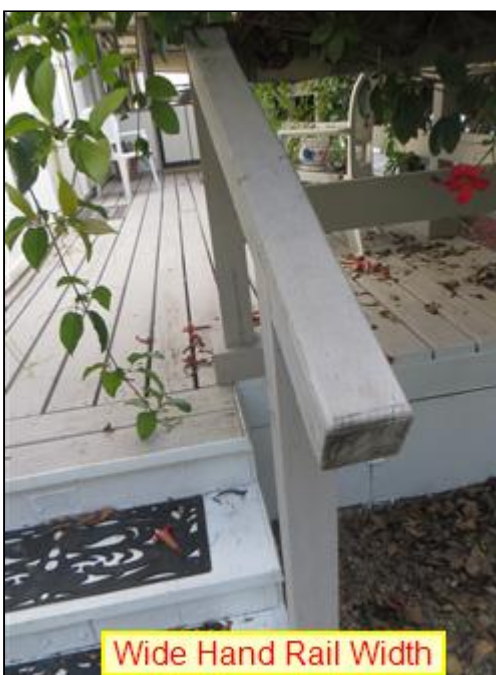
(2) **Wide Hand Rail Width**. The hand grip surface of the handrails at the rear of the house are currently greater than 2 inches. Handrails should have a hand grip surface of no less than 1.25 inches nor more than 2 inches in cross sectional dimension. **Recommend correction of handrail width.**

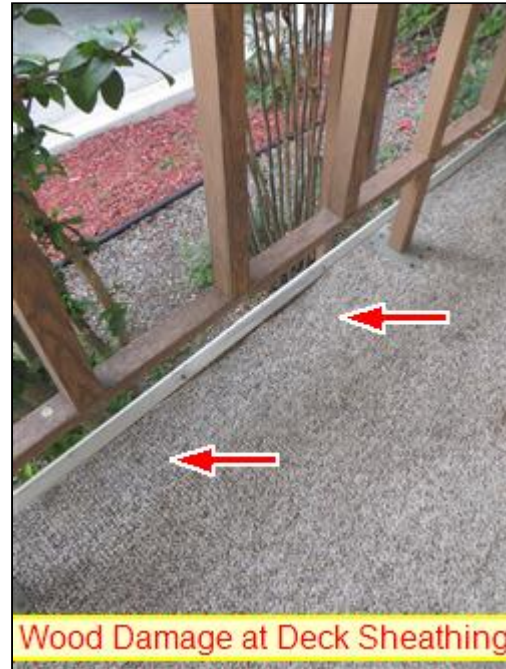
(3) **Wood Damage** . There was some wood damage noted at sub floor of the front deck. It is recommended that this area be further evaluated and that all damaged wood be repaired or replaced as needed by a licensed contractor.

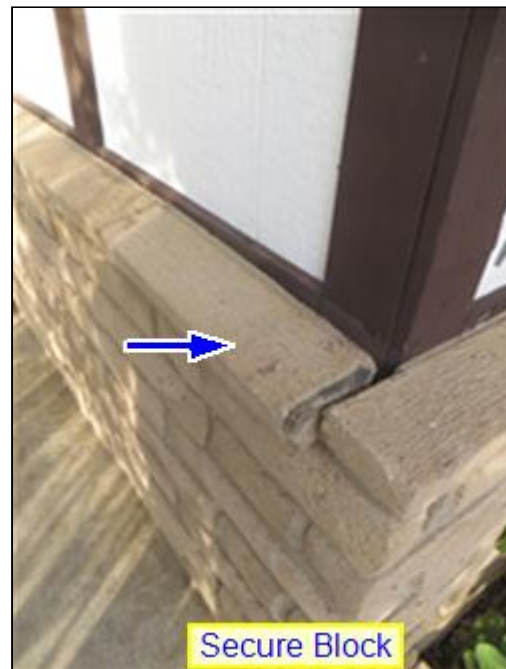
(4) **Loose Block**. There was a loose brick noted at the entry way at the left side of the home. It is recommended that this block be properly secured.

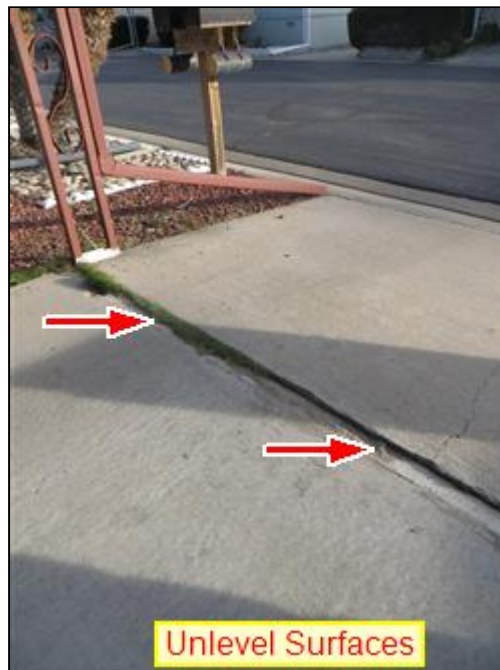
(1) **Possible Trip Hazards.** There were areas at the driveway where the walkway was not level. It is recommended that these areas be repaired as needed that that care be taken when walking on these surfaces.

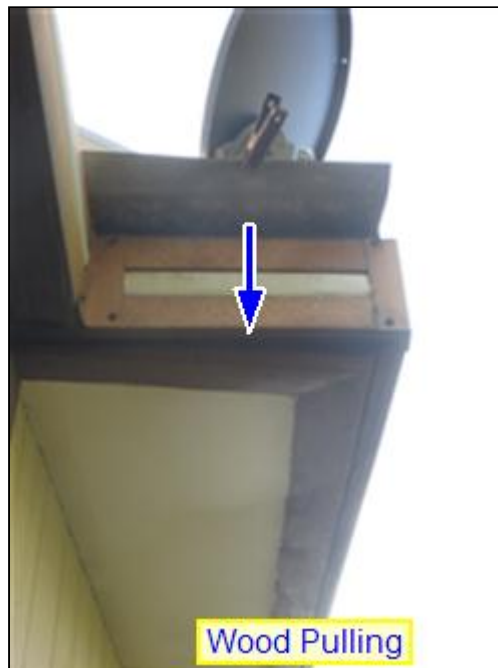
**Wood Pulling.** There was a section of eave in which the wood was beginning to pull. This was noted at the rear right corner of the home. It is recommended that this be repaired as needed by a licensed contractor.

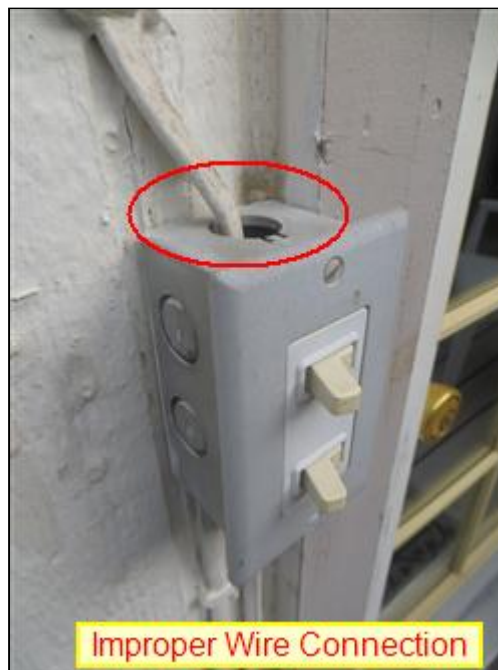
(2) **Improper Wire Connection.** There was a junction box at the exterior of the house that had some exposed openings. These openings can allow water to enter the boxes. All exterior outlets should be equipped with proper fittings to allow for the protection of the outlet. Recommend that these boxes have proper weatherproofing installed.

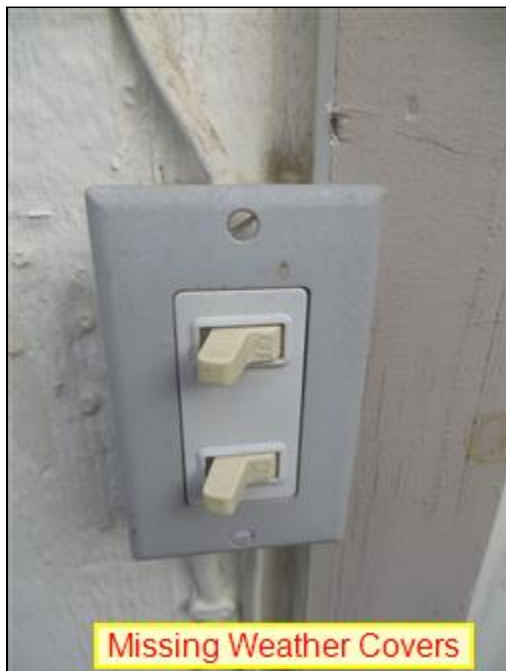
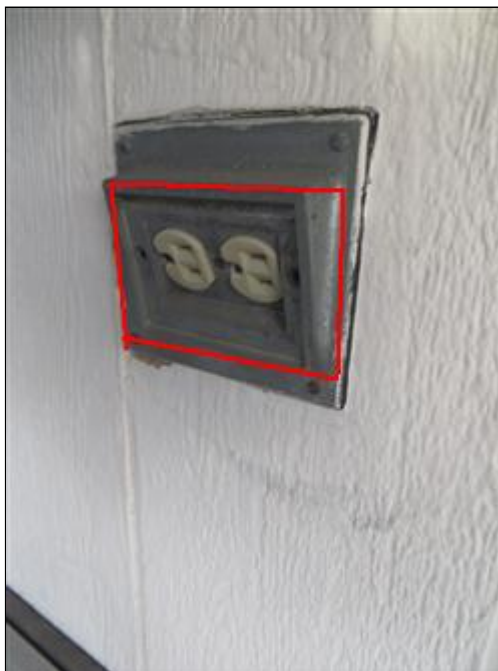
(3) **Missing Weather Covers.** There are some outlets or switches that did not have covers provided. All junction boxes should be provided with covers to help avoid the possibility of damage and electric shock. **It is recommended that this box be fitted with a proper cover.**

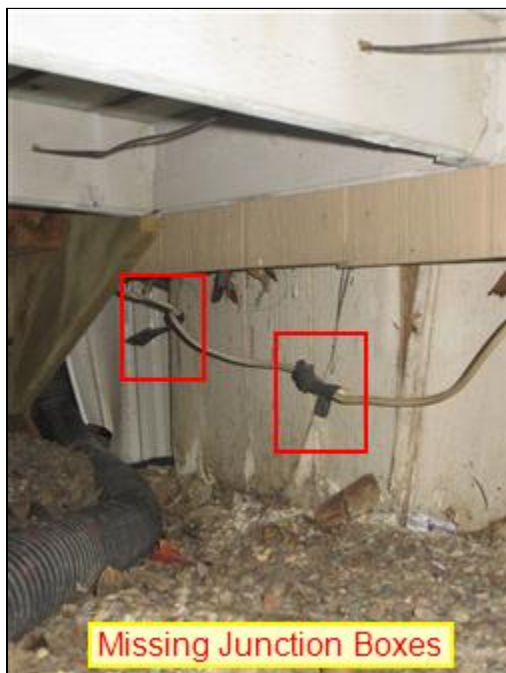
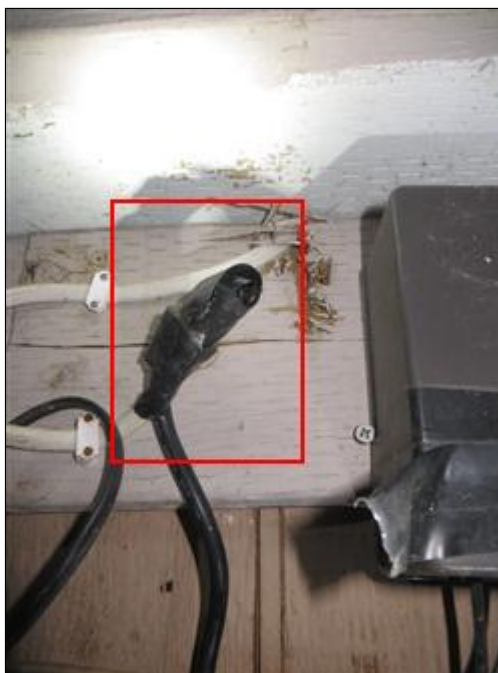
(4) **Missing Junction Boxes.** All wire connections, and splices should be contained within a listed junction box. Junction boxes secure and conceal all wire connections and help to inhibit damage and shock. **It is recommended that a junction box be provided at this location by a licensed electrician or contractor.**

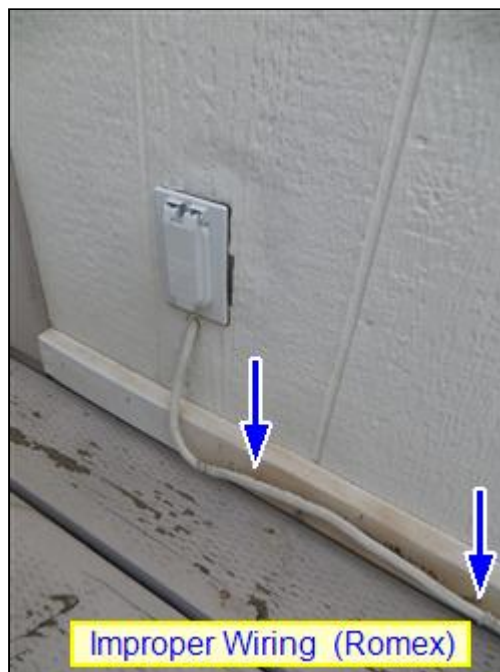
(6) Improper Location/ Use of Romex

The use of Romex or NM-B wiring at the underside of the eaves is not permitted. Romex is not permitted in wet or damp locations. It is recommended that all Romex wiring at these locations be further evaluated and changed to an appropriate material by a licensed electrician.

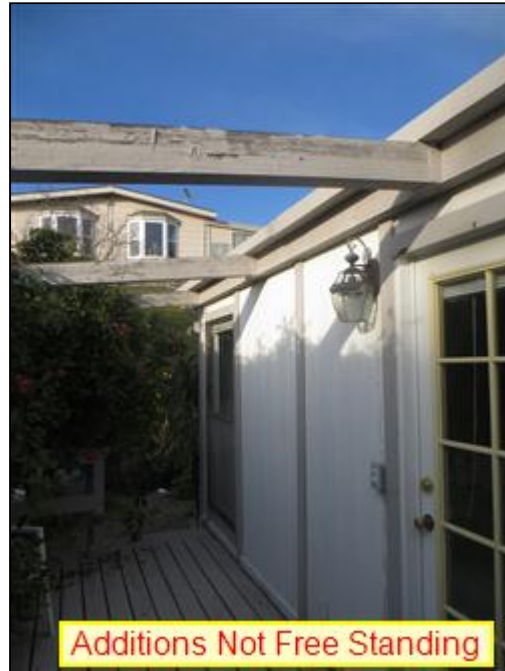
(2) **Improper Support of Addition.**

The porch and percolate addition at the left side of the home is not free standing and uses the exterior wall of the home as a means of support. **All additions, porches, decks and other additions to modular homes modular homes must be free standing.** This is to ensure that the integrity is not compromised. **It is recommended that this be further evaluated and repaired as needed by a licensed contractor.**

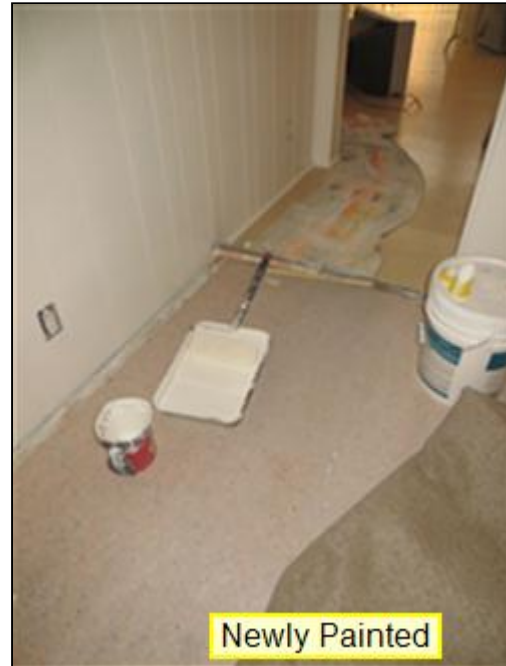
(1) **Newly Painted Note:** It was noted that the walls and or ceilings of this house have recently been painted. Painting of these areas can often hide: patching, stains or other clues we use to help determine if there are greater issues present. Although we do our best to find all current and potential problems, newly painted areas can often make it impossible to find current issues. This is noted for your information.

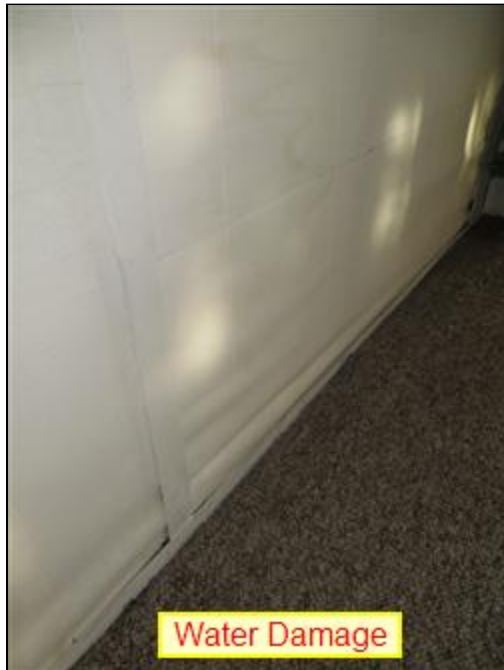
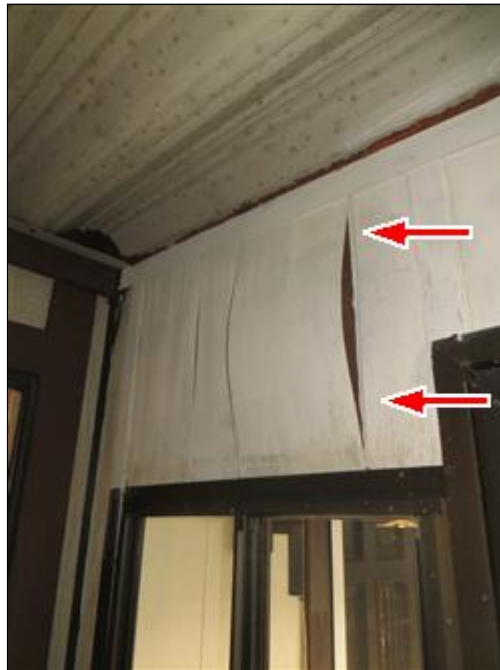
(2) **Wood Damage.** The base of the walls and the windows at the patio enclosure have water staining and damage. It appears that water enters this area at the exterior seam, and collects within the lower channel. It is recommended that all damaged materials be replaced by a licensed contractor.

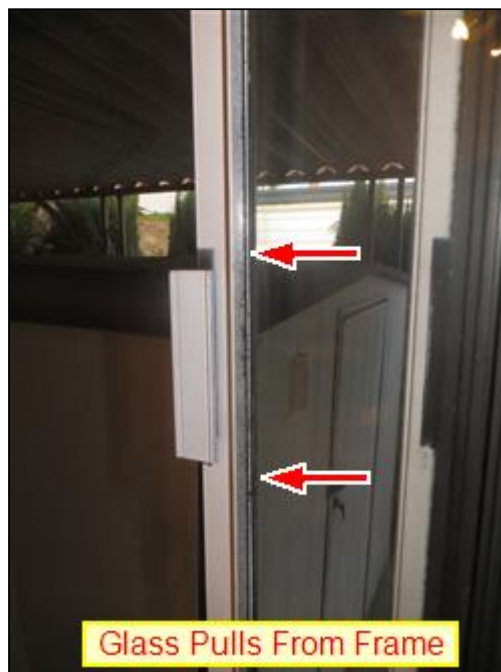
The window pane in bedroom #1 has glass which comes out of the seal within the frame. This allows the glass to pull away from the frame exposing the edge of the glass, and increasing the potential for injury. It is recommended that this window be repaired by a licensed contractor or window specialist.

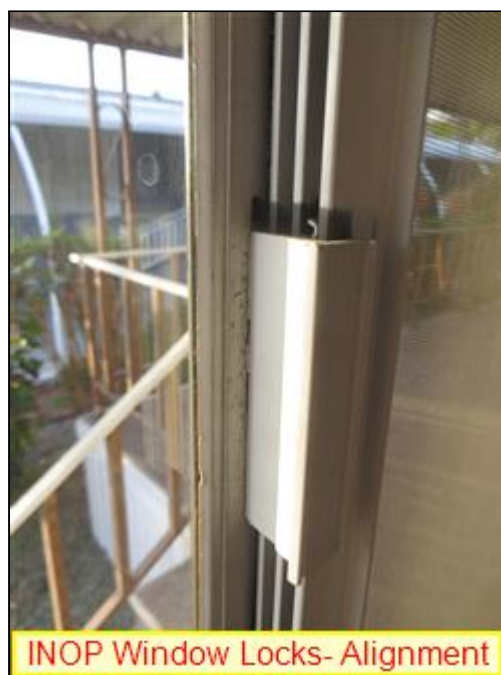
(2) Inoperative Window Locks. The window lock(s) for the windows in some of the rooms did not function. It was noted that the window did not align within the frame. For safety purposes it is recommended that this window be adjusted, repaired or supplied with some sort of locking device.

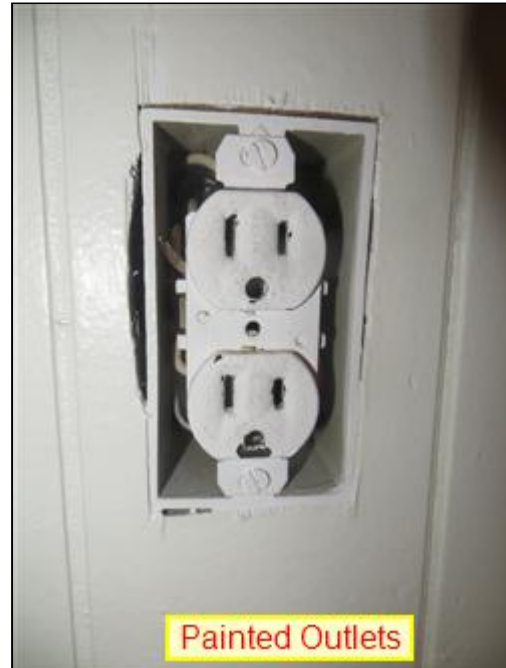
(2) **Painted Outlets.** Some of the outlets in this house were not covered when painting was conducted, and the outlets were painted. Painting of outlets increases the risk paint chips entering the receptacle and creating resistance. **This can cause the outlet to over heat causing damage to the outlet and an increased risk of fire.** **It is recommend that all outlets which have been painted be replaced as needed by a licensed electrician.**

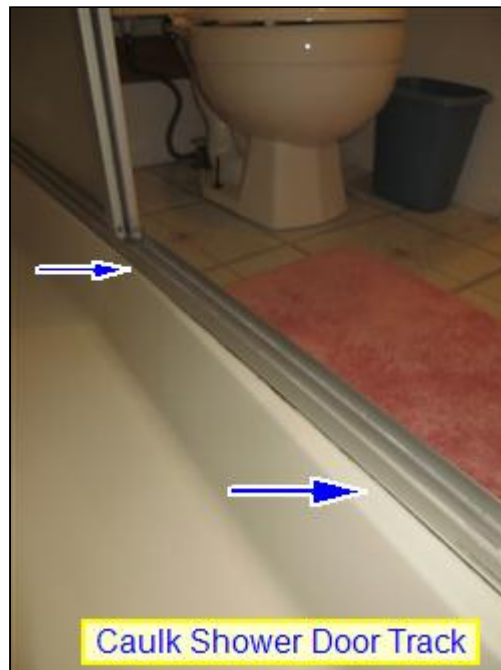
**Caulking Needed.** The track to the shower door was loose and was not caulked. It is recommended that this be properly caulked.

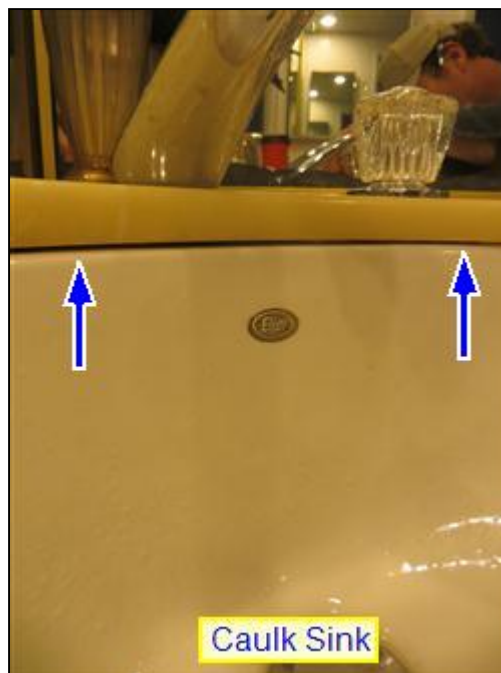
**Caulking Needed.** There was an area around the sink/ counter connection that are in need of some caulking. It is recommended that this area be properly caulked by a qualified professional.

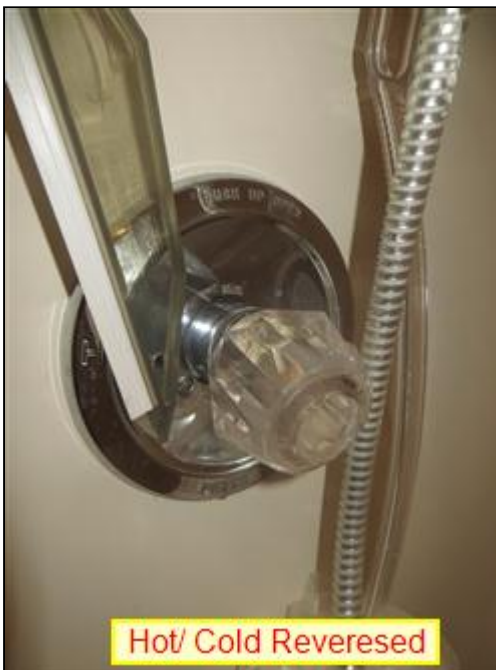
🏠 **Hot/Cold Reversed at the Shower Fixture** . It is standard that hot water is turned on the left, at the faucet; and cold water is derived from the right. In this application the hot and cold are reversed. **This is a simple fix and should be corrected for safety and burn purposes.**

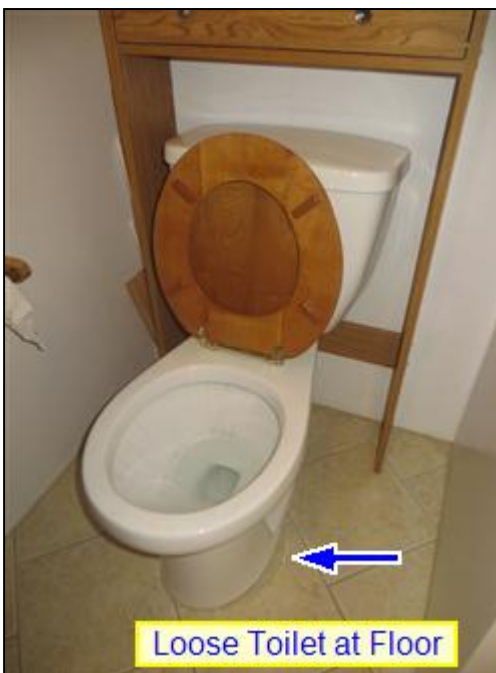
🏠 (1) **Loose Toilet**. The toilet fixture in this bathroom is loose at the floor. This could cause the wax ring to become dislodged and your toilet to leak water onto the floor. **It is recommended that this toilet have the wax ring replaced and the toilet secured to the floor (to ensure a proper seal), and caulking be applied to the base of the toilet. (WARNING) Over tightening will cause the porcelain to crack and the need for replacement of the toilet .**

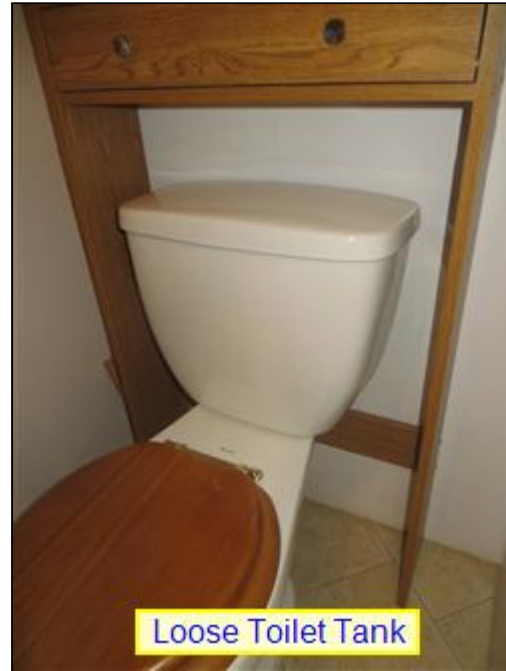
(2) **Loose Toilet Tank.** The tank at the back of the toilet is loose and should be tightened to ensure no leaks develop. **(WARNING) Over tightening will cause the porcelain to crack and the need for replacement of the toilet/ tank.**

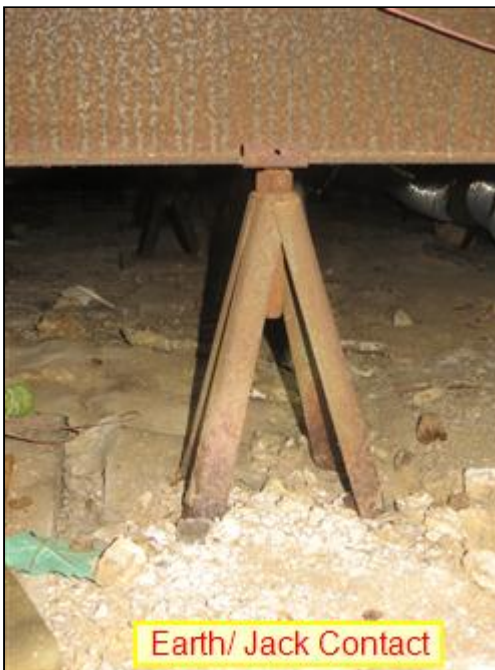
(1) **Earth/ Jack Contact.** It was noted that there were about three jacks at the underside of the home that have soil on the jacks. It appears that work has been conducted and soil has been pushed against these jacks. Soil against these jacks can cause moisture damage and jack deterioration. It is recommended that these jacks have the soil removed, and that any damaged jacks be repaired or replaced as needed.

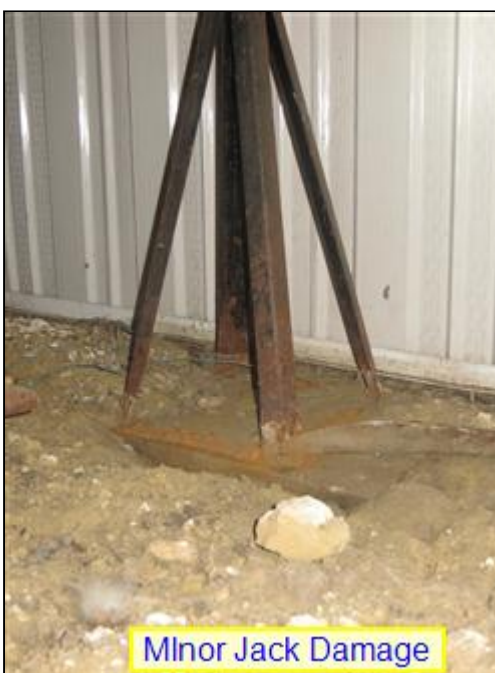
(2) **Minor/ Moderate Jack Damage.** There are a few jacks at the underside of the home that had some damage. It is recommended that the jacks at the underside of the house be further evaluated for damage and that all damaged jacks be repaired or replaced as needed by a licensed contractor.

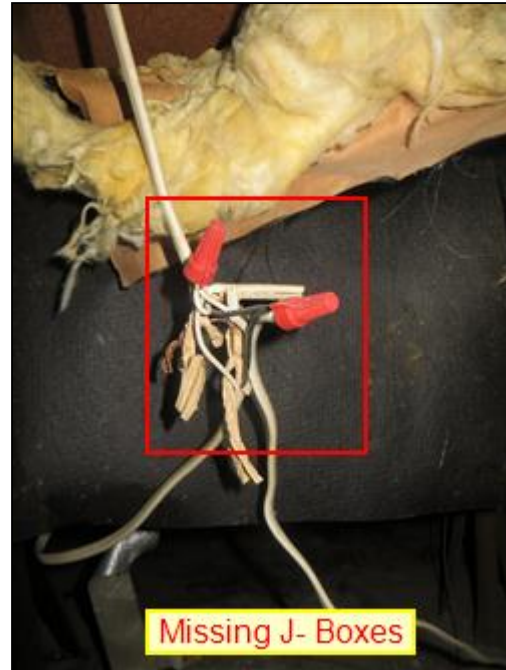
**Missing Electrical Boxes.** All wire connections need to be concealed within proper listed electrical boxes. Currently there are wire connections not contained with gang boxes. Gang boxes are used to conceal wire connections, protecting them from damage and decreasing the risk of fire. **Recommend installation of outlet boxes on all exposed wire connections.**

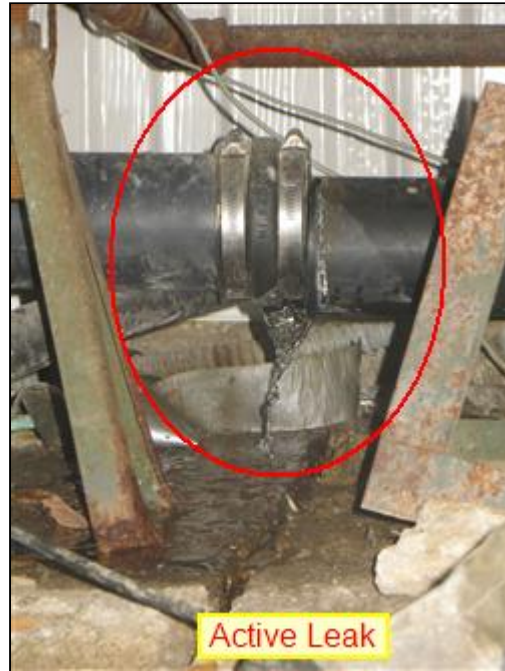
**Active Leak.** There was a large leak noted at the waste line at the underside of the house. This leak occurs at a waste line transition. It is recommended that this leak be further evaluated and repaired as needed by a licensed plumber.

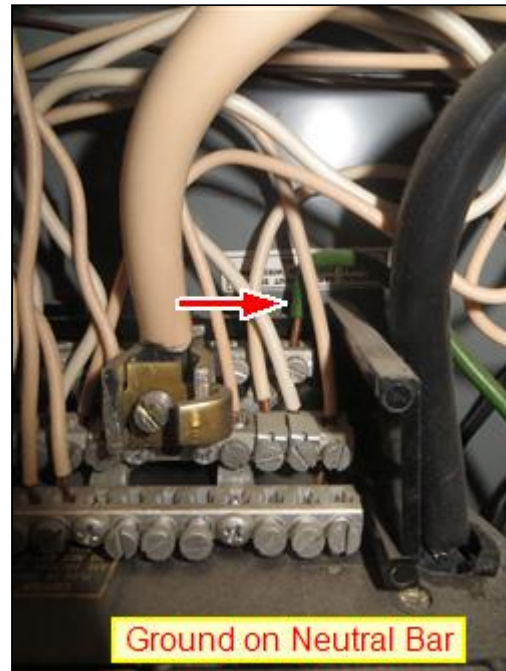
**Grounds On Neutral Bar.** The sub-panel currently has the grounding wires bonded with the neutral. In sub-panels, the neutral (white) wires should be "floating" (not touching the panel, the grounding wires ((bare copper or green)), or any other metal part of the panel) . In this application the grounding wires have been attached to the neutral bar . **Bonding of these conductors is improper and hazardous** . It is highly recommended that this be repaired by a licensed electrician.

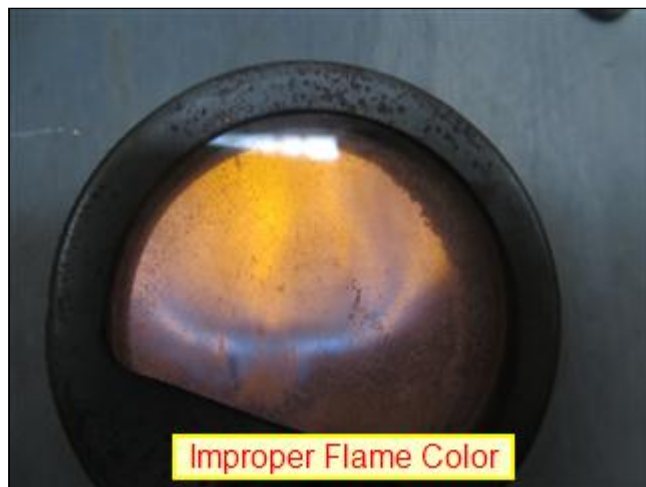
(3) **Improper Flame Color.** The heater did not appear to have any visible cracks at the heat exchangers, however the furnace had an improper flame color. This could be caused by multiple reason, including: burning particles on the burners, improper air/ gas mixture, or a crack in the heat exchanger. **Do Not Use This Heater Until It Has Been Further Evaluated by a Licensed HVAC Specialist.** It is recommended that this heater be further evaluated and repaired by a licensed HVAC specialist.

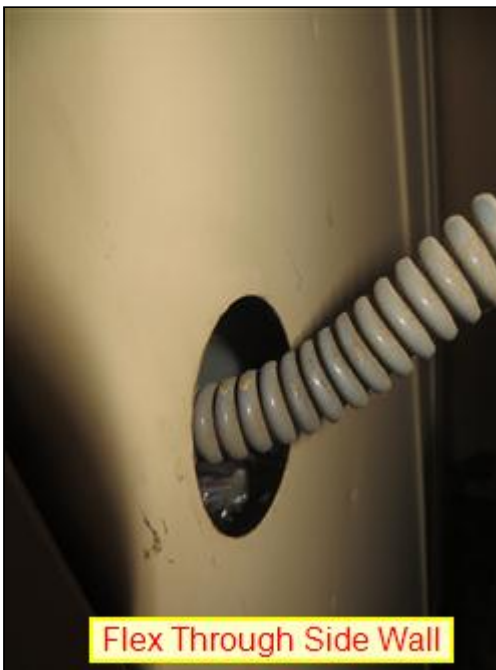
(4) Improper Gas Line Connection .

The flexible gas line, for the furnace, currently extends into the burner compartment. The line entering into this compartment should be of rigid metal . It is recommended that this be changed out by a licensed plumber or HVAC professional.
