Inspection Report

Property Address:
8295 La Mesa Blvd.
La Mesa Ca 91941

Date: 4/25/2014	Time: 08:30 AM	Report ID: J042514A
Property: 8295 La Mesa Blvd. La Mesa Ca 91941	Customer: Sample Report	Real Estate Professional:

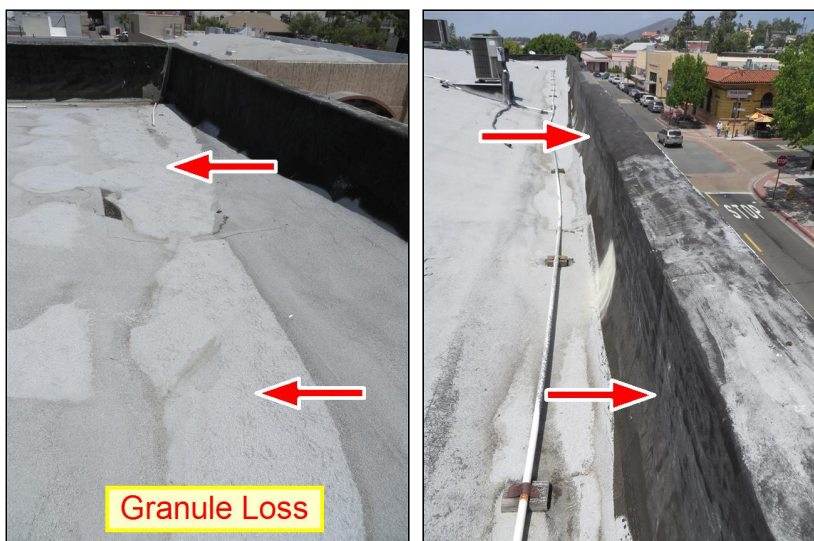
(2) **Granule Loss.** There were large areas of hydrocarbons forming at the lower sections of the roof. These granules are designed to impregnate the roofing material and protect it from the sun and other elements. The loss of these granules exposes the asphalt, and will speed up the rate of deterioration. **There was currently no protection at the parapet walls and cap.** It is recommended that the roof be further evaluated for defects and repaired as needed by licensed roofing contractor.

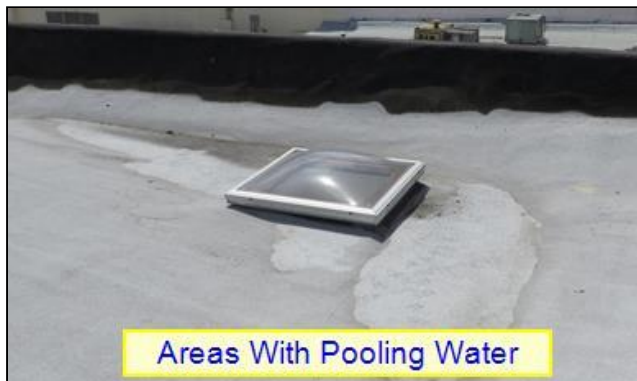
(3) **Improper Slopes- Pooling Water.** There are some locations on the roof in which there is evidence of pooling water. There were unlevel surfaces which are collecting water. This was noted at the Northwest corner. **It is recommended that efforts are made to slope these areas to allow the water to effectively shed water to the drains.**

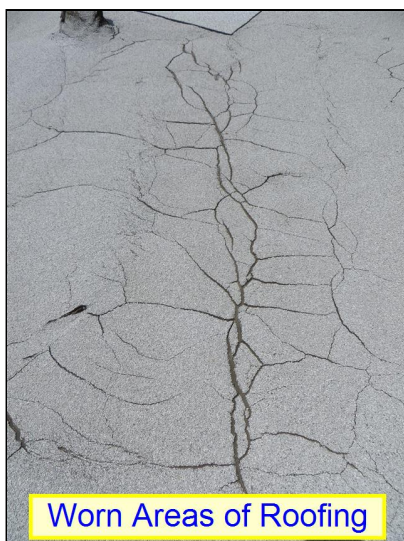
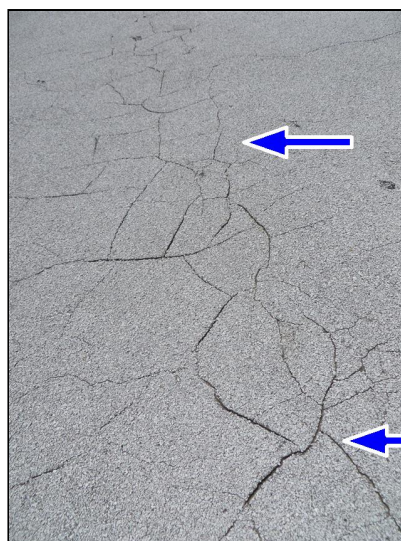
(4) **Worn Areas of Roofing.** There were some areas of the flat roof that have begun to wear. There was alligatoring/ cracking of the material at several locations. Due to the nature of flat roofs and the increased risk of roof leaks, it is recommended that this area be further evaluated. **It is recommended that the roof be further evaluated by a licensed roofing contractor and repaired as needed.**

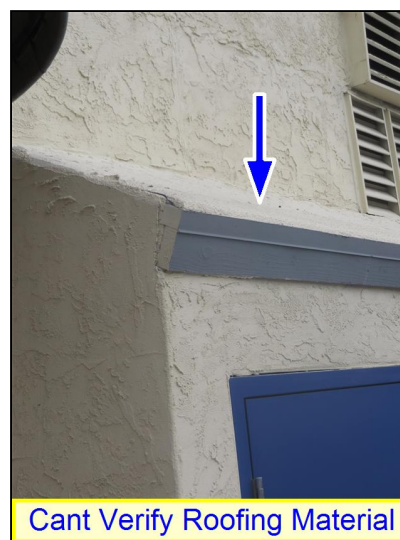
(5) **Cant Verify Roofing Material.** The roof of the electrical closet, at the rear of the building, was stuccoed and the water-proofing membrane was not able to be determined. There was no water staining at the interior ceiling of this location. **This is noted for your information and further evaluation should be conducted to ensure proper materials have been used.**

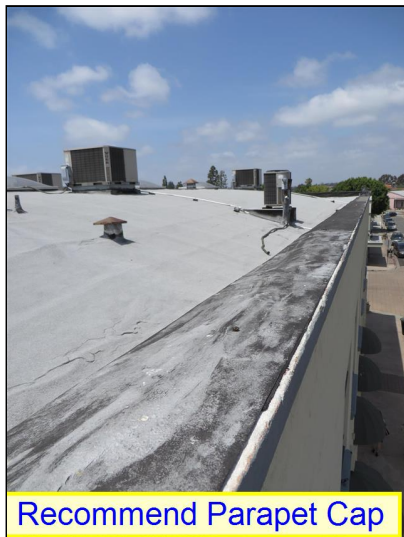
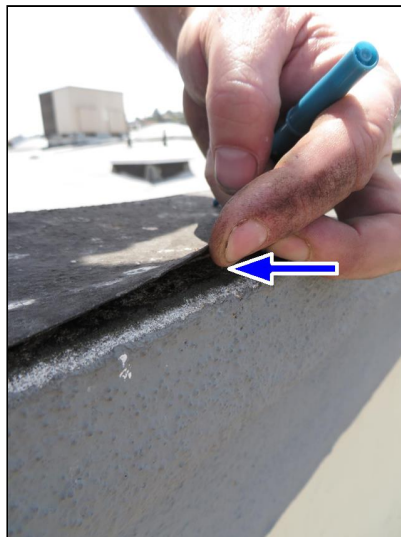
📍 (1) **No Caps at Parapet Wall.** This building has a parapet wall. Due to the nature of parapet walls, and the the difficulty of properly sealing the roofing materials at these locations, it is recommended that all parapet walls be properly flashed with a listed cap. This will help guard against the possibility of water intrusion at these locations. **It is recommended that a proper cap be installed at the parapet wall by a licensed roofing contractor.**

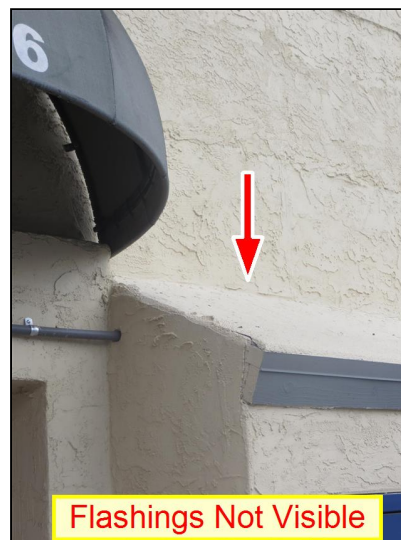
(2) **Flashing Not Visible.** There was not a visible flashing at the roof wall connection of the electrical enclosure. It was not able to be verified that there were flashings at these locations. Flashings should be installed and provided with counter flashings that are properly imbedded into the wall and stucco. **Missing flashings increase the risk of water intrusions and leaks.** **It is recommended that these areas be further evaluated and repaired as needed by a licensed roofing contractor.**

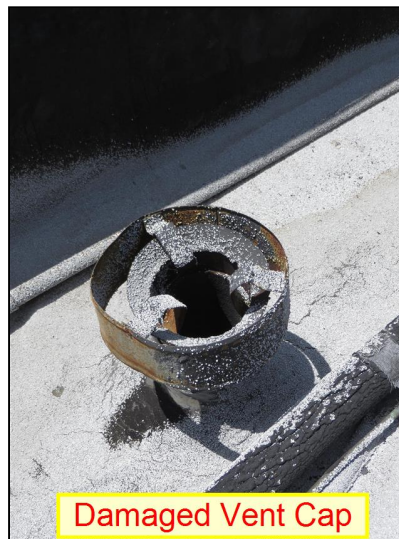
(2) **Damaged Vent Cap.** There was a vent termination at the roof that had a damaged vent cap. Vent caps are metal fittings which extend over the vents of gas fired appliances. This inhibits water from entering the vent stack which could cause damage to the equipment in which it serves. This vent goes to the water heater. It is recommended that this vent either be properly capped, or be removed by a licensed contractor or roofer.

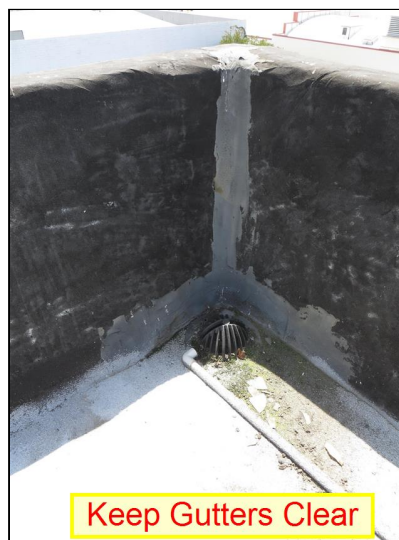
Keep Gutters Clear. There roof is not provided with secondary roof drains. Should the primary roof drains become blocked, water will pool at the roof's surface. It is recommended that these drains be kept clear of any debris and you may want to consider the installation of secondary scupper drains.

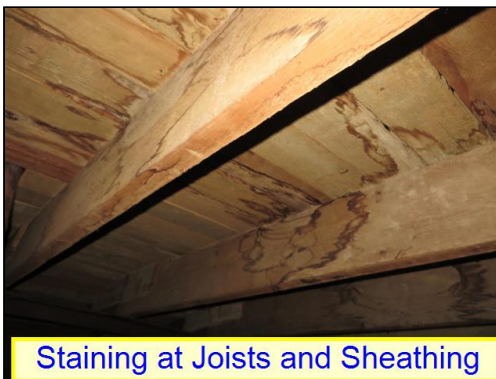
(1) **Water Staining Noted.** There were several areas of water staining at some of the sheathing and or rafters in the attic. **It could not be determined at time of inspection if there were any active leaks.** It is recommended that these areas be further evaluated and repaired as needed by licensed roofing contractor.

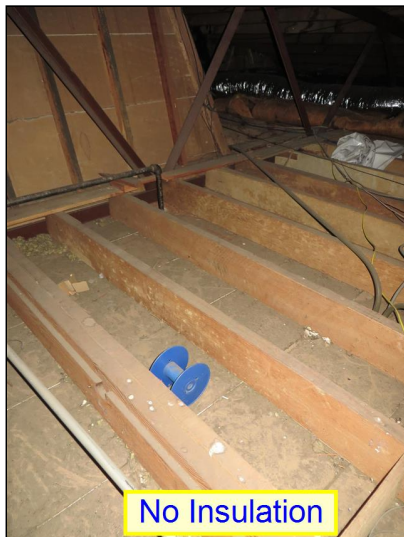
No Insulation

Missing Areas of Insulation. There are several areas in the attic where the insulation is missing or is not sufficient. Insulation is used to help keep a building energy efficient. Areas of missing or inadequate insulation will not only cause the building to not efficiently heat and cool; but it also can decrease the life expectancy of the roof. It is recommend that these areas have sufficient insulation provided to allow for the proper R-Value for today's energy requirements.

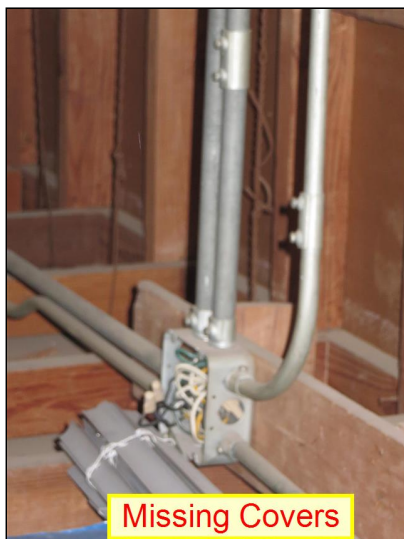
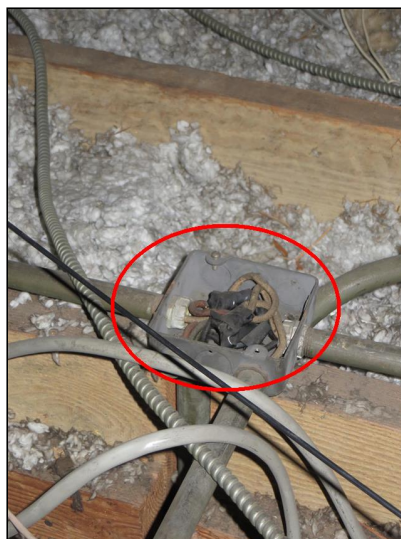
Missing Covers

📍 (1) **Missing Cover on Junction Boxes.** There is at least one missing cover at the junction boxes in the attic. Junction boxes are used to conceal wire connections, protecting them from damage and decreasing the risk of fire and shock. **Recommend installation of cover plates on all outlet boxes.**

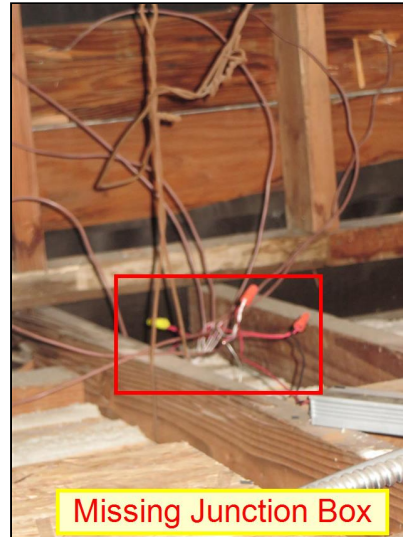
(2) **Missing Electrical Boxes.** All wire connections need to be concealed within proper listed electrical boxes. Currently there are wire connections not contained with junction boxes. Junction boxes are used to conceal wire connections, protecting them from damage and decreasing the risk of fire. **Recommend installation of outlet boxes on all exposed wire connections.**

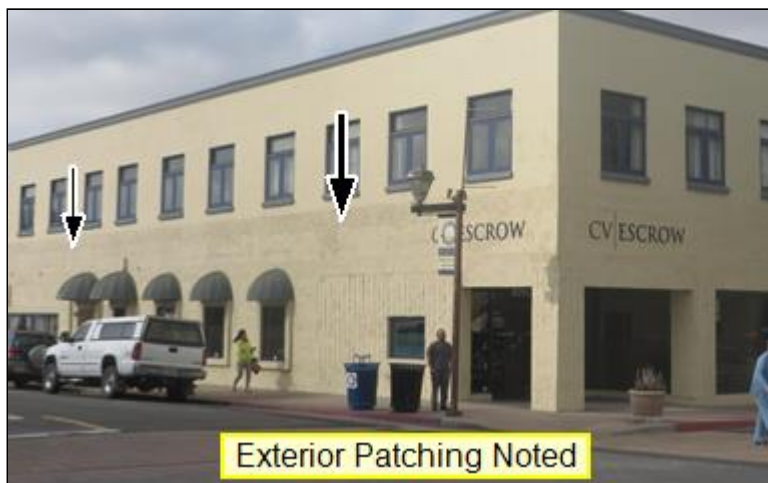
Exterior Patching Noted

↑ (2) NOTE: It was noted that there were areas of patchwork as some areas of the building. The reason for all of the patchwork was not be determined. It was observed that some of this patchwork was caused when some of the exterior wood was removed from the wall face. There were currently no visible problems with these areas at the time of inspection and this is noted for your information only.

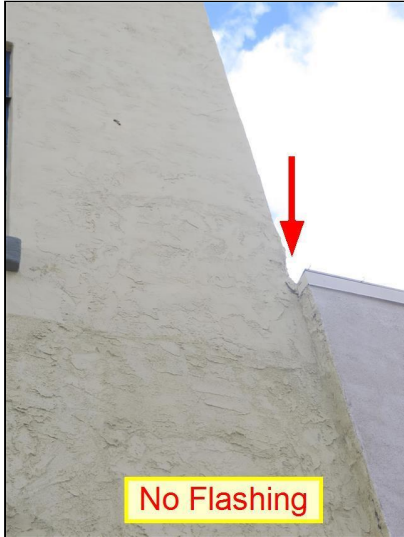
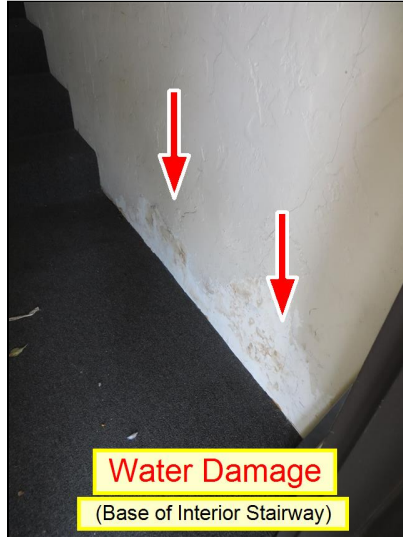
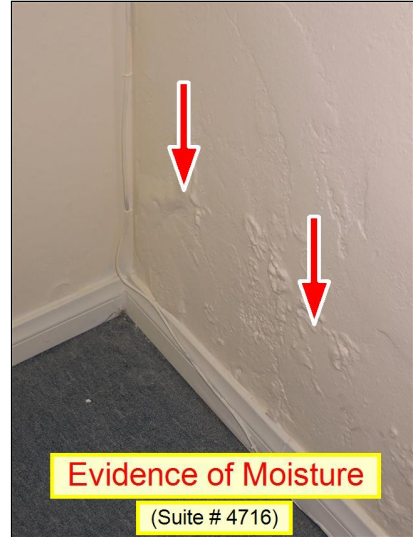
(3) **Flashings Not Visible.** There were no visible flashings between this building and the adjacent building. **Typically this is not a common flashing, however there were areas of moisture damage present at the interior walls at these locations.** The source of this moisture damage was not able to be identified, however it is possible that water may be getting between the buildings. **It is recommended that the interior walls be further evaluated and the source be located. Flashings may be needed at the connection point between buildings.**

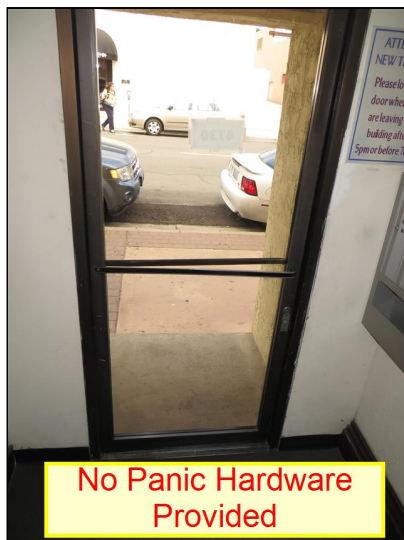
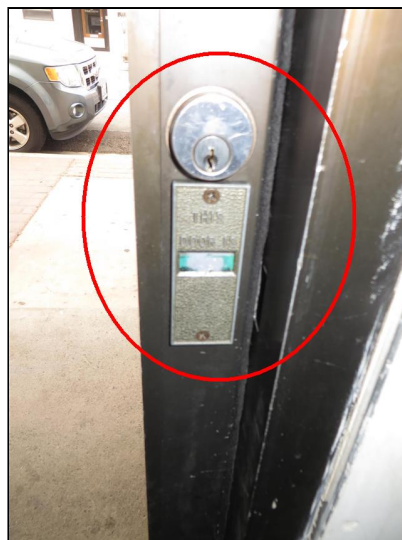
🚪 Safety Hazards. The egress doors (main doors) for the upstairs office access are not provided with panic hardware. Currently a key is needed to unlock one of the doors- when locked. Should a fire or other emergency occur after hours or when the doors are locked and tenants, clients or customers are inside the building, they would not be able to exit the building. This is a health and safety issue that should be addressed. **It is recommended that you check with the local jurisdiction about the door requirements at these locations.**

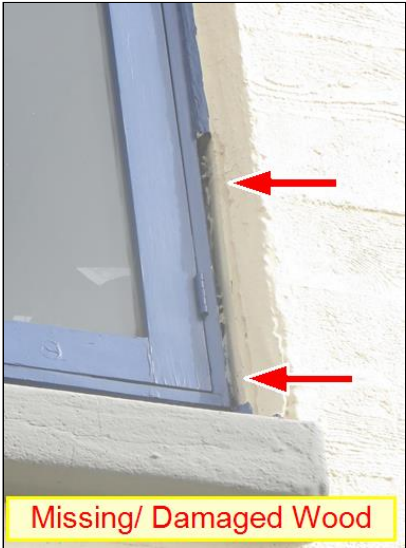
Missing/ Damaged Wood

(2) **Missing Wood at Frame.** One of the exterior windows was missing a section of the frame. This was noted at the rear window (suite # 209). There was water staining and or damaged noted to the interior wall at this location. *It is recommended that this be further evaluated and repaired as needed.*

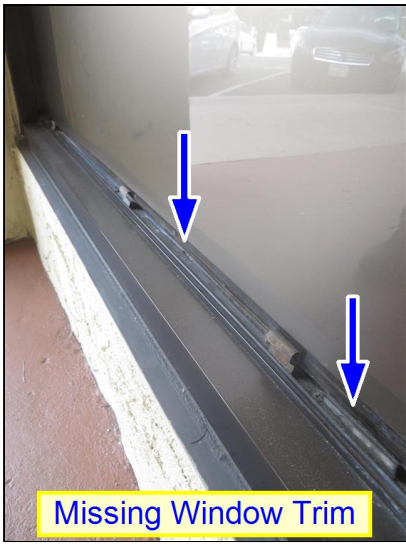
Missing Window Trim

(3) **Missing Window Trim.** It was noted that a section of the front window trim is missing. This trim helps to keep the windows within the frames. *It is recommended that all areas of missing and damaged window trim be repaired.*

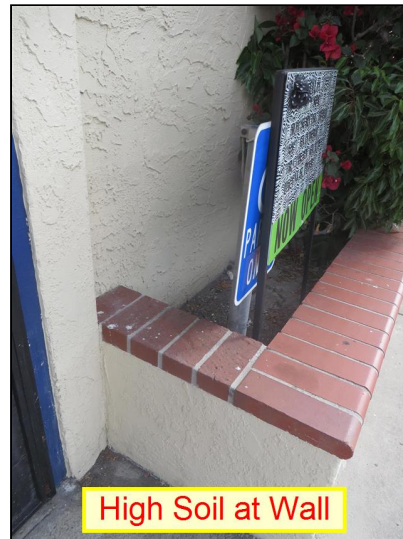
(1) **Planter Boxes Against Building.** There are areas around the perimeter of the building which have planter boxes. These planter boxes can allow the soil level to become too high at the wall. Soil should not extend above the foundation due to the increased possibility of moisture damage to the walls and interior structure. **The interior wall at this location was not able to be inspected due to not having access to this unit.** It is recommended that the planter boxes be removed and the soil be leveled at this area.

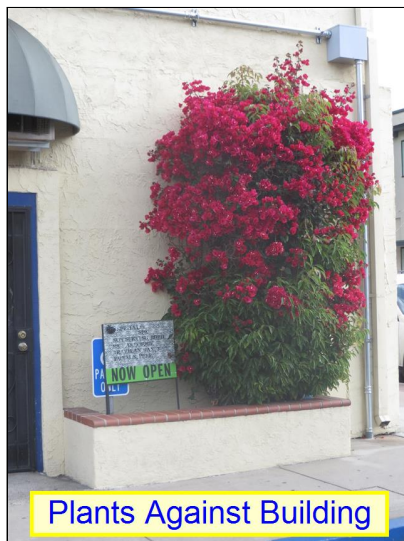
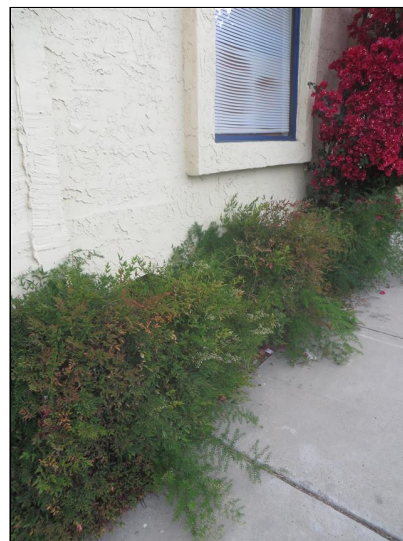
(2) **Plants Against Building.** There are areas where the shrubs or tree limbs come into contact with the roof line or the walls of the building. It is recommended that all shrubbery and trees be cut away from the house to create a clear space of about 12 inches. This will help to minimize potential moisture and pest related problems.

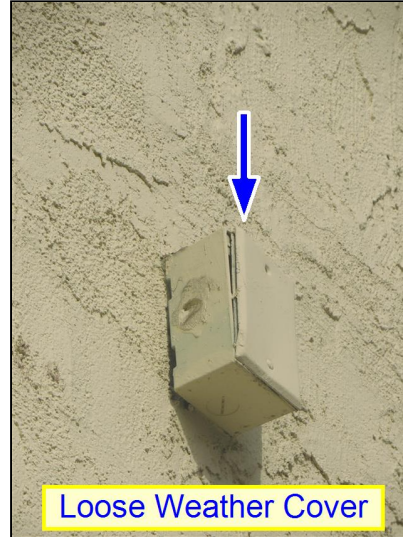
(2) **Loose Electrical Cover.** All electrical outlets outside should have protective weather covers provided. Currently there was a junction box at the east side of the building that had a loose cover. This can allow for water to enter this box. **It is recommended that this cover be secured to ensure proper working order.**

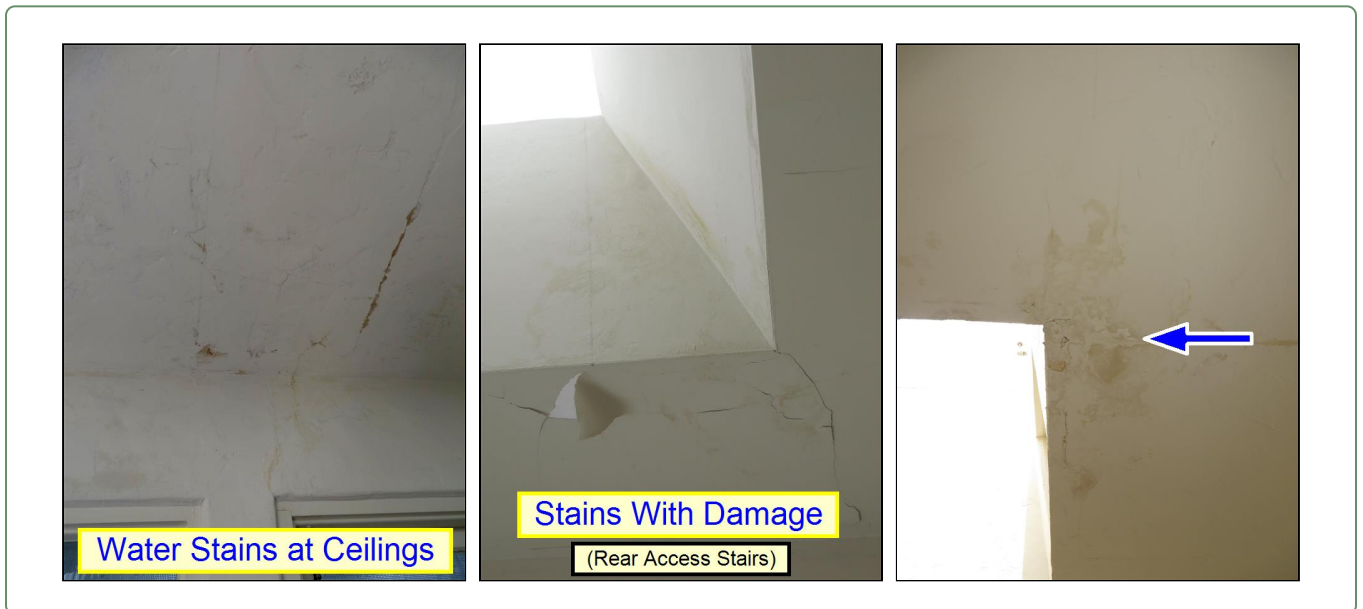
(2) **Ceiling Water Stains.** There were several areas with water staining noted at the ceilings of the upstairs hallways and offices. It appears that there have been several roof leaks at these locations. **It could not be determined if these leaks have been properly repaired.** The most extensive staining was noted in suite # 209. The ceiling has been replaced with a drop-down type ceiling and the extent of damage was not able to be determined. **It is recommended that the roof and ceiling be further evaluated and repaired as needed by a licensed roofing contractor.**

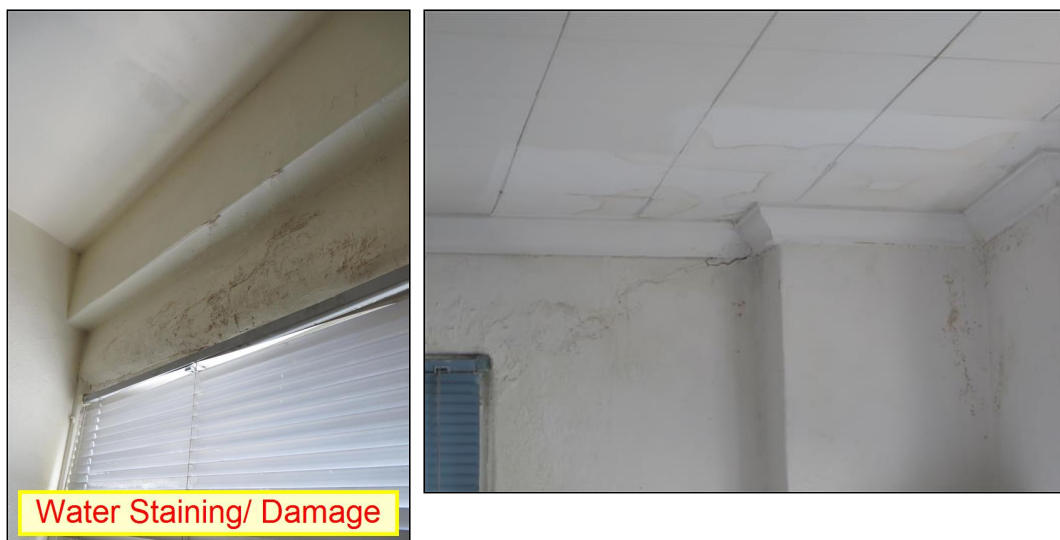
(2) **Water Staining and Damage.** There was some water damage noted at some of the walls of this building. The most extensive staining was located in suite # 209. This unit is located below a roof drain. There was severe staining at both the ceilings and walls of this unit. **It is recommended that further evaluation be conducted in this suite to ensure there is no structural damage that was not visible at the time of the inspection.**

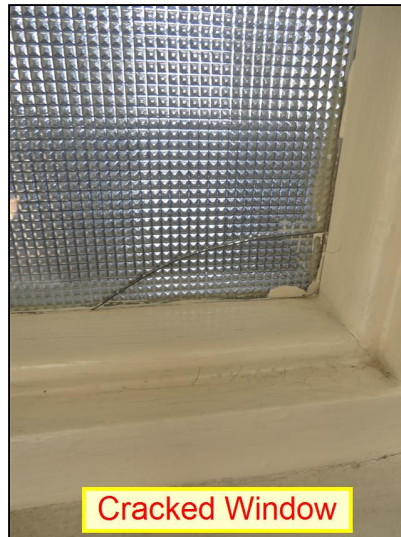
**Cracked/ Damaged Window.** The window in the upstairs hallway was cracked at one of the office windows. It is recommended for safety purposes that this be repaired or replaced by a licensed contractor or window professional.

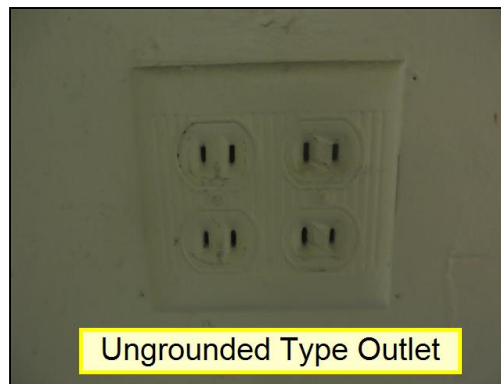
(1) **FYI:** Due to the year in which this building was constructed, the original style of two pronged outlets have remained at some locations. It is important to know and understand that the two pronged outlets may have not been upgraded with grounding.

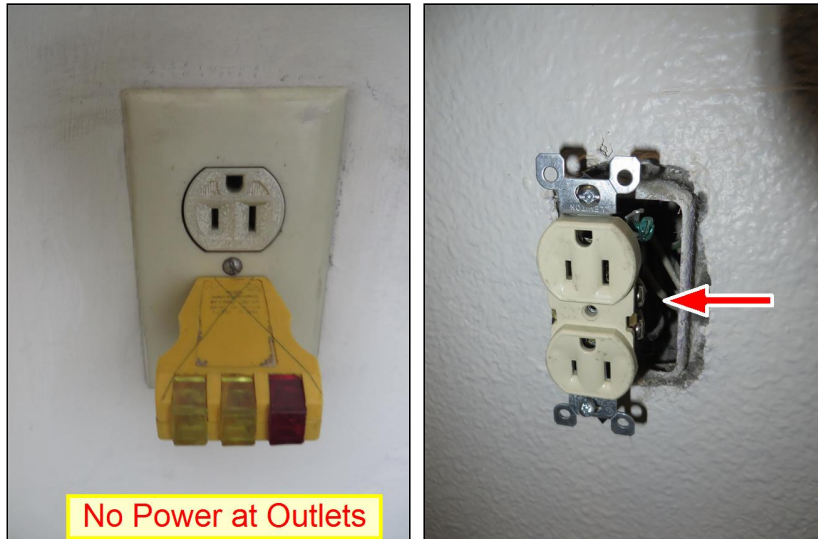
(2) **Inoperative Outlets.** There were a few outlets that did not work at time of inspection. These were noted at being located in the upstairs hallway (outside of suite # 211) and in one of the offices of suite # 8295. **There was no power at these outlets.** It is recommended that this be further evaluated by a licensed electrician.

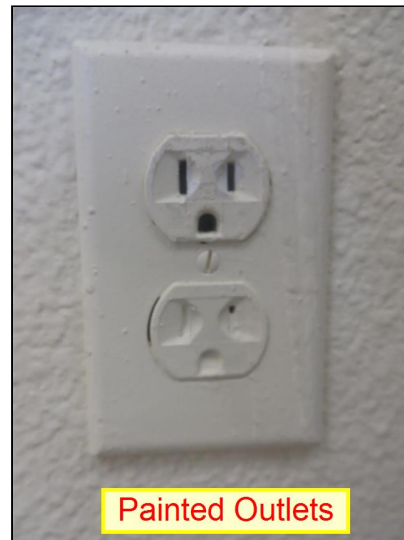
(3) **Painted Outlets.** Several of the outlets in suite # 8295 were not covered when painting was conducted, and the outlets were painted. Painting of outlets increases the risk paint chips entering the receptacle and creating resistance. **This can cause the outlet to over heat causing damage to the outlet and an increased risk of fire.** It is recommend that all outlets which have been painted be replaced as needed by a licensed electrician.

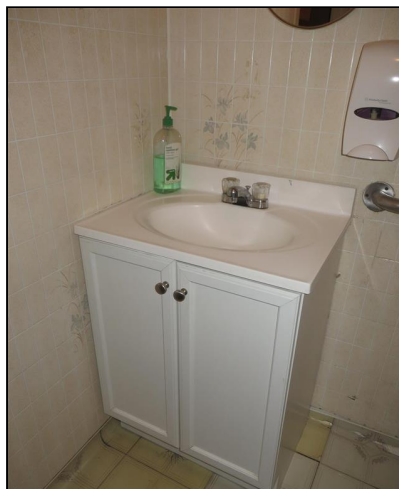
Not Secured to Wall/ Floor

Movement of this can cause personal injury as well as pipe and plumbing separation, and or damage. It is recommended that the vanity be properly secured to the wall.

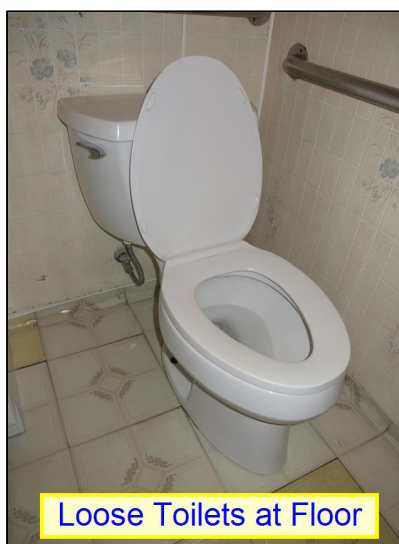
Loose Toilets at Floor

🏠 (3) **Loose Toilet.** The toilet fixtures in the lower bathrooms (both men's and Women's) were loose at the floor. This could cause the wax ring to become dislodged and your toilet to leak water onto the floor. It is recommended that this toilet have the wax ring replaced and the toilet secured to the floor (to ensure a proper seal), and caulking be applied to the base of the toilet. **(WARNING) Over tightening will cause the porcelain to crack and the need for replacement of the toilet.**

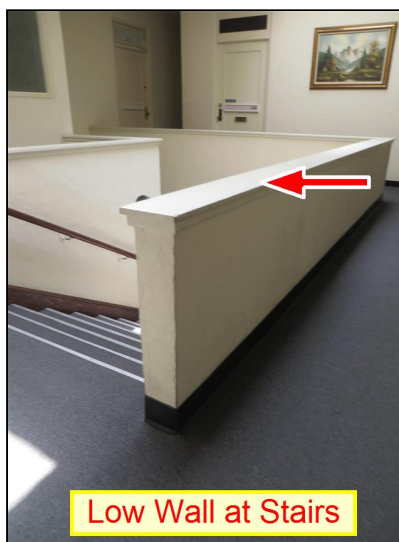
Low Wall at Stairs

🏠 **Improper Wall Height.** The wall (guard rail) around the interior stairs does not meet today's height requirements. It is required for today's standards that guard rails have a minimum height of 42 inches. The current height of the wall at around the staircase is only **29 inches**. Currently this wall is low for today's standards. For safety purposes it is recommended that this be altered to meet the today's standard safety requirements.

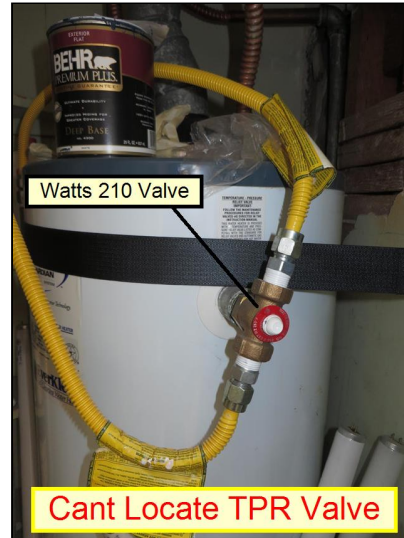
↑ (2) Cant Verify TPR Valve. This water heater is equipped with a Watts 210 Gas shut off valve in lieu of the standard TPR type blow off type valve. This valve will shut off the gas if the water pressure or temperature exceeds the tanks limits. **This system still REQUIRES a TPR valve to be located at an exterior cold water line.** This is a required safety measure that was not able to be verified at the time of the inspection. It is recommended that this TPR Valve be located or installed as needed by a licensed plumber.

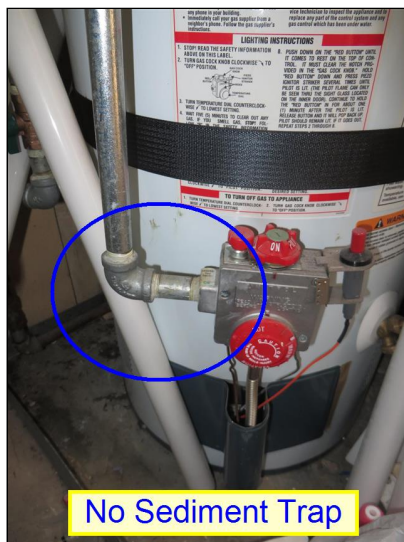
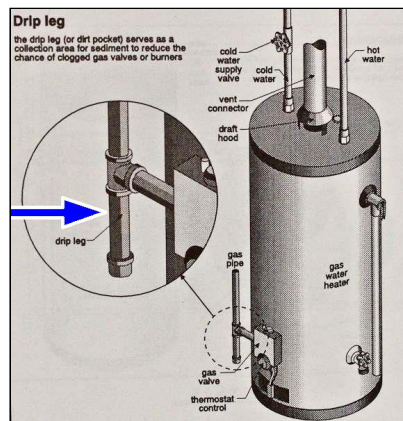
↑ (3) No Sediment Trap. There was currently no sediment trap on the gas line leading into the hot water heater. It is recommended by the manufacturer that a sediment trap be installed at this heater. It is recommended that a trap be installed by a licensed plumber.

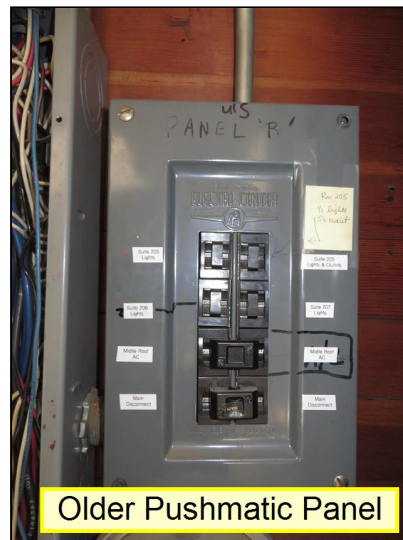
(1) **NOTE:** There is an older Pusmatic type breaker system. This is an older system which utilizes a breaker system that is no longer being used or manufactured. Replacement breakers for this panel are difficult to find and expensive. You may wish to convert this to a more modern breaker type system. This is noted for your information.

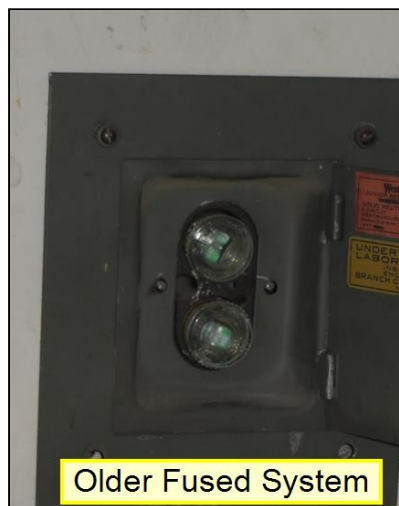
📍 (2) **NOTE:** There was a panel that is on a old fuse type system. This is an older system that is considered to be outdated for today's standards. You may wish to convert this to a more modern breaker type system. This is noted for your information.

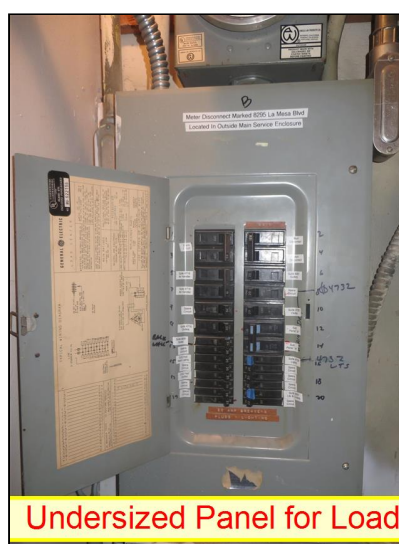
📍 (3) **Undersized Panels.** It appears that the sub-panel for unit 8295 "B" and 4730 are undersized (rated at 125 and 100 Amps) for the amount and sizing of breakers provided. This load appears to be too large for the panel capacity. This may cause your breakers to "Trip" due to overloading of the circuits. **This Panel may need to be upgraded to a larger service.** It is recommended that this panel be further evaluated and the loads be properly calculated by a licensed electrician and repaired or replaced as needed.

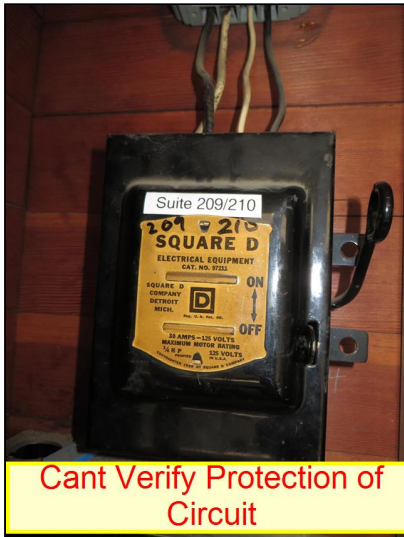
Cant Verify Protection of Circuit

📍 (4) **Could Not Verify Protection of Circuit.** There was an improperly connected branch/ feeder wire located in the upstairs service closet. The wire leading to the disconnect, labeled "Suite 209/210" was double tapped at the supply lug and may be improperly connected within the gutter. Hot and neutral wires may not share termination points at the bussing or at connected breakers and should be appropriately sized according to AWG standards.

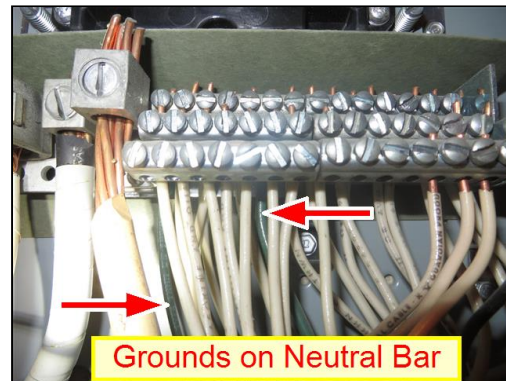
Grounds on Neutral Bar

📍 (5) **Grounds On Neutral Bar.** The sub-panel currently has the grounds bonded to the neutral bar. In sub-panels, the neutral (white) wires should be isolated or "floating" (not touching the panel, the grounding wires ((bare copper or green)), or any other metal part of the panel). It is recommended that a licensed electrician further evaluate this panel and correct as needed.

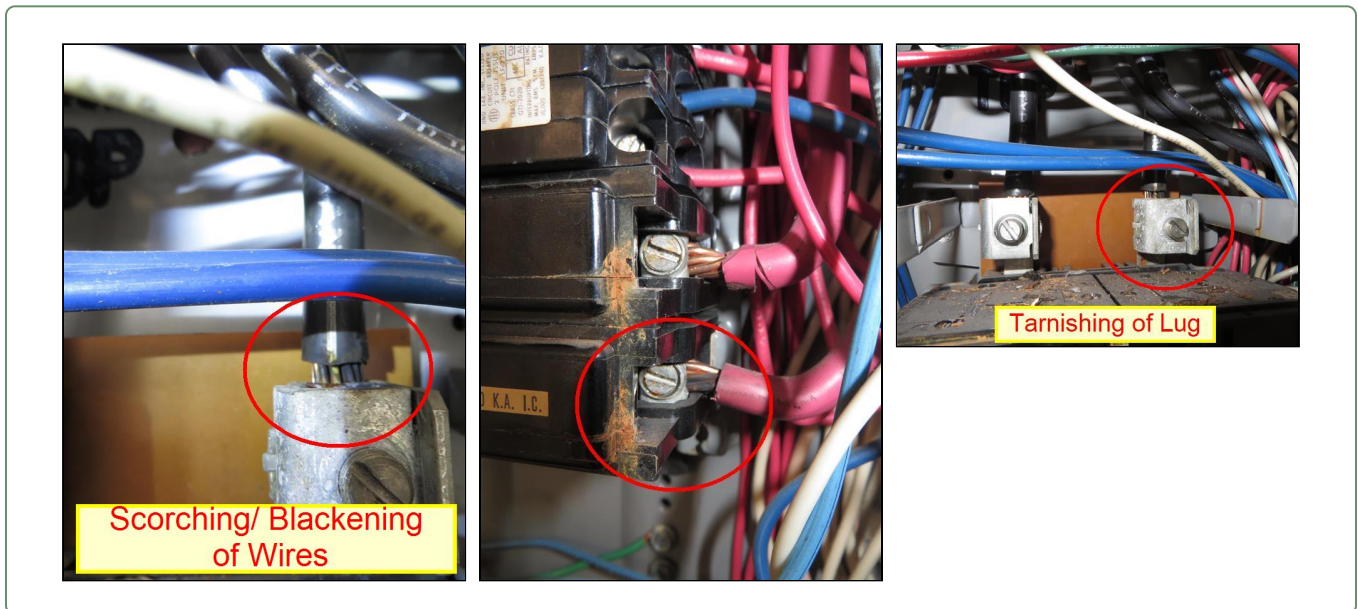
📍 (7) **Scorching of Wires.** There are scorched wires and tarnished of the service lug noted within the sub panel of unit # 4730. Currently this panel was undersized but protected for the current load potential. It is recommended that this is further inspected and repaired by a licensed electrician.
