Inspection Report

Property Address:
2364 Ponderosa Way #3
Carlsbad Ca 92009

Nation Wide Inspections

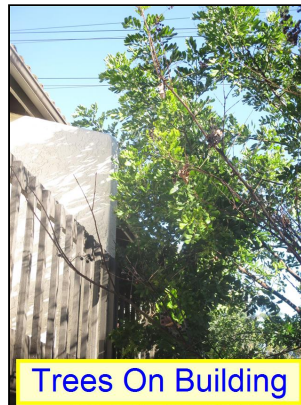
**(1) Trees On Building.** There are areas where the shrubs or tree limbs come into contact with the roof line or the walls of the building . Trees can damage the shingles or roofing materials increasing the risk of leaks . **It is recommended that all shrubbery and trees be cut away from the house to 12 inches.** This also helps minimize potential moisture and pest problems.

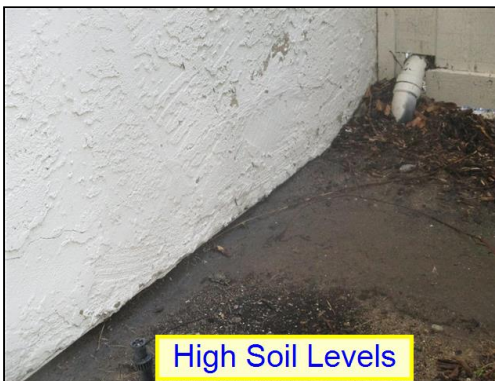
(2) **High Soil Levels.** Some areas around the house have soil levels which rise to the base of the weep screed. Weep screeds are a metal flashing at the wall base designed to allow the wall to breathe and water to drain from within the wall. Covering these areas increases the chances of moisture related problems within the wall. **Soil levels should fall 4 to 6 inches below the screed. This is noted for your information, and the soil at these locations should be leveled.**

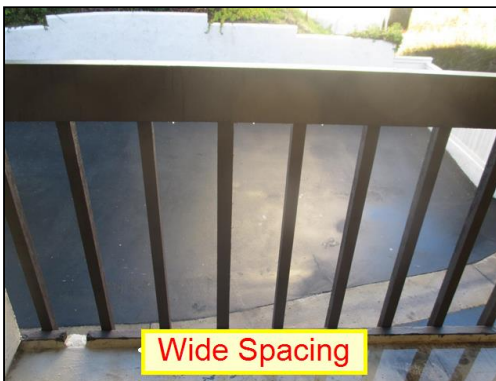
(1) **Wide Spacing.** The stringers at the exterior balcony railings are currently spaced greater than 4 inches. **Although this may have been standard at the time this was built, is recommended for today's standards, that the spacing of these balusters be no greater than 4 inches.** This is a safety measure to help ensure that a child cannot slip through this area. **It is recommended that you add a screen or more balusters at this location.**

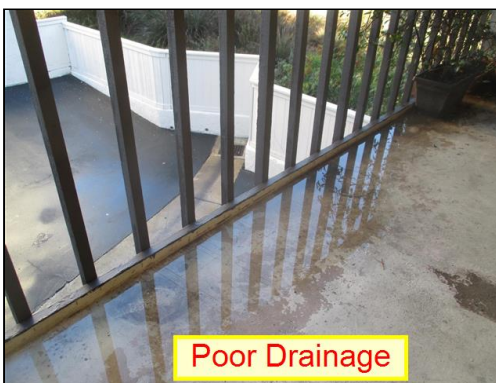
(2) **Poor Drainage.** The rear balcony had poor drainage. There was a lower rail that dammed the water. There was pooling water noted at the lower balcony at the time of the inspection. Pooling water increases the risk of leaks at damage. **There was no evidence of active leaks at the time of the inspection.** **It is recommended that drainage be added at this location at the balcony water proofing be further evaluated and repaired as needed.**

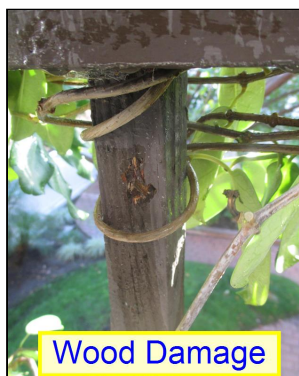
(3) **Wood Damage.** There was some wood damage noted at the balcony stringers at both the front and rear of the home. **It is recommended that all damaged wood be repaired or replaced as needed by a licensed contractor.**

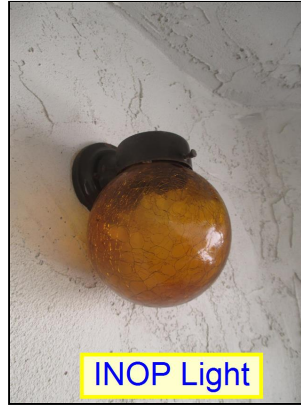
(2) **Inoperative Light... Bulb?** One of the exterior light fixtures did not operate when fixture was turned on. This could be because the fixture bulbs need replacement, OR there could be an electrical problem with the fixture. **Recommend changing lights bulbs to determine the problem and replace as needed.**

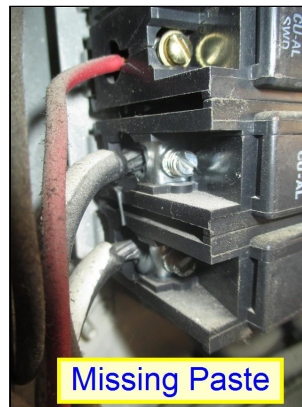
**Missing Paste.** There was no antioxidant paste visible on the aluminum wire connections. Antioxidant paste protects aluminum wire from corrosion and ensures proper connection to panel. **Recommend installation of paste on all connections involving aluminum wiring.**

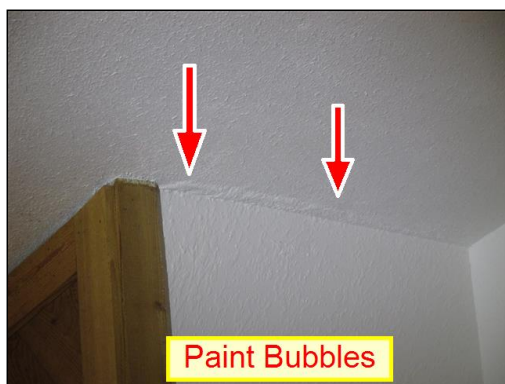
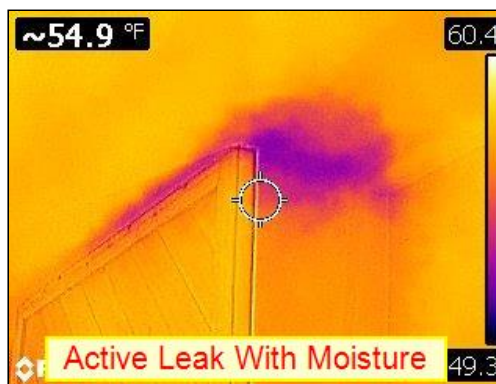
(1) **Paint Bubbles -- Active Leak.** There were areas of paint at the family room ceiling which had bubbling paint. This was noted at the right side of the chimney/ceiling connection. The ceiling was wet at the time of the inspection. **The ceiling was wet at this location suggesting that there is an active leak. It is recommended that a licensed contractor be called out for further analysis and repair as needed.**

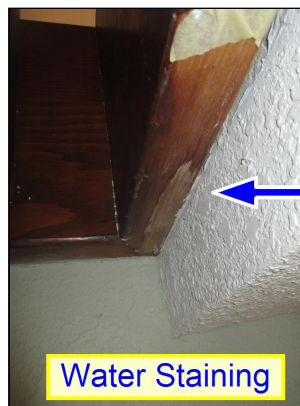
📍 (2) **Ceiling Water Stain.** There was some water staining noted on the ceilings of the main entry stairway. It appears that there have been a roof leaks at these locations at one time. **It could not be determined if these leaks have been properly repaired.** There did not appear to be any signs indicating that there is an active leak. **It is recommended that you ask the current owner about these stains and that a roofing contractor be hired to further evaluate these areas if needed.**

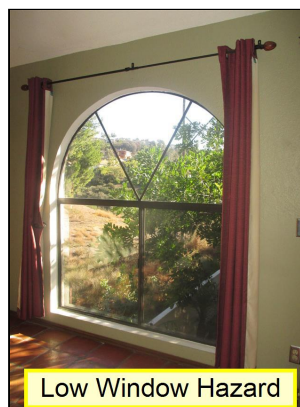
(1) **NOTE: Low Window Hazard.** There was an openable window (above the first floor) that was low to the interior floor level. **Low windows, above the first floor, can be a safety hazard for homes with small children.** Should a child or children be present in the house, additional security should be added at or around these windows to help prevent an accidental fall or injury when the window is in the open position.

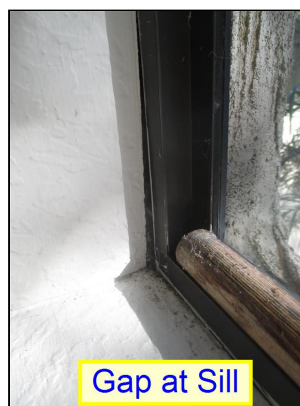
(2) **Gap at Sill.** There was a small gap between the window and the sill at bedroom #1. This should be sealed to avoid drafting.

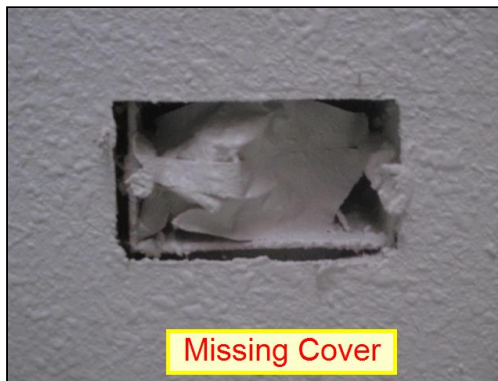
(1) **Missing J-Box Cover.** There was a missing cover for the ceiling J-Box in the entryway. Missing covers expose electrical wires and create a potential shock hazard. For safety reasons all electrical boxes should have secure covers to reduce the chance of electric shock. **It is recommended that the tape be removed from these wires and a proper cover be provided.**

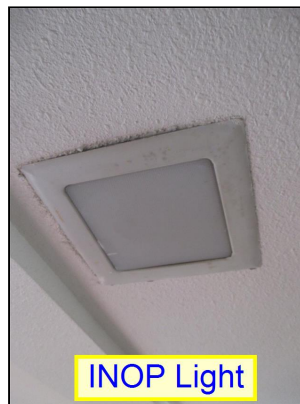
📌 (2) **INOP Light.** The light in the hallway did not operate at time of inspection. This could be due to the bulb not working OR an electrical problem. **It is recommend that the existing bulb be replaced with that of a new bulb and the light be retested. If light still does not work, it is recommended that this be further evaluated by a licensed electrician.**

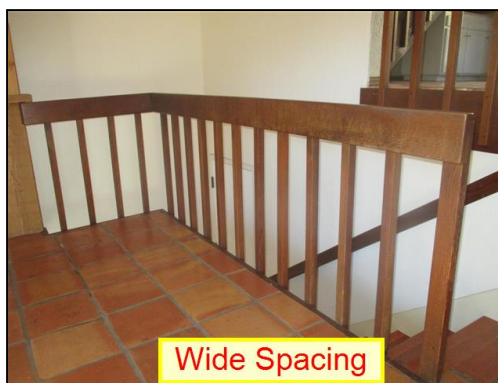
📌 (2) **Wide Spacing.** The balusters at the stairs are currently spaced greater than 4 inches. **Although this may have been standard at the time this was built, it is recommended for today's standards, that the spacing of these balusters be no greater than 4 inches.** This is a safety measure to help ensure that a child cannot slip through this area. **It is recommended that you add a screen or more balusters at this location.**

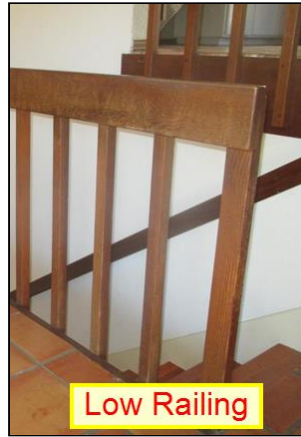
(3) **Improper Guard Rail Height.** The guard rail does not meet today's height requirements. It was required that all guard rail have a minimum height requirement of 36 inches. **New regulations state the railings should be 42 inches.** The current height of the railing is **below 36 inches.** For safety purposes it is recommended that this be altered to meet the standard safety requirements.

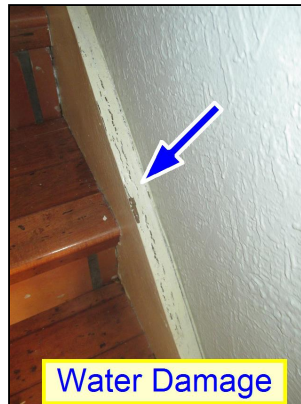
(4) **Water Damage.** There was some swelling of the side board at the lower section of stairs. It appears that water from the roof leak has caused damage and swelling to the wood at this location. It is recommended that these locations be further evaluated and repaired as needed.

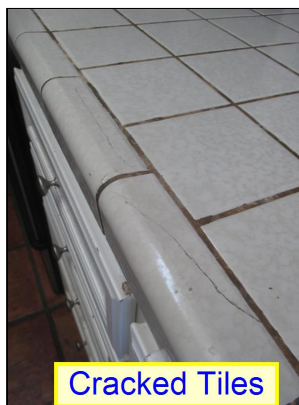
**Cracked Tiles Noted.** There are cracked tiles at the counter. This is a cosmetic repair that can be repaired at your convenience if so desired.

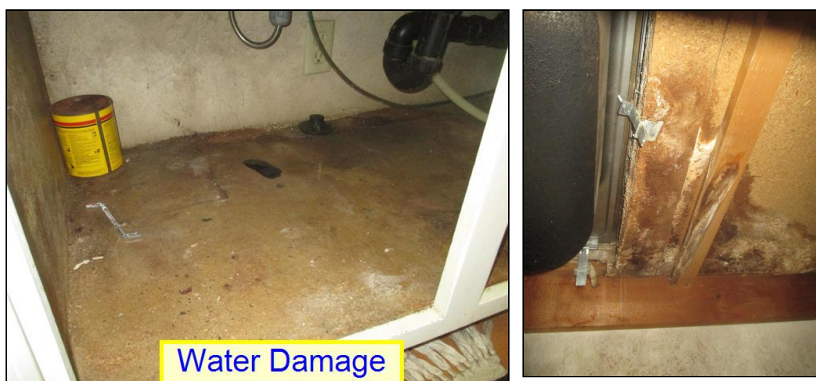
(2) **Water Damage.** The cabinet floor, and counter support (under the sink) has some moderate water damage. There cabinetry was dry at the time of the inspection and there was currently no visible growth at this location. It appears that there was a leak at this location at one point in time. This is noted for your information and can be repaired or replaced at your convenience if so desired.

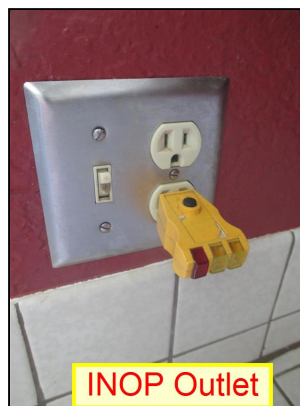
(2) **Inoperative Outlet.** The outlet to the right of the sink did not work at time of inspection. There was no power at this outlet. It is recommended that this be further evaluated by a licensed electrician and repaired as needed.

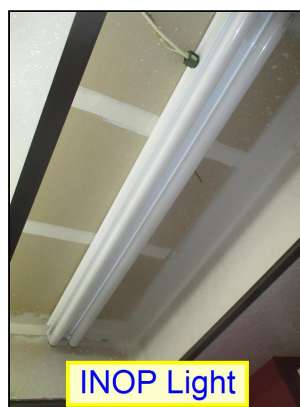
(3) **Inoperative Light... Bulbs?** There were one or more bulbs that did not function in the kitchen. It could not be determined if they do not work because of the bulb, the fixture, or a more extensive electrical issue. It is recommended that the bulb be replaced, and the light be tested. If that does not work, it is recommended that a licensed electrician be called out to further inspect and repair this issue.

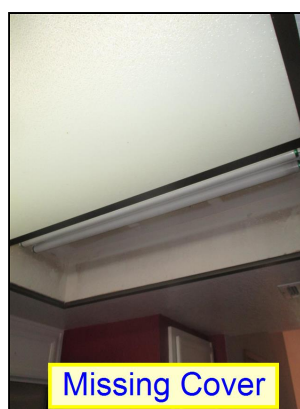
(4) **Missing / Damaged Light Panel.** The light in the kitchen has a cracked or missing a panel. This panel hides the fluorescent light fixture from being seen in the kitchen. It is recommended that this panel be replaced at your convenience.

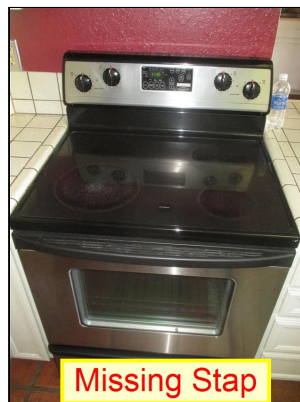
**No Safety Strap on Oven.** Ovens come with a child safety strap (Anti-tip strap) to prevent the oven from tipping and falling if children use the oven door as a step . It is recommended, especially if children are present, that this oven be equipped with a safety strap.

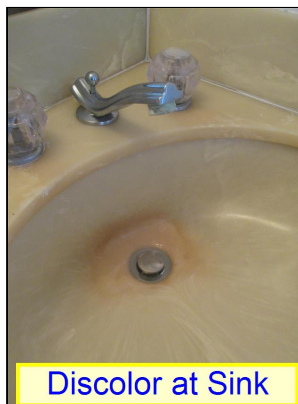
(1) **Discolor of Sink.** There is some wear and discoloration of porcelain at the sink. This does not effect the performance of the sink. This is a cosmetic fix and can be replaced at your convenience.

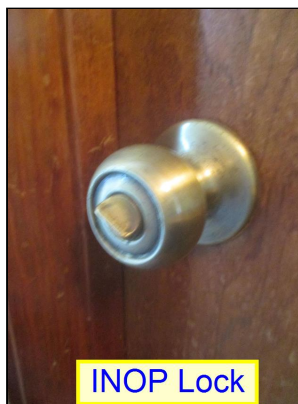
**Inoperative Lock.** The lock for the door at this bathroom did not function at time of inspection. For privacy purposes it is recommended that a locking device be provided on these doors.

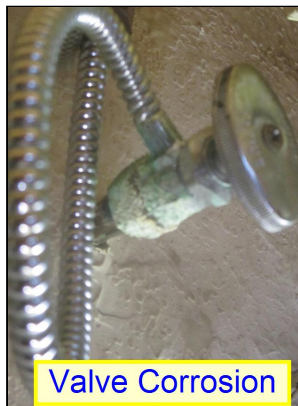
**Corrosion at Valves.** The water shut off valves at the underside of the sink have some minor to moderate corrosion. **We do not test these shut off devises.** There is a chance that these shut off valves may leak or not properly function when turned. **It is recommended that these valves be further evaluated and repaired as needed.**

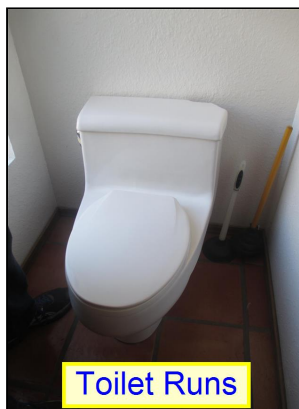
(1) **Toilet Runs.** It appears that the toilet flapper is worn and leaks water. The toilet flapper in the tank appears to be worn which may be the cause of the tank to leak. Worn flapper can cause your toilet to occasionally run through out the day. **It is recommended that a plumber be called out for further evaluation and repair.**

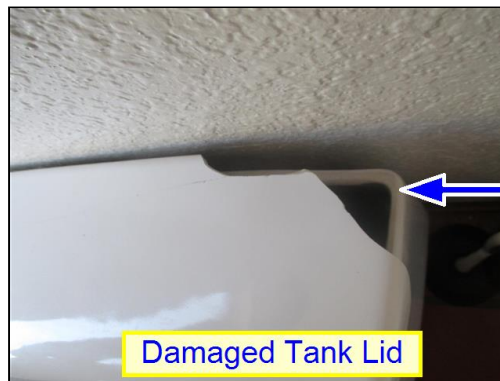
(2) **Cracked Lid at Tank.** The lid to the toilet tank is cracked and broken. **It is recommend that this be replaced as needed.**

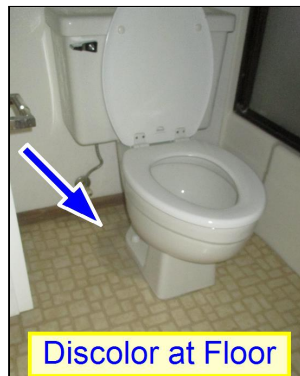
**Discoloration of Linoleum.** There was some discoloration of the linoleum at the base of the toilet in this bathroom. **This is noted for your information and can be repaired at your convenience.**

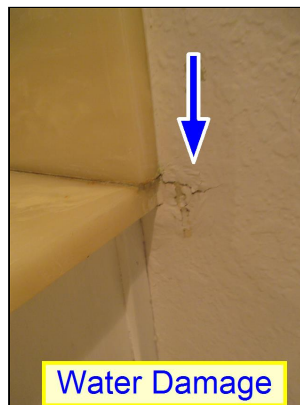
**Minor Water Damage.** There was some minor water damage to the wall at the left side of the counter. It appears that the sink faucet handle leaks, and has caused damage to the wall at this location. **This is noted for your information and can be repaired at your convenience.**

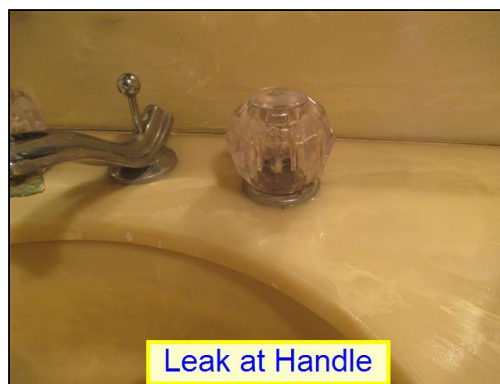
(2) **Handle Leak.** It appears that there is a leak at the base of the sink handle and counter connection. **It is recommended that this be further evaluated and repaired as needed by a licensed plumber.**

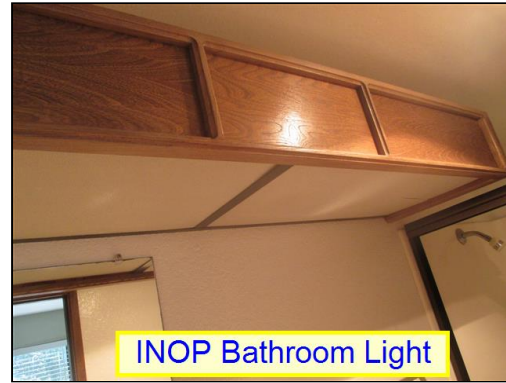
📍 (2) **Inoperative Light**. Light in the bathroom did not operate at time of inspection. This could be due to the bulb not working OR an electrical problem. **Recommend replacing existing bulb with that of a new bulb and retesting unit. If light still does not work recommend calling licensed electrician to test light switch or replace light fixture.**

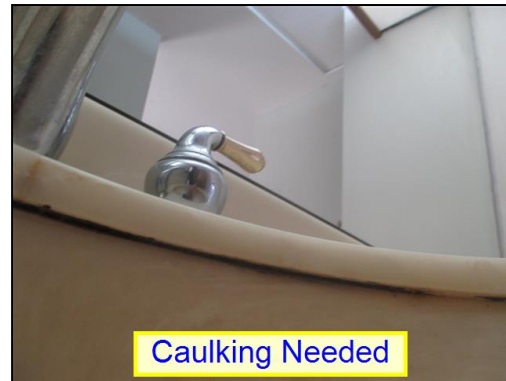
(2) **Caulking Needed**. There was an area around the sink/ counter connection that are in need of some caulking. **It is recommended that this area be properly caulked by a qualified professional.**

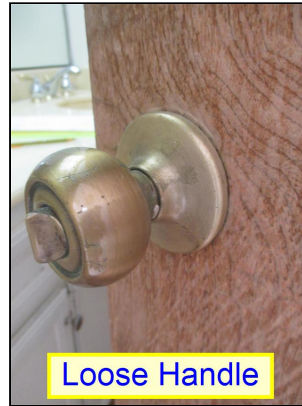
**Loose Door Handle.** The door knob was loose at time of inspection. It is recommended that this be repaired or replaced for proper working order.

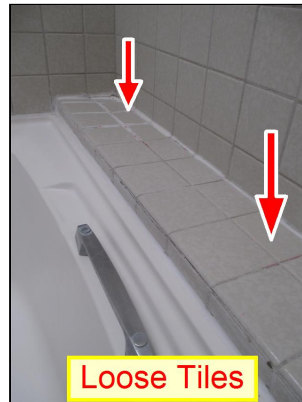
(1) **Loose Tiles At Shower.** It was noted that there were was a loose or damaged tile in the shower enclosure. **Loose or damaged tiles can allow for water to enter the wall cavity increasing the risk of water damage.** It is recommended that these areas be further evaluated and patched as needed to help ensure that water does not enter into these areas possibly causing damage.

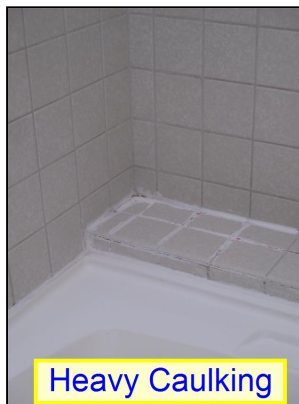
📍 (2) **Heavy Caulking at Tub.** The sides of the tub were heavily caulked. This may indicate that there was a problem at this location. It is recommended that the tub be properly sealed as needed by a licensed contractor.

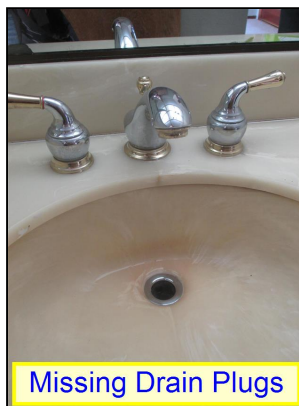
📍 (1) **Missing Drain Plugs.** The drain plugs for the sinks were missing and did not work at time of inspection. Recommend replacement for proper water retention.

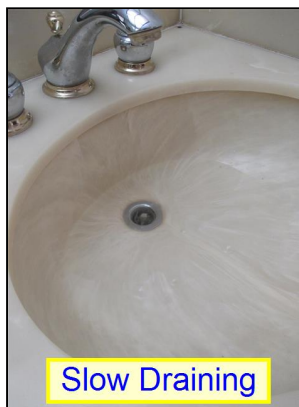
(2) **Slow Draining.** The drain line was filled with debris at the right sink and was slow at draining. **The water did not functionally drain.** It is recommended that these drains be cleaned out to ensure proper drainage of water.

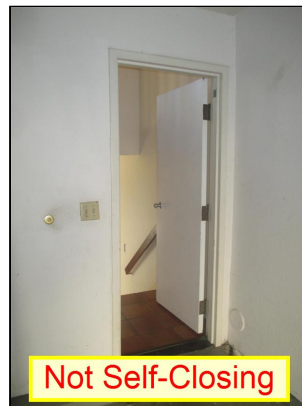
The wall of the house, that share the same wall as the garage is a fire rated wall. This wall is to have all openings and penetrations protected. This includes having a self closing, fire rated door. **This door is missing or has inoperative hardware that enables this door to be self-closing.** This is a safety hazard that should be corrected. It is recommend that this door have proper hardware installed to allow the door to be self-closing.

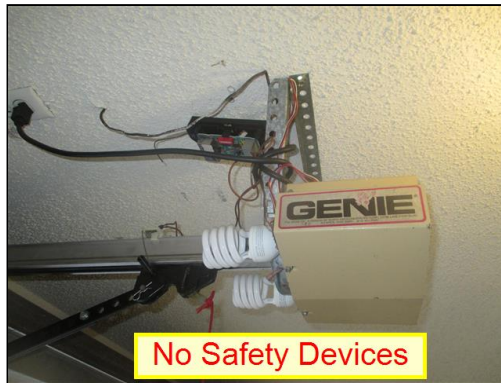
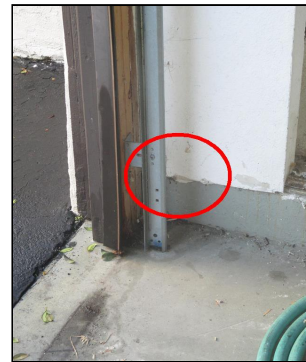
No Safety Devices- Older Unit. The garage door opener was of an older model and was not equipped with today's safety features: **Today's garage door openers have two safety features: (1.)** safety beam (six inches from ground) was not installed or not in operation at time of inspection. This device is designed to retract the garage door when the beam is broken **(2.)** When pressure was applied to the garage door while closing. This, like the beam, is a system designed to retract the door when it is met with resistance. These are safety devices installed to reduce the risk of injury while door is closing . **Neither of these items worked or were present at the time of inspection.** Recommend installation of safety beam and adjusting the pressure sensor so the door will retract when met with force.

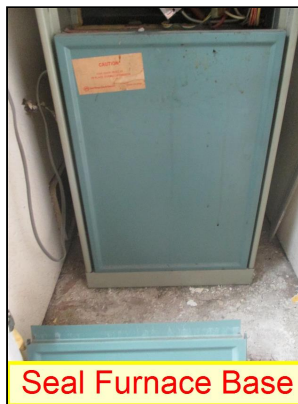
(3) **Seal Furnace Base.** Penetrations in Return air Plenum. The furnace is not sealed at the base and has penetrations or gaps at the furnace/platform connection. **These penetrations allow for combustion air to mix with the return air.**

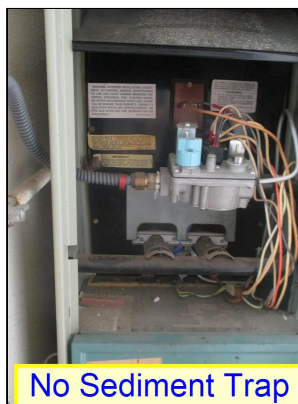
(4) **No Sediment Trap.** There was currently no sediment trap on the gas line leading into the furnace. **At the time this furnace was installed a sediment was not required.** It is recommended that a sediment trap be installed at this heater. **It is recommended that a trap be installed by a licensed plumber or HVAC specialist.**

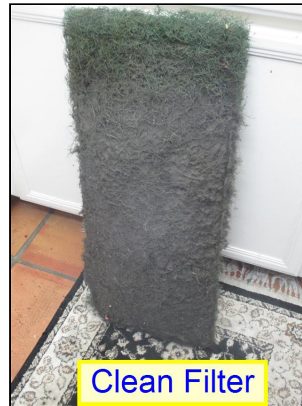
(2) **Replace/ Clean Filter.** The Air filter is dirty and needs changing or replacement. **It is recommended that this filter be replaced.**

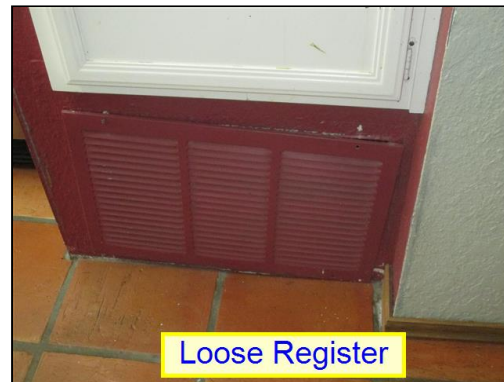
(3) **Loose Register.** One of the return air registers in the kitchen was loose. Registers allow you to control the airflow to that room. **This is noted for your information and should be secured at your convenience.**

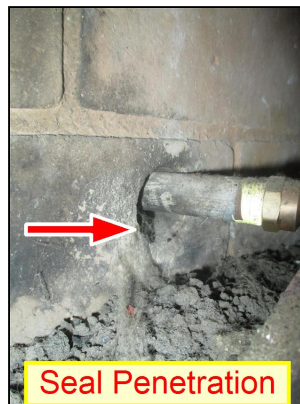
**Seal Penetrations.** The gas log starter lines should be properly sealed at the wall penetration. This is to help ensure to flames enter the chase and create a fire. **It is recommended that this is properly sealed with a fire approved material to prevent the possibility of backdrafting.**

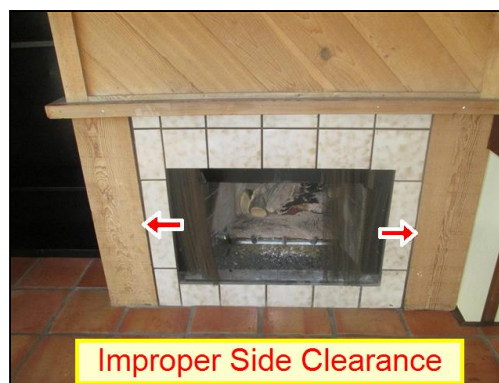
(1) **Improper Clearance.** There should be no combustible materials within the first 6 inches of the fireplace opening. Currently the wood siding less than 6 inches from the opening of the fireplace. **This can create a fire hazard.** **It is recommended that this be further evaluated and repaired as needed.**

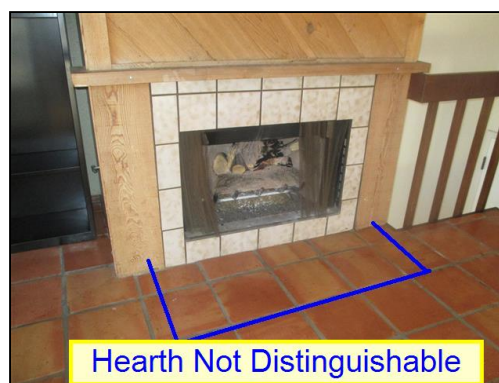
(2) **Hearth Extension Not Distinguishable.** The tile at the front of the fireplace did not display a distinguishing feature. Hearth extensions should extend at least 16 inches from the opening of the fireplace and extend at least 8 inches beyond the fireplace sides. The materials used for the hearth extension should be of non-combustible material and be readily distinguishable from the surrounding or adjacent floor. **Currently the floor and the hearth extension are of the same material do not display any distinguishing separation features.** **This is noted for your information and a distinguishing feature should be created.**

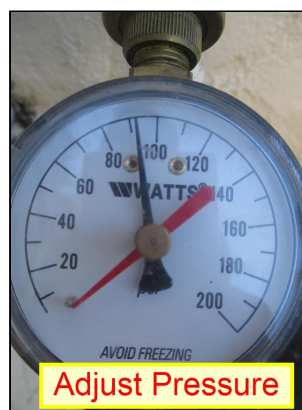
Adjust Water Pressure. Water pressure at time of test was noted at being **91 PSI**. It is required that when the water pressure exceeds 80lbs, a water pressure regulator be installed due to heightened risk of plumbing malfunction due to pressure. This unit has a regulator installed, but apparently needs adjustment or replacement. **Recommend adjusting/ or purchase of new regulator, so water pressure is between 50lbs- 80lbs when valve is fully open.**

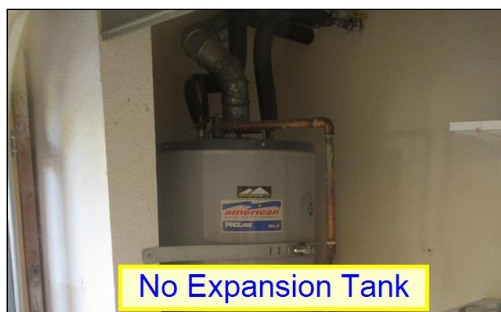
(3) **Missing Expansion Tank.** The water heater was not provided with an expansion tank. Water heaters installed on a closed system (with a water pressure regulator or backflow preventer) are now required to have expansion tanks installed. This is to help reduce stress in the pipes from water expansion. **It is recommended that an expansion tank be installed by a licensed plumber.**

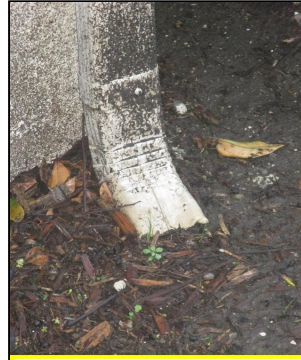
Buried Termination

There was a downspout termination at the of the house in which the termination was buried or blocked.

This can cause water to backup within the downspout and can overflow the trough system rendering the gutter system useless. **It is recommended that the termination at this location be unblocked and ensure that the drainage at this location is properly functioning.**
