Inspection Report

Sample Report

Property Address:
1202 Missouri Ave
Oceanside Ca 92054

Nation Wide Inspections

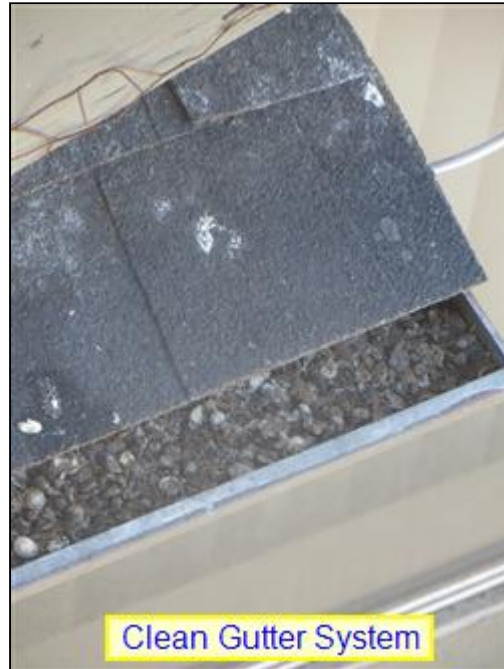
(4) **Clean Gutters**. The rain gutters are filled with debris and should be cleaned out so the water can flow freely towards the drain . It is recommended that these drains be cleaned of any debris.

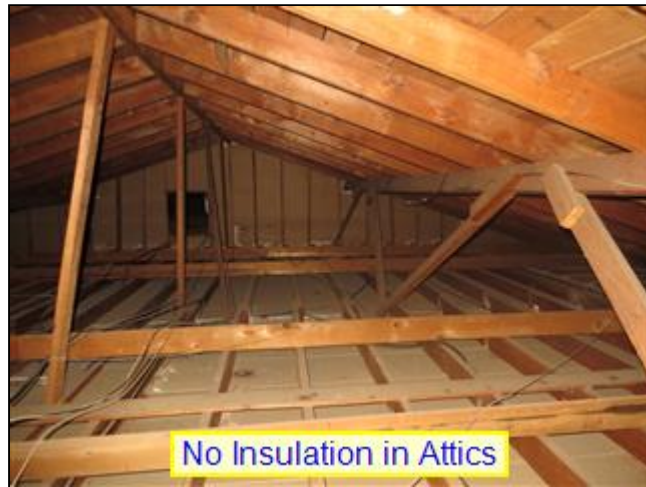
**No Insulation.** There was currently no insulation in the attics. Insulation is used to help retain the heat in the winter and help cool the building in the summer. Areas missing insulation or with inadequate insulation, will not only cause the building and units to not efficiently heat and cool; but it can also decrease the life expectancy of the roof. **Recommend replacement of missing or insufficient insulation.**

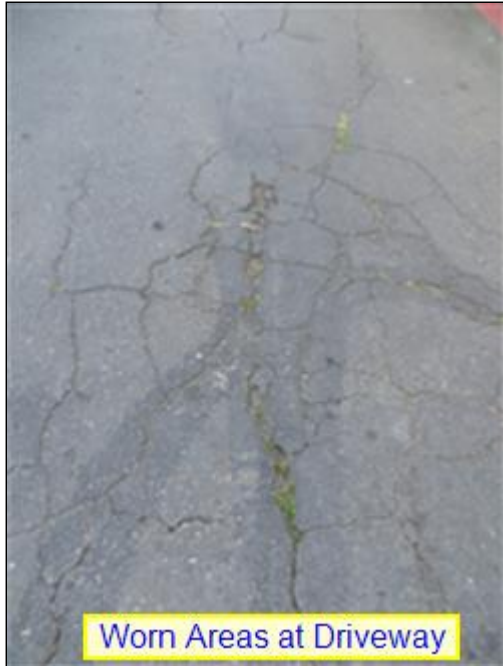
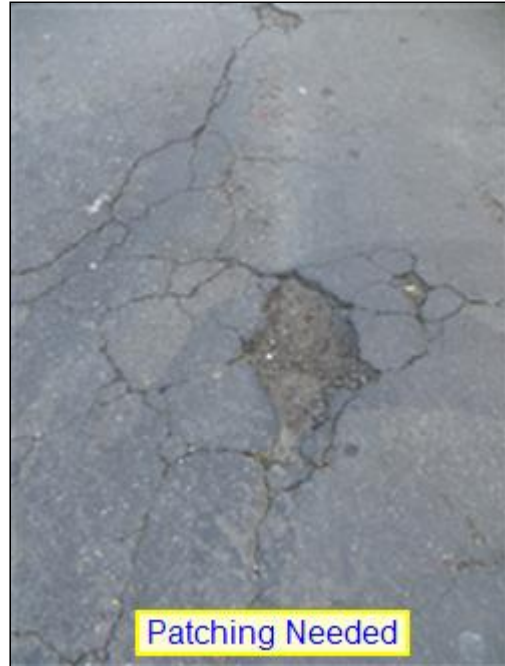
**Erosion and Damage of Asphalt.** The driveways at the front of the buildings were worn and deteriorated at multiple locations. It was noted that there were sections of the driveway that did not have adequate drainage or a proper directional slope, allowing water to puddle or run in multiple paths. There was no designated drainage running down the driveway, and there was only one visible storm drain at the base of the driveway. The driveways need patching at several locations and re-sealing. **It is recommended that the driveway be further evaluated and repaired as needed by a licensed contractor.**

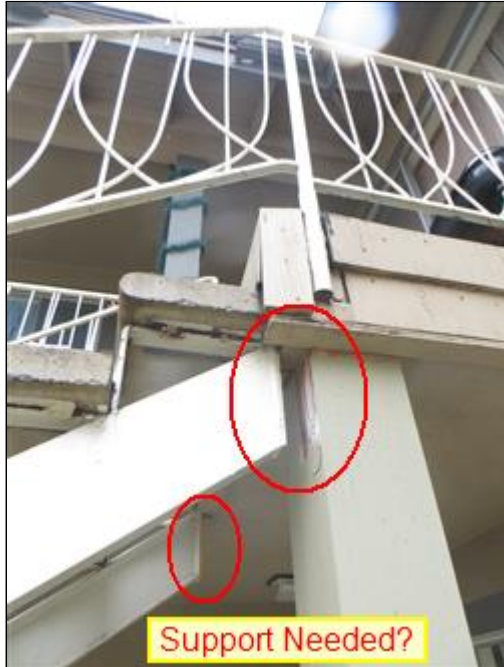
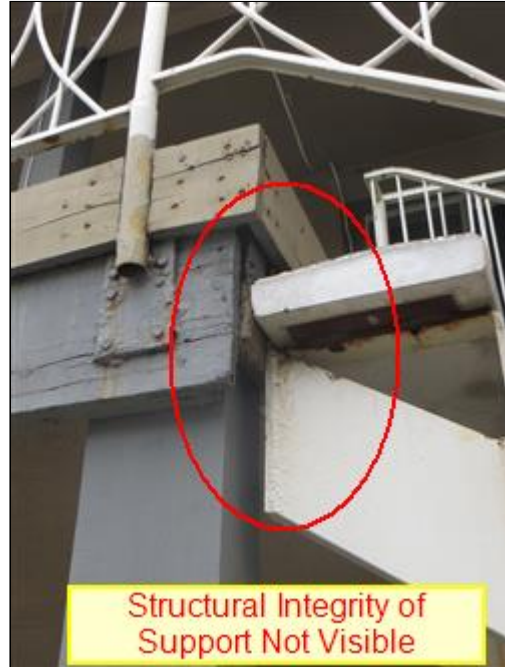
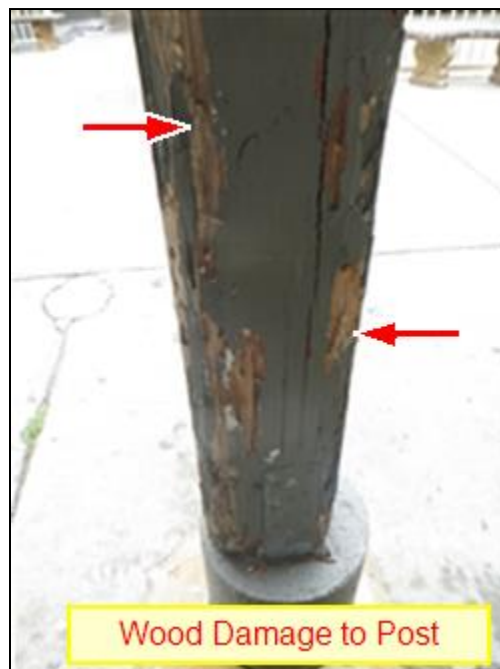
(2) **Improper / Damaged Support.** There were several stairs at the exterior of the buildings that did not appear to have proper support. **The connection of these stairs was not able to be fully verified.** It was however noted that the wood at the supporting fasteners was severely deteriorated at several locations and the stairs did not appear to be properly supported at the base of the upper run. **It is recommended that these areas be further evaluated and repaired as needed by a licensed contractor.**

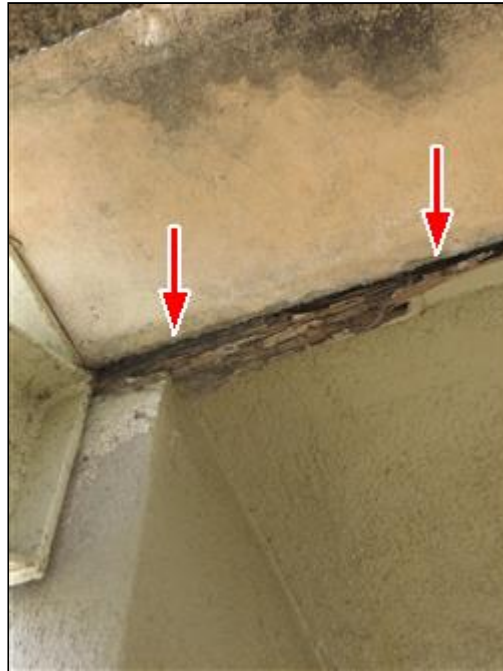
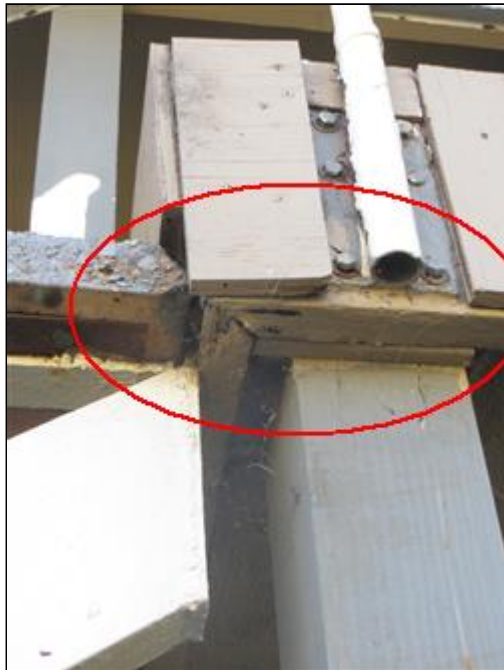
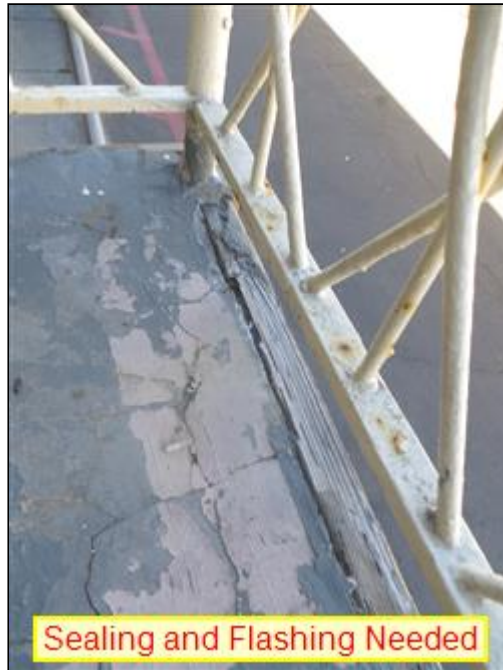
📍 (3) **Wood Damage- Further Evaluation Needed.** The landings at several of the stairs had worn decking and damaged wood. Because the interior structural elements were not able to be inspected and the condition determined it is recommended that these areas be further evaluated. It was noted that there was evidence of water intrusion at some of these locations as well as serious wood damage at the stair connection. **Due to the severe visible wood damage, it is recommended that the interior locations of these landings be further evaluated.** It is recommended that these areas be further evaluated and repaired as needed by a licensed contractor.

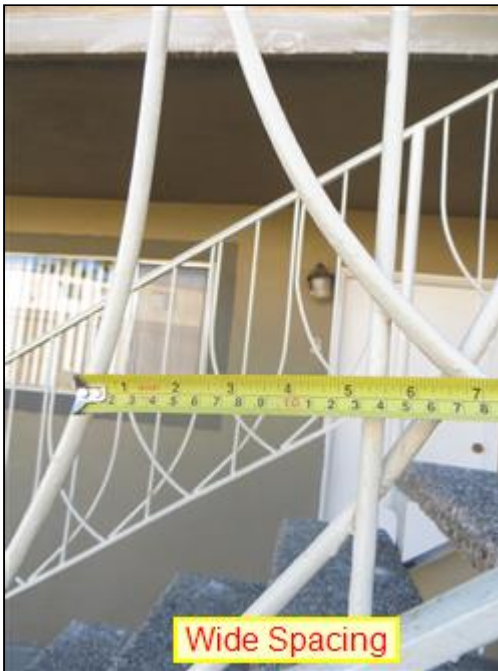
(4) **Wide Spacing.** The stringers at the front walkway and exterior stairs railings are currently spaced greater than 4 inches. Although this may have been standard at the time this was built, is recommended for today's standards, that the spacing of these balusters be no greater than 4 inches. This is a safety measure to help ensure that a child cannot slip through this area. **It is recommended that you add a screen or more balusters at this location.**

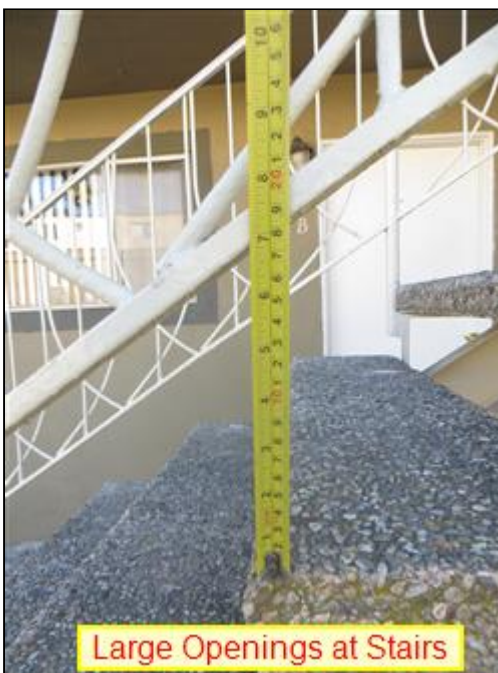
(5) **Large Openings.** The bottoms of the railings are currently spaced greater than 4 inches. Although this may have been standard at the time this was built, is recommended for today's standards, that the spacing of these balusters be no greater than 4 inches. This is a safety measure to help ensure that a child cannot slip through this area. **It is recommended that you add a screen or more balusters at this location.**

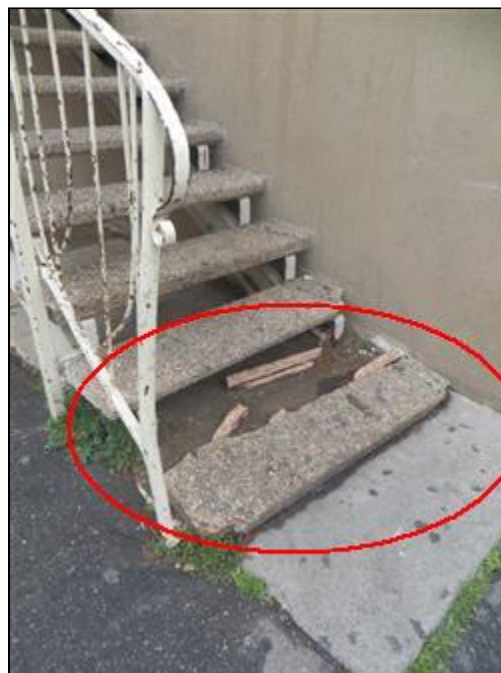
(6) **Damaged Stair Treads.** There were several loose and damaged treads at the front stairs of the buildings. **It is recommended for safety purposes that all damaged areas be further evaluated and repaired or replaced as needed by a licensed contractor.**

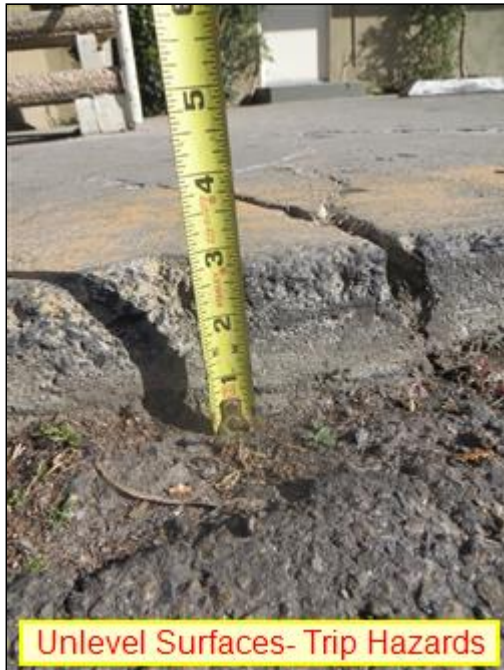
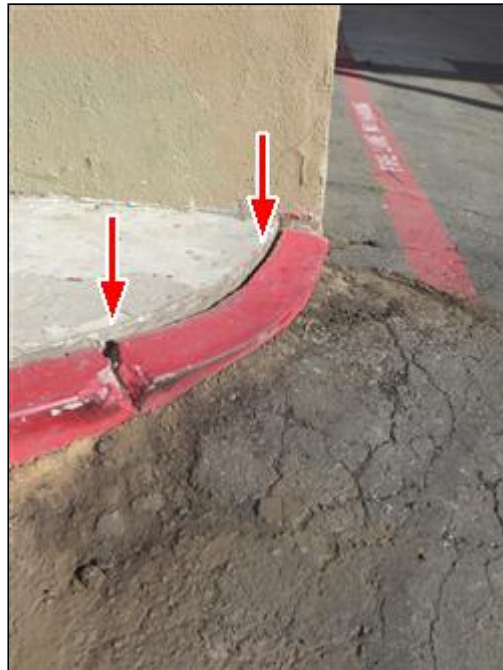
(7) **Unlevel Surfaces- Trip Hazards.** There were areas at the exterior of the building which had unlevel and raised surfaces noted . These areas may pose as a trip hazard. The cause of these unlevel surfaces are not known. It is recommended that adjustments be made to create a smooth walking surface at these locations.

Unlevel Surfaces-Trip Hazards

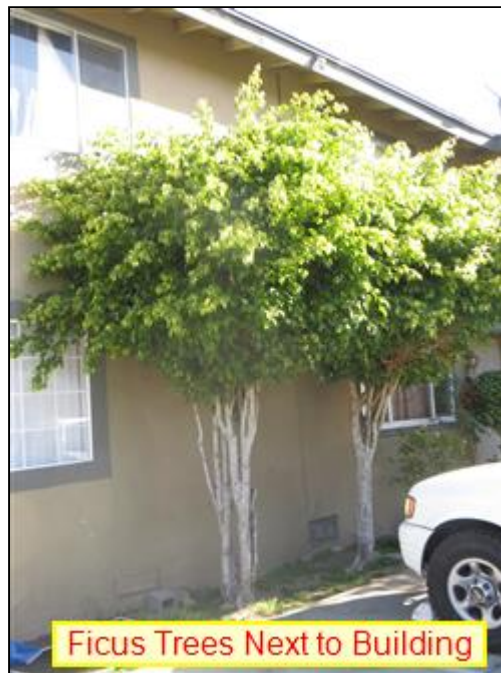
(1) **Ficus Benjamin** Note: These trees are Ficus Benjamins and are located in close proximity to the west building. **Ficus's are known to have a very shallow and evasive root system which can cause serious damage to the foundation, plumbing, and other aspects of the building.** "The United States Forest Service states "Roots can grow rapidly, invading gardens, growing under and lifting sidewalks, patios and driveways". **It is recommended that this tree be further evaluated by an arborist or other plant specialist to determine the affects it could have on the building and foundation.**

Ficus Trees Next to Building

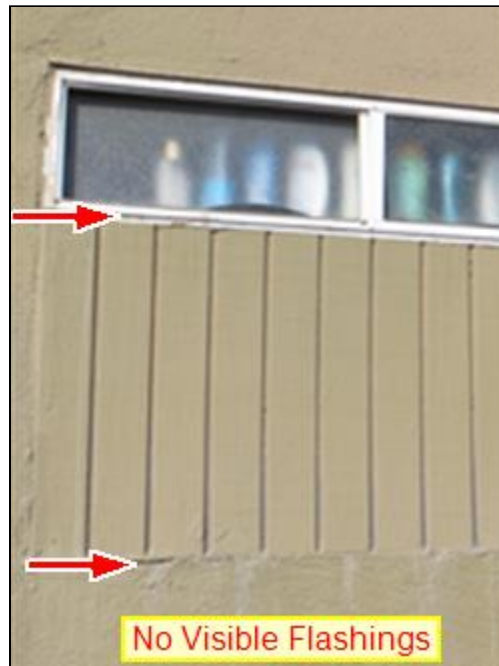
(2) **Unprotected Openings** . There were some penetrations noted at the exterior walls of the second and 4th (west) buildings. Also there were no visible flashings at the wood patching at the underside of the replaced bathroom windows. **These penetrations do not appear to be properly sealed or flashed. This can allow for water intrusion and animal infestation.** It was noted that there was internal wood damage at these locations as well as evidence of moisture. **It is recommended that these areas be patched or sealed as needed by a licensed contractor.**

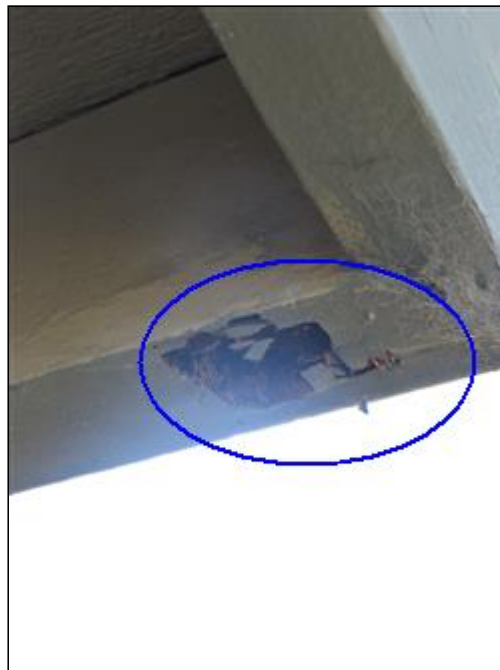
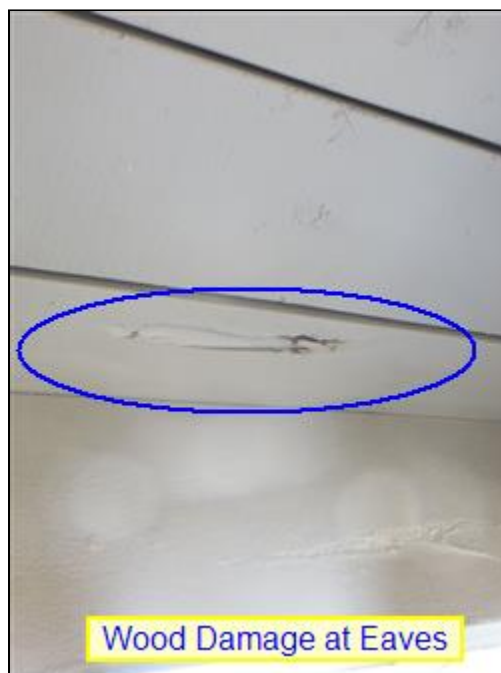
**Wood Damage.** There was some extensive wood damage noted at several areas of eaves and fascia of the buildings. **It is recommended that a termite report be conducted and that all reports about damaged materials be read.** All damaged wood should be properly repaired or replaced as needed according the the report by a licensed contractor.

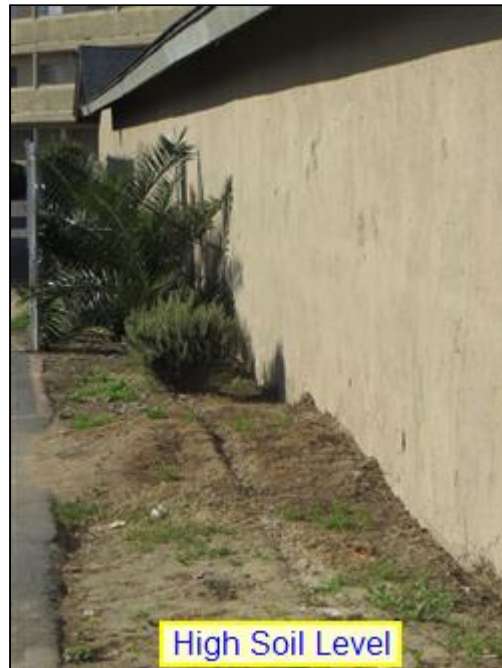
(3) **High Soil Level.** There was a location at the rear of the (east Side) garages in which the soil level was a bit high. Improper soil level can allow for moisture intrusion and structural damage. **It is recommended that the soil at the back of this garage be properly leveled and the interior of the garage wall at this location be further evaluated for damage and repaired as needed.**

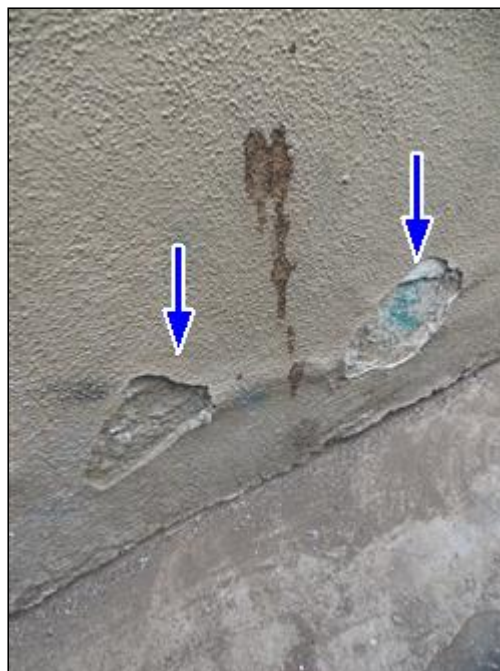
(4) **Delamination of Stucco.** There was some delamination of stucco noted at the exterior walls of the parking garages. The stucco is beginning to delaminate at the exterior of the buildings. Although there are many causes of delamination, most often, it is due to excess moisture wicking into the stucco, and causing it to fail. **This is a cosmetic fix but, but efforts should be made to keep the area around the building and foundation dry.**

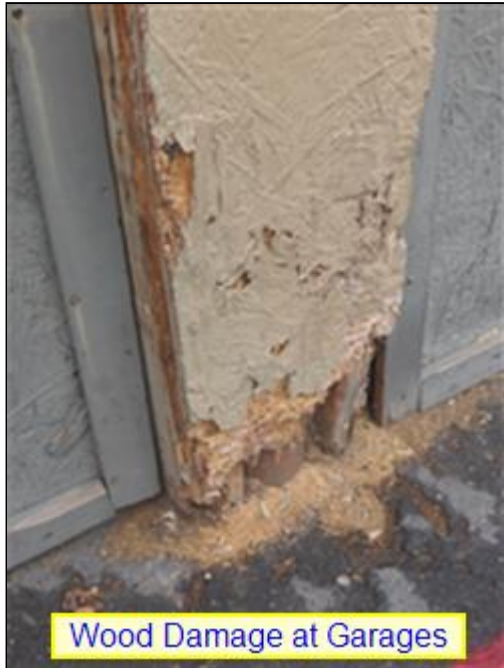
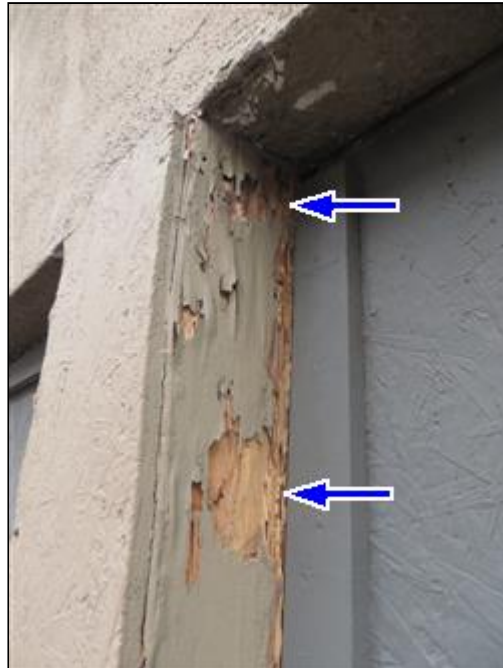
(5) **Wood Damage.** There were several locations which had wood damage at some of the interior garages. This damage was noted at the front of the garage door framing on the second and third buildings. **Some of the wood at these locations was not designed for exterior use and has begun to deteriorate at several**

locations. It is recommended that all damaged wood be further evaluated and repaired or replaced as needed by a licensed contractor.

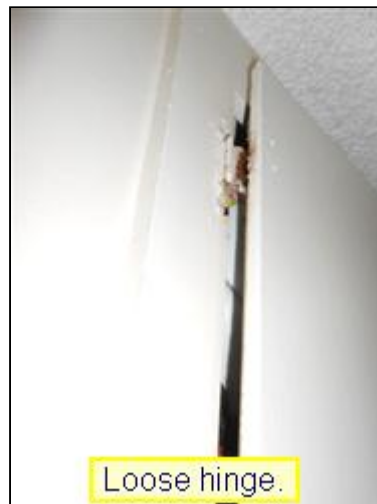
**Loose Hinges.** There was at least one loose hinge noted at one of the cabinets. It is recommended that this hardware be secured, repaired or replaced to ensure proper function of cabinet hardware.

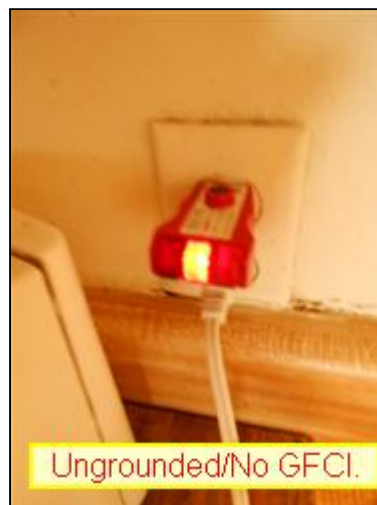
**Ungrounded Outlets with No GFCI.** There outlets in the kitchen that were not grounded and not GFCI protected. It is recommended that all outlets within 6' (six feet) of any water source be grounded OR replaced with an GFCI protected outlet by a licensed electrician.

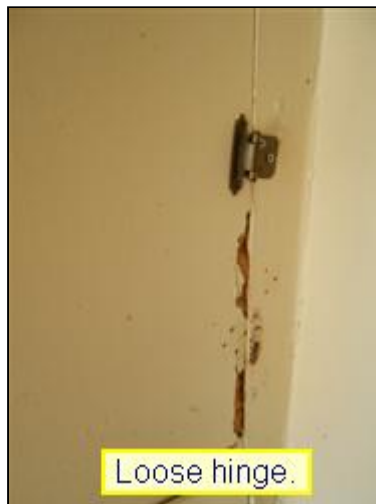
**Loose Hinges.** There was at least one loose hinge noted at one of the cabinets. It is recommended that this hardware be secured, repaired or replaced to ensure proper function of cabinet hardware.

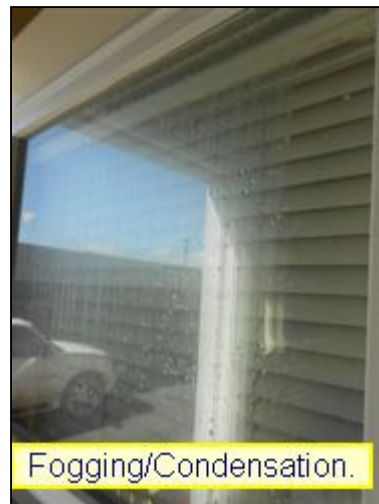
Dislodged Seal. The seal at the kitchen window was dislodged and there was fogging and condensation present within the panes. This is noted for your information and can be repaired by a window specialist.

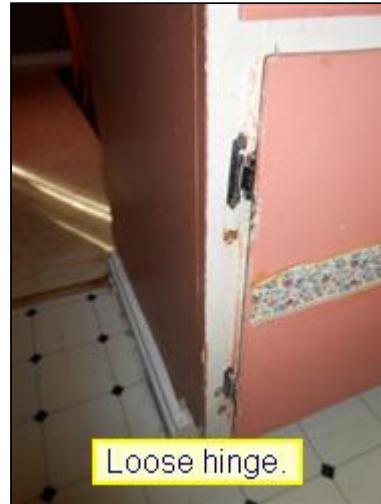
**Loose Hinges.** There was at least one loose hinge noted at one of the cabinets. It is recommended that this hardware be secured, repaired or replaced to ensure proper function of cabinet hardware.

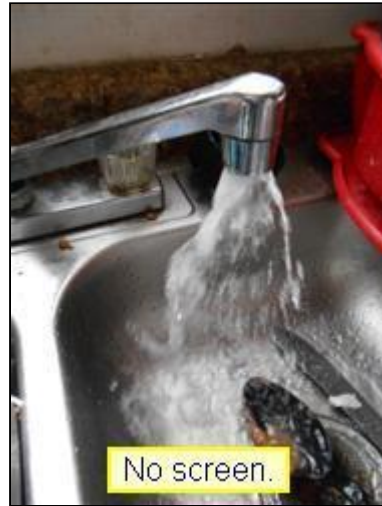
**Missing Screen.** It was noted that the screen at the kitchen faucet was missing causing water to flow out unevenly. It is recommended that a screen be installed by a qualified person.

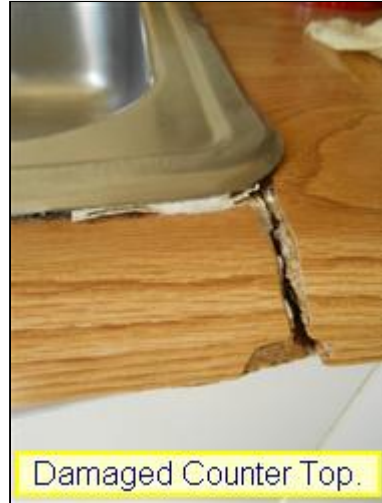
**Damaged counter top.** There are multiple areas of counter top that are worn and damaged. Severe damaged areas should be repaired replaced as needed . It is recommended that further evaluation is needed by a licensed contractor.

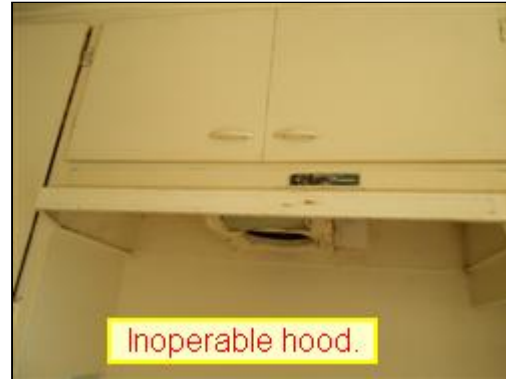
**Inoperative Hood System.** The hood fan and the light did not work at the time of the inspection. The cause of this could not be determined at the time of the inspection. It is recommended that this be further inspected or replaced by a licensed contractor.

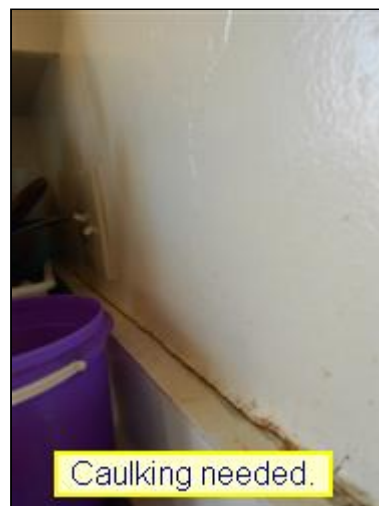
**Caulking Needed.** There are some areas that needed caulking at the counter backsplash. Gaps or missing grout, around this area can lead to water intrusion and moisture issues. It is recommended that the sink be properly caulked at these locations.

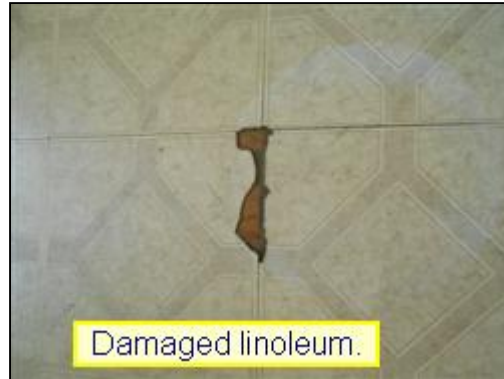
**Floor Damage.** There were areas of flooring that either had minor damage. **This is noted for your information.**

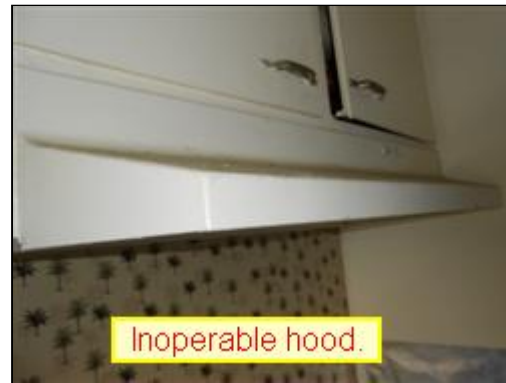
**Inoperative Vent Fan.** The hood did not work at the time of the inspection. The cause of this could not be determined at the time of the inspection. **It is recommended that this be further inspected or replaced by a licensed contractor.**

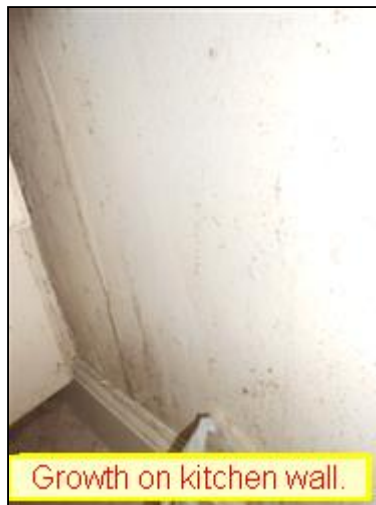
Growth on walls. There were walls in the kitchen that where growth was noted. It is recommended that this area be further evaluated properly repaired by a licensed contractor specializing in mildew and mold.

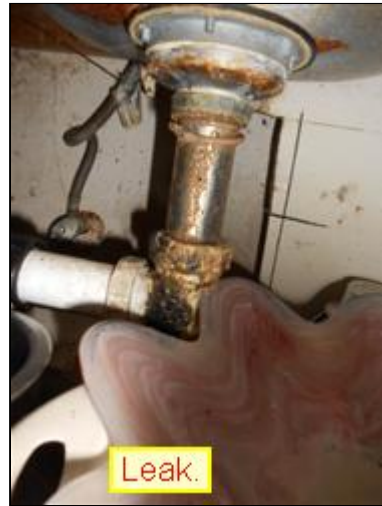
**Leak Under Sink.** The waste line is leaking at the underside of the kitchen sink. It is recommended that a qualified, licensed, plumber be called out to repair or correct as needed.

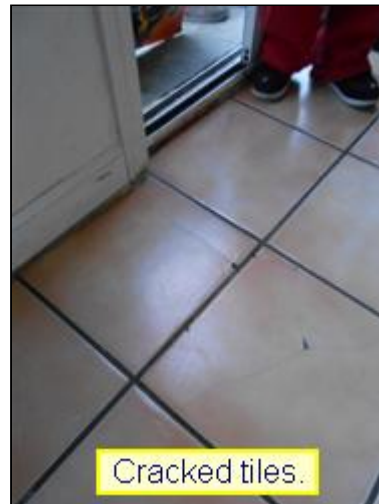
**Cracked Tiles.** There was at least one tile that was cracked at the floor tile in the kitchen. This is noted for your information and can be repaired at your convenience if so desired.

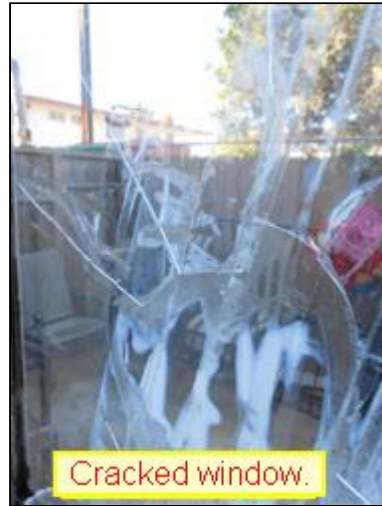
Cracked Window. There was a cracked in the window at the kitchen. It is recommended, for safety purposes, that this window be repaired or replaced by a qualified professional.

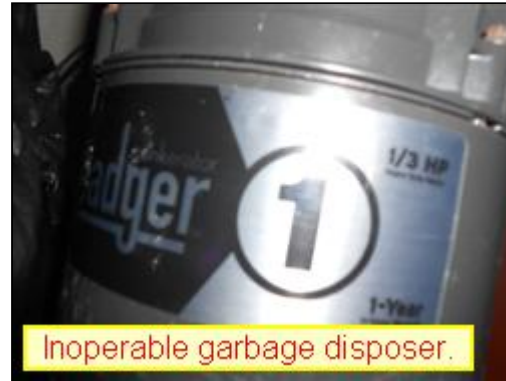
Inoperative Garbage Disposer.

The Garbage disposer did not work at time of inspection. The unit did not function or make a noise when turned "ON". It is possible that the rotors were locked, It was not determined at the time of the inspection if this unit can be corrected or will need to be replaced . It is recommended that this be repaired or replaced by a licensed professional.

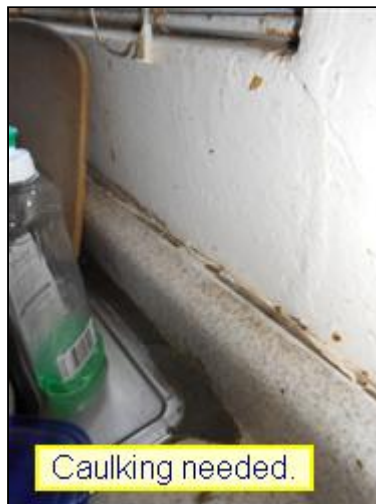
📍 (1) **Caulking Needed.** There are some areas where caulking is needed at the counter backsplash. Gaps or missing grout, around this area can lead to water intrusion and moisture issues. It is recommended that the sink be properly caulked at these locations.

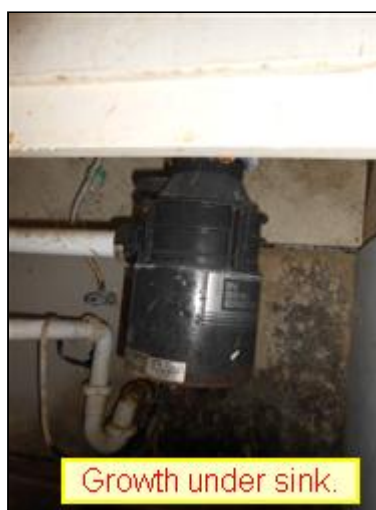
📍 (2) **Growth under sink.** There was growth under the kitchen sink noted. It is recommended that this area be further evaluated properly repaired by a licensed contractor specializing in mildew and mold.

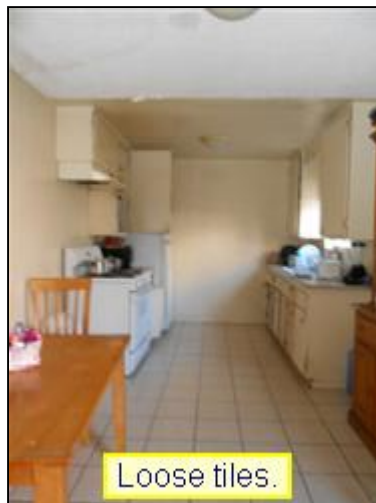
📍 **Loose Tiles.** There were several loose tiles in the kitchen. This is noted for your information and can be repaired at your convenience if so desired.

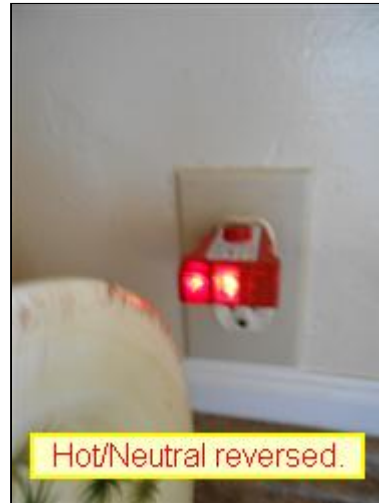
(2) **Hot/ Neutral reversed.** There was an outlet in the kitchen that has been incorrectly wired and, the hot and neutral have been reversed. **This is improper and should be corrected by a licensed electrician.**

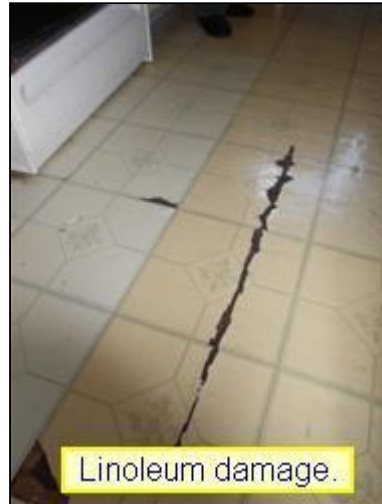
Linoleum Damage. The linoleum flooring in the kitchen is worn and has some minor damage. It is recommended that this flooring be repaired or replaced at your convenience.

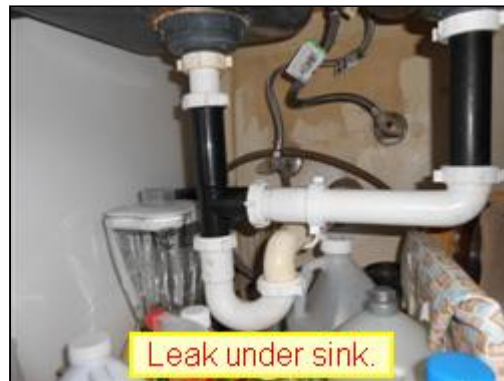
Leak Under Sink. The waste line is leaking at the underside of the kitchen sink. It is recommended that a qualified, licensed, plumber be called out to repair or correct as needed.

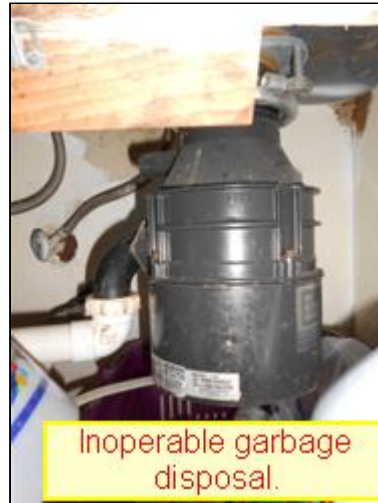
**Inoperative Garbage Disposer.** The Garbage disposer did not work at time of inspection. The unit did not function or make a noise when turned "ON". It is possible that the rotors were locked, It was not determined at the time of the inspection if this unit can be corrected or will need to be replaced . **It is recommended that this be repaired or replaced by a licensed professional.**

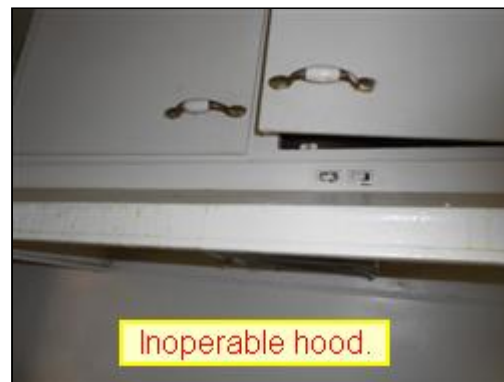
**Inoperative Vent Fan.** The hood did not work at the time of the inspection. The cause of this could not be determined at the time of the inspection. **It is recommended that this be further inspected or replaced by a licensed contractor.**

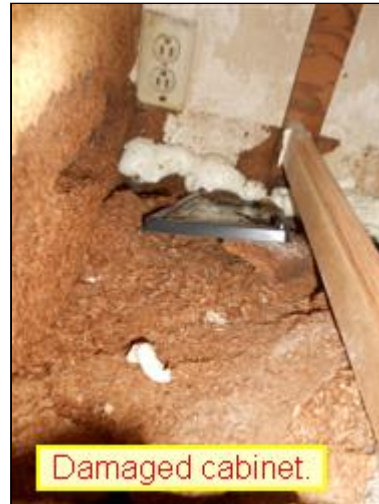
**Water Damage to Cabinet.** The cabinet in the kitchen has water damage at the underside of the sink. This cabinet is made of particle board which swells and warps when damaged. Once this material has had water damage it loses its strength, and warps. It is recommended that this vanity be replaced to limit the possibility of mold.

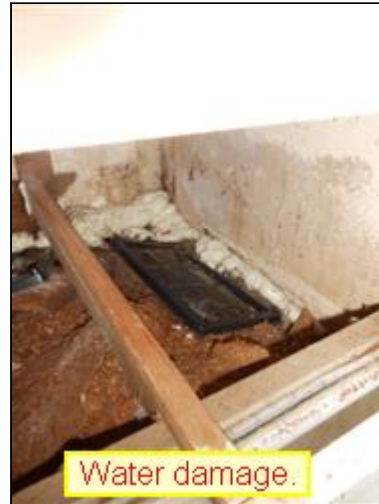
Water Damage With Musty Smell.

The cabinet at the underside of the kitchen counter shows evidence of past water damage and there is a strong musty smell. **This may indicate that there are greater problems at this location and further evaluation is highly recommended to ensure there is no growth that was not visible at the time of the inspection. It is recommended that this area be further evaluated for potential growth and damage by a licensed contractor and repaired as needed.**

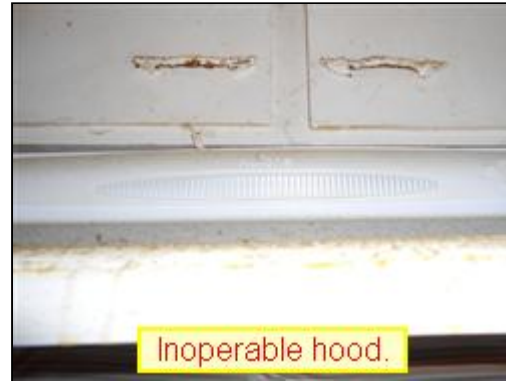
**Inoperative Vent Fan.** The hood did not work at the time of the inspection. The cause of this could not be determined at the time of the inspection. It is recommended that this be further inspected or replaced by a licensed contractor.

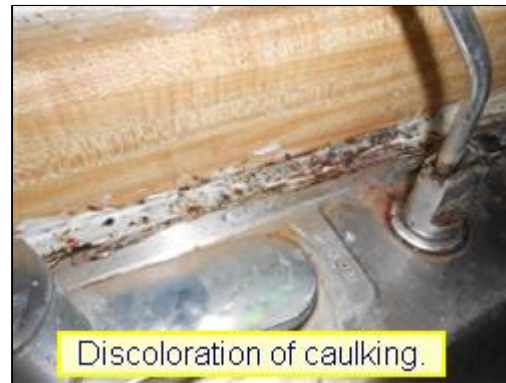
**Discoloration of Caulking.** There was some discoloration of the grout at the counter/ sink connection. This discoloration occurs when water had penetrated the grout at this location. It is recommended that this area be cleaned with a bleach solution and that this area be re-caulked or grouted.

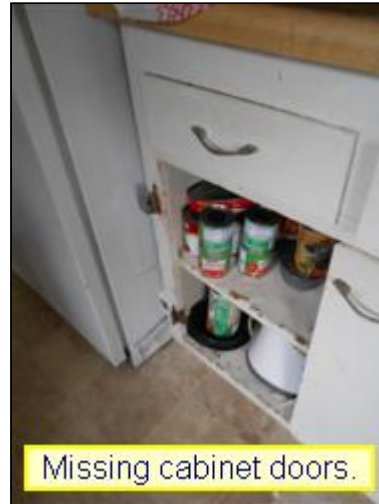
**Missing Cabinet Doors.** It was noted that a few kitchen cabinets were missing doors. This is noted for your information.

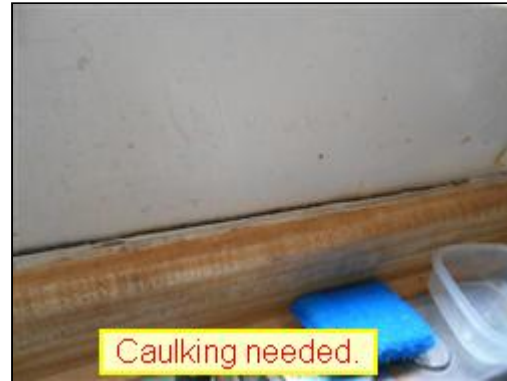
Caulking Needed. There are some areas that need some Caulk / grout at the counter backsplash. Gaps or missing grout, around this area can lead to water intrusion and moisture issues. It is recommended that the sink be properly caulked at these locations.

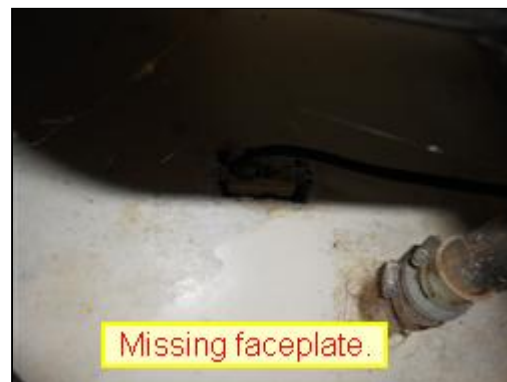
(2) Missing Outlet Cover. There was an outlet under the sink that does not have a faceplate. Missing faceplates expose electrical parts of receptacle outlets, and switches creating a potential shock hazard. For safety reasons all outlets and switches should have secure covers to reduce the chance of electric shock.

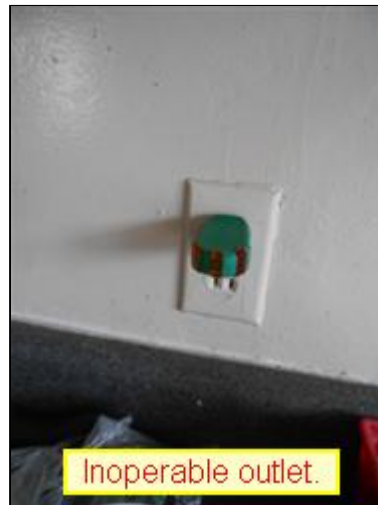
(2) **Inoperative Outlet.** The outlet at the kitchen counter did not work at time of inspection. There was no power at this outlet. **It is recommended that this be further evaluated by a licensed electrician and repaired as needed.**

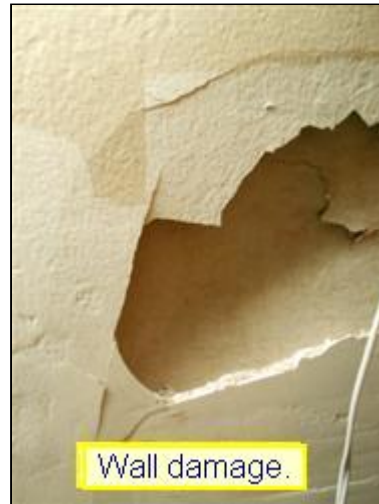
📍 (2) **Wall Damage.** There was some minor damage to the drywall noted in the bedroom. It is recommended that this area be patched at your convenience.

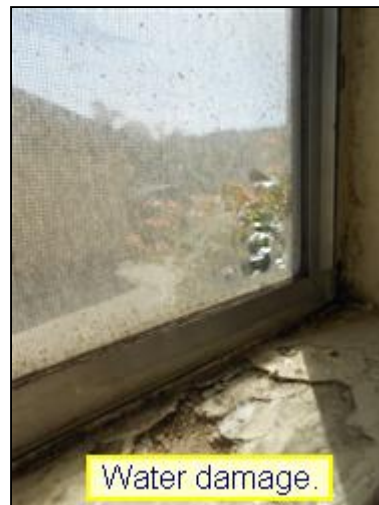
📍 (1) **Water Damage at Sill.** There was some water damage noted on the window sill in the bedrooms. It could not be determined at time of inspection if this damaged occurred to a leak caused by a faulty window system, or by the window being left open during a rain . **It is recommended that this be further inspected and that all water damaged materials be repaired or replaced by a licensed contractor to help ensure against the possibility of growth and further damage.**

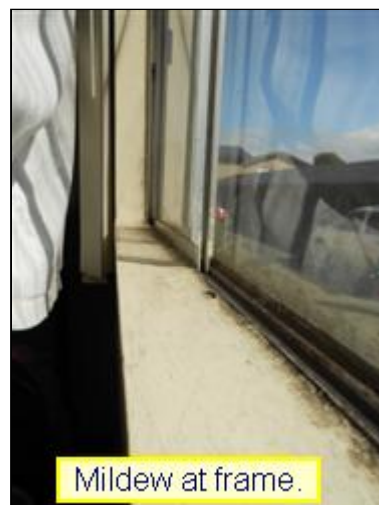
📍 (2) **Mildew at Window Frames.** There was mildew at the frames of the bedroom windows. This is common for aluminum windows. Due to the differing temperatures between the interior and exterior of the unit, the windows will often condensate. This moisture, along with dust particles often produced a mildew type growth at the window frames. This is only observed at the frames. **It is recommended that these areas be cleaned with a bleach/water solution.**

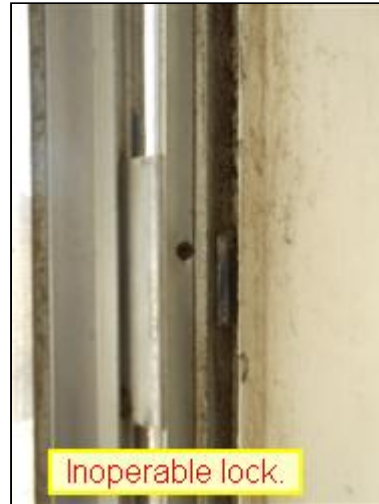
(3) **Inoperative Window Locks.**

The window locks for the windows in the bedrooms did not function. For safety purposes it is recommended that the windows be supplied with some sort of locking device.

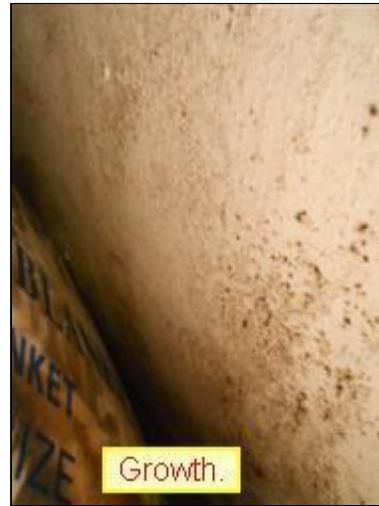
(2) **Growth on walls.** There were walls in the bedroom where growth was noted. It is recommended that this area be further evaluated properly repaired by a licensed contractor specializing in mildew and mold.

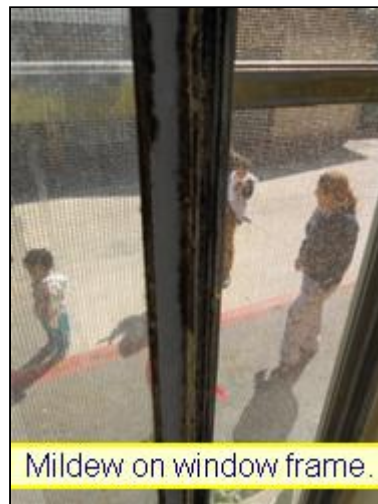
🏠 (1) Mildew at Window Frame.

There was mildew at the frame of the kitchen window. This is common for aluminum windows. Due to the differing temperatures between the interior and exterior of the unit, the windows will often condensate. This moisture, along with dust particles often produced a mildew type growth at the window frames. This is only observed at the frame and there is no growth or damage at the sills. It is recommended that these areas be cleaned with a bleach/water solution.

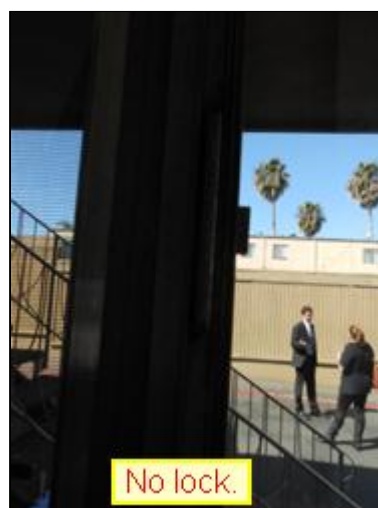
🏠 (2) Inoperative Window Locks.

The window locks for the windows in the unit did not function. For safety purposes it is recommended that this window be adjusted, repaired or supplied with some sort of locking device.

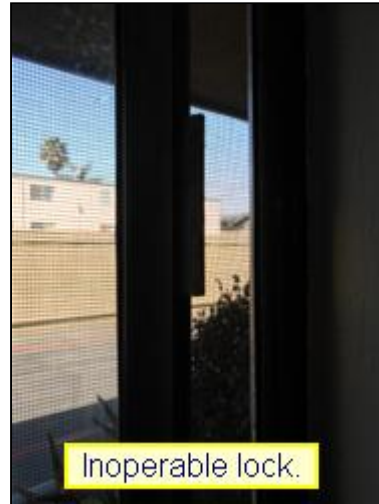
**Inoperative Window Locks.** The window locks for the windows in the unit did not function. For safety purposes it is recommended that this window be adjusted, repaired or supplied with some sort of locking device.

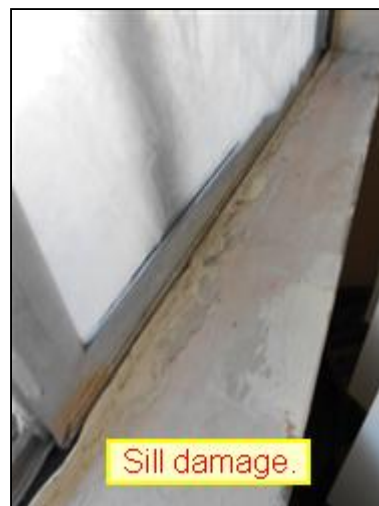
📍 (1) **Water Damage at Sill.** There was some water damage noted on the window sill in the living room window. It could not be determined at time of inspection if this damaged occurred to a leak caused by a faulty window system, or by the window being left open during a rain . **It is recommended that this be further inspected and that all water damaged materials be repaired or replaced by a licensed contractor to help ensure against the possibility of growth and further damage.**

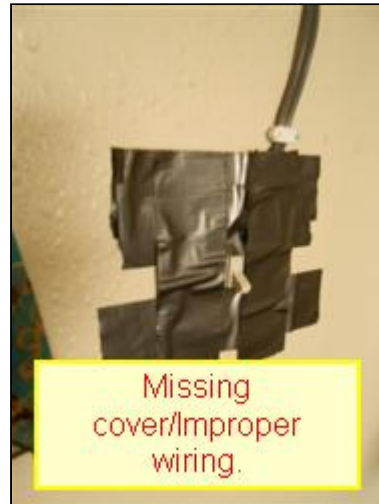
🏠 (2) **Missing cover/Improper wiring.** It was noted that a light switch did not have a cover and was improperly wired. It is recommended that this switch be properly wired by a licensed electrician.

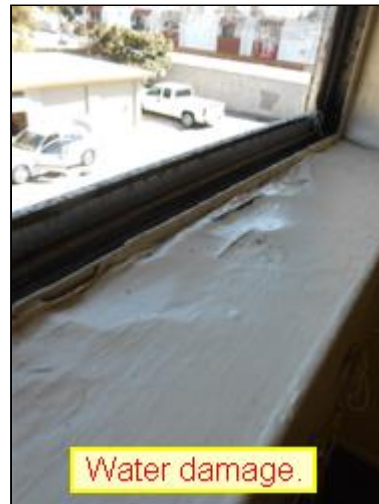
(2) **Water Damage at Sill.** There was some water damage noted on the window sills in the unit. It could not be determined at time of inspection if this damaged occurred to a leak caused by a faulty window system, or by the window being left open during a rain . **It is recommended that this be further inspected and that all water damaged materials be repaired or replaced by a licensed contractor to help ensure against the possibility of growth and further damage.**

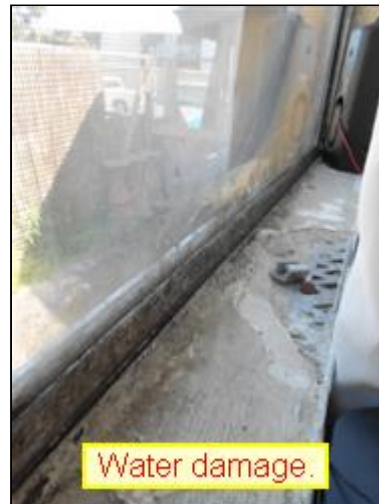
(2) **Water Damage at Sills.** There was some water damage noted on the window sills in the unit. It could not be determined at time of inspection if this damaged occurred to a leak caused by a faulty window system, or by the window being left open during a rain . **It is recommended that this be further inspected and that all water damaged materials be repaired or replaced by a licensed contractor to help ensure against the possibility of growth and further damage.**

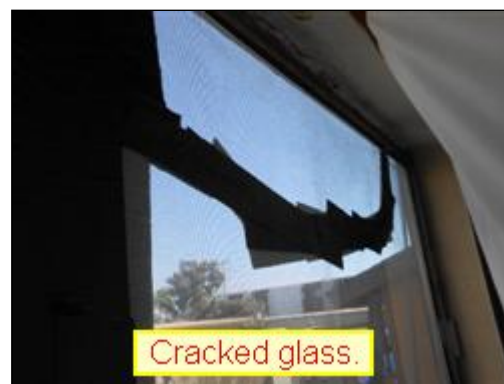
(3) **Cracked/ Damaged Window.** The window in the bedroom was cracked. **It is recommended for safety purposes that this be repaired or replaced by a licensed contractor or window professional.**

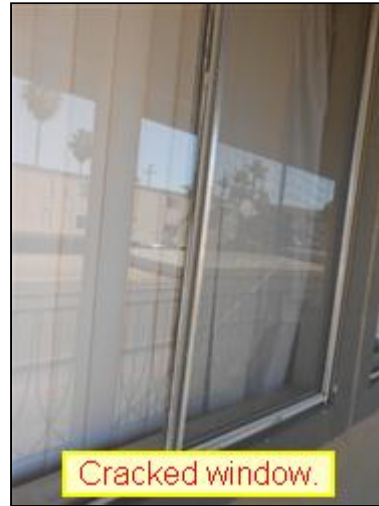
(1) **Cracked/ Damaged Window.**

The window in the living room was cracked. It is recommended for safety purposes that this be repaired or replaced by a licensed contractor or window professional.

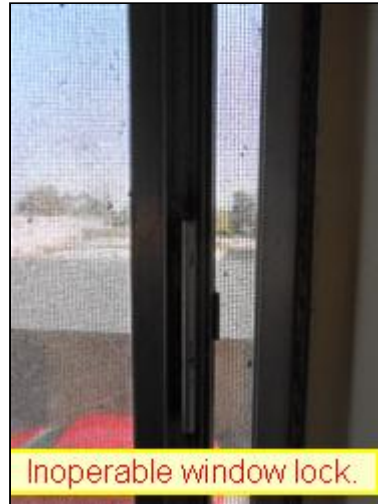
🏠 (1) Inoperative Window Locks.

The window locks for the windows in the unit did not function. For safety purposes it is recommended that this window be adjusted, repaired or supplied with some sort of locking device.

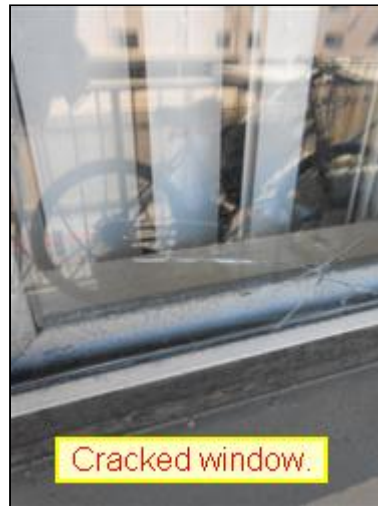
(2) **Cracked/ Damaged Window.** The window in the living room was cracked. It is recommended for safety purposes that this be repaired or replaced by a licensed contractor or window professional.

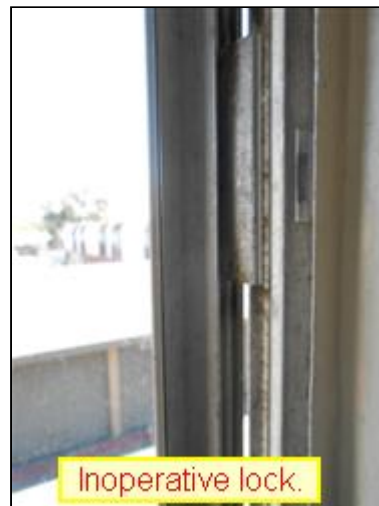
🏠 **Inoperative Window Locks.** The window locks for the windows in the unit did not function. **For safety purposes it is recommended that this window be adjusted, repaired or supplied with some sort of locking device.**
