Inspection Report

Sample Report

Property Address:
1202 Missouri Ave
Oceanside Ca 92054

Nation Wide Inspections

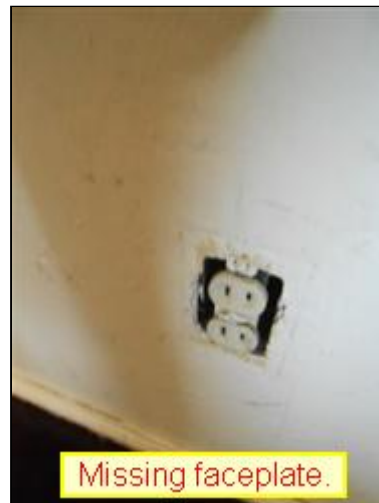
(2) **Missing Outlet Cover.** There was a missing cover in the living room. Missing faceplates expose electrical parts of receptacle outlets, and switches creating a potential shock hazard. **For safety reasons all outlets and switches should have secure covers to reduce the chance of electric shock.**

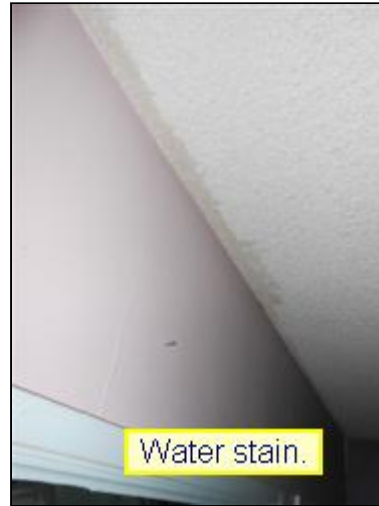
Ceiling Water Stain. There was some water staining noted on the ceilings of the hall. It appears that there have been a roof leaks at these locations at one time. **It could not be determined if these leaks have been properly repaired.** There did not appear to be any signs indicating that there is an active leak. It is recommended that you ask the current owner about these stains and that a roofing contractor be hired to further evaluate these areas if needed.

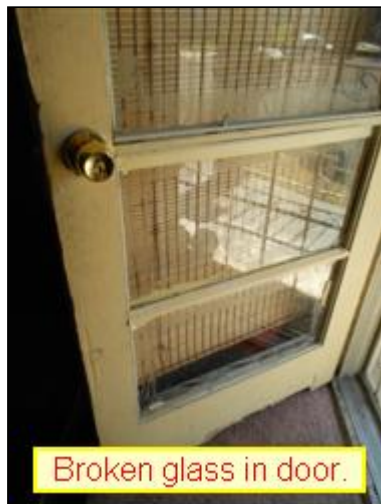
🏠 (1) **Broken Glass in Door.** The glass in the door in the living room was broken. Due to the safety hazard of this, it is recommended that the door or the glass be replaced by a licensed contractor or qualified professional.

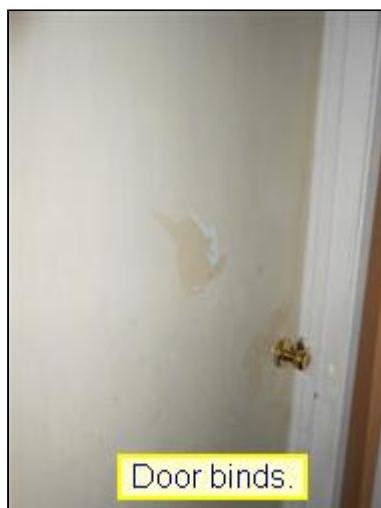
(2) **Doors Binds.** The door located in the bedroom does not properly close and hinge on the door frame. The doors shut, but are in constant pressure due to proximity of the door to the frame. It is recommended that the door be adjusted by a licensed contractor to allow the door to freely close.

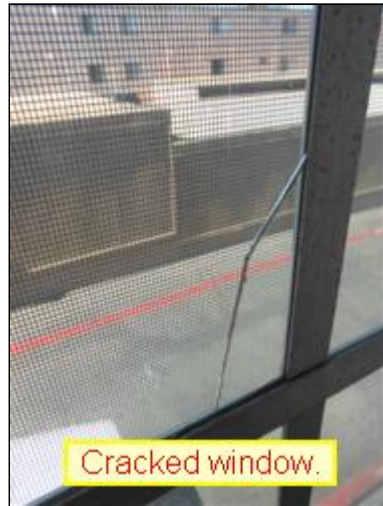
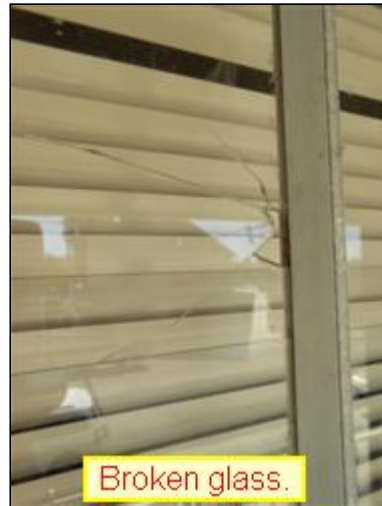
(2) **Cracked/ Damaged Windows.** The windows in the dining room, living room and bedroom were cracked. It is recommended for safety purposes that this be repaired or replaced by a licensed contractor or window professional.

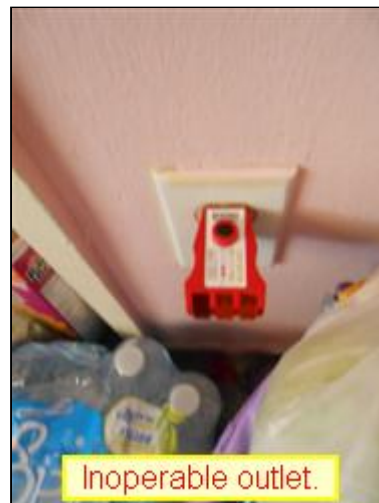
(2) **Inoperable Outlet.** There was an outlet in bedroom that did not work at time of inspection. **There was no power at this outlet.** It is recommended that this be further evaluated by a licensed electrician.

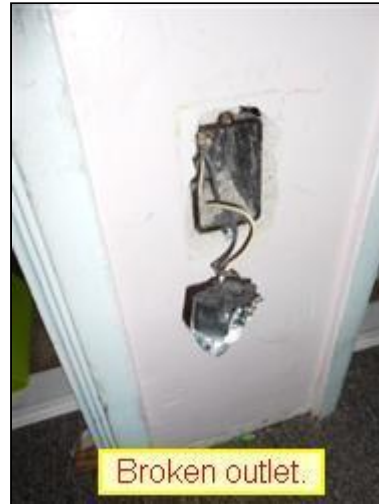
(3) **Loose Outlet.** There was a loose at the wall connection in the hall.

Loose outlets can pull the wires from the back of the receptacle causing the wires to arch or cause electric shock.

For safety reasons it is recommended that these outlets be properly secured.

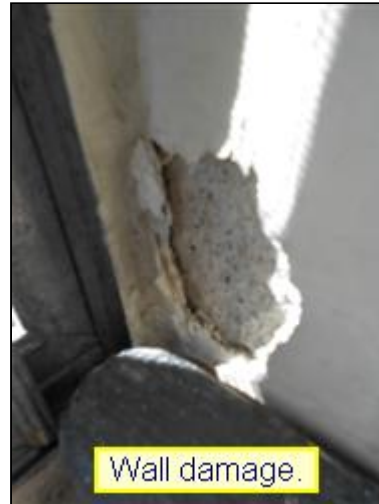
📍 (1) **Wall Damage.** There was some minor damage to the drywall noted in the unit. It is recommended that this area be patched at your convenience.

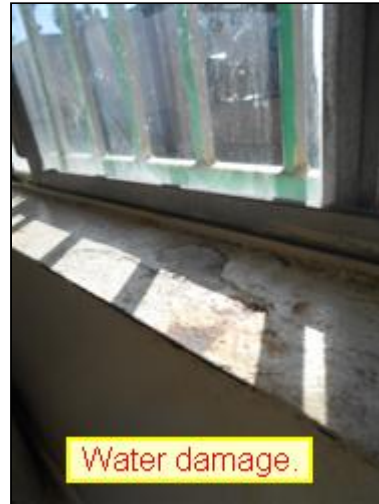
(2) **Water Damage at Sill.** There was some water damage noted on the window sill in the family room in the living room window. It could not be determined at time of inspection if this damaged occurred to a leak caused by a faulty window system, or by the window being left open during a rain . It is recommended that this be further inspected and that all water damaged materials be repaired or replaced by a licensed contractor to help ensure against the possibility of growth and further damage.

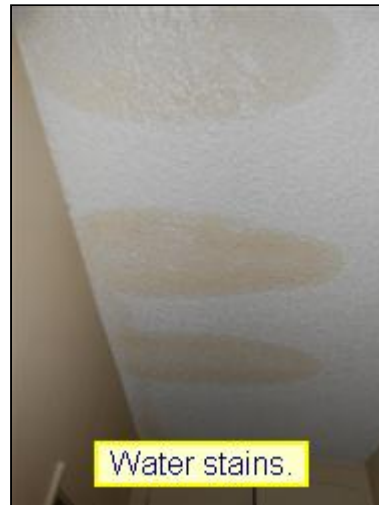
**Ceiling Water Stain.** There was some water staining noted on the ceilings of the hall. It appears that there have been a leak at this locations at one time. **It could not be determined if the leak has been properly repaired.** There did not appear to be any signs indicating that there is an active leak. **It is recommended that you ask the current owner about these stains and that a roofing contractor be hired to further evaluate these areas if needed.**

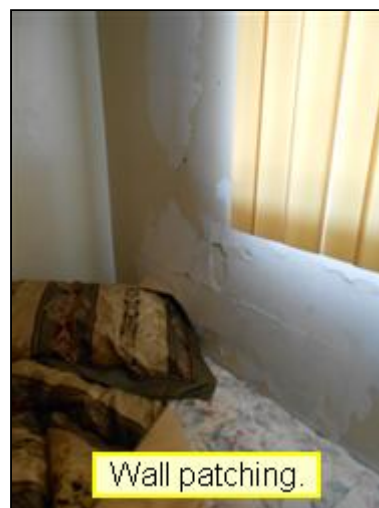
(1) **NOTE:** There were some areas of patchwork noted at some of the walls. The reason for this patchwork could not be determined, but there did not appear to be any current damage or issues at these areas. This is noted only for your information.

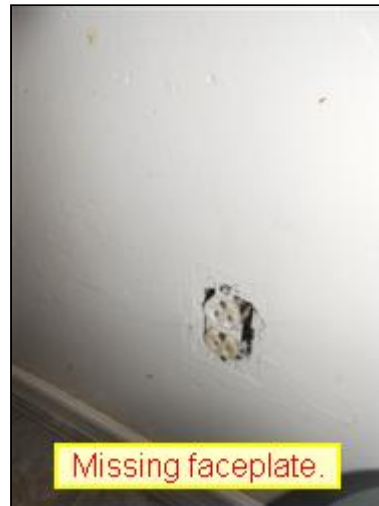
(2) **Missing Outlet Cover.** There was a missing cover in the dining room. Missing faceplates expose electrical parts of receptacle outlets, and switches creating a potential shock hazard. **For safety reasons all outlets and switches should have secure covers to reduce the chance of electric shock.**

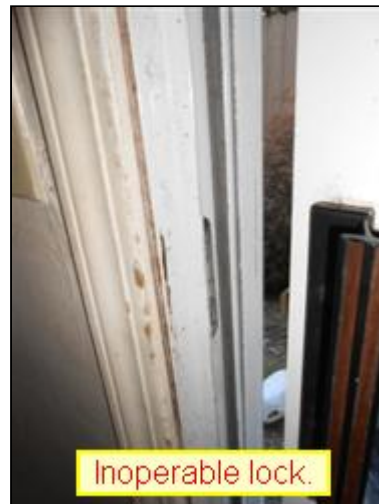
📍 **Inoperative Lock at Slider.** The lock on the slider located in the dining room did not properly function and did not lock. It appears the at the alignment of the hardware is a bit off and does not allow the latching mechanism to connect. **It is recommended that this hardware is adjusted or replaced to allow the lock to properly engage and lock.**

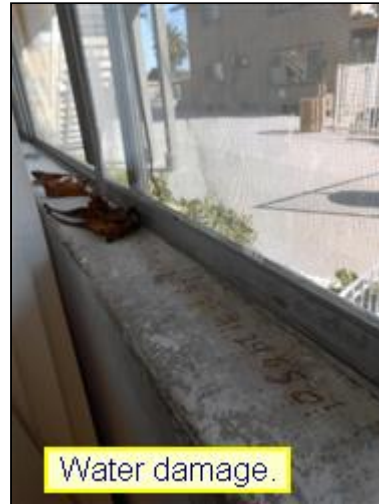
(2) **Water Damage at Sill.** There was some water damage noted on the window sill in the living room window. It could not be determined at time of inspection if this damaged occurred to a leak caused by a faulty window system, or by the window being left open during a rain . It is recommended that this be further inspected and that all water damaged materials be repaired or replaced by a licensed contractor to help ensure against the possibility of growth and further damage.

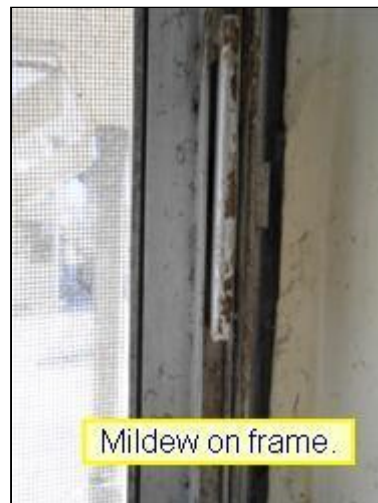
(2) **Mildew at Window Frame.** There was mildew at the window frames in the unit. This is common for aluminum windows. Due to the differing temperatures between the interior and exterior of the unit, the windows will often condensate. This moisture, along with dust particles often produced a mildew type growth at the window frames. This is only observed at the frames and there is no growth or damage at the sills. **It is recommended that these areas be cleaned with a bleach/water solution.**

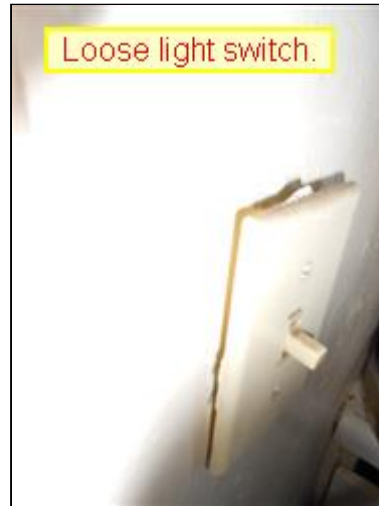
🏠 (2) **Loose Light Switch.** There was a loose switch at the wall connection. Loose switches can pull the wires from the back of the receptacle causing the wires to arch or cause electric shock. **For safety reasons it is recommended that these outlets be properly secured.**

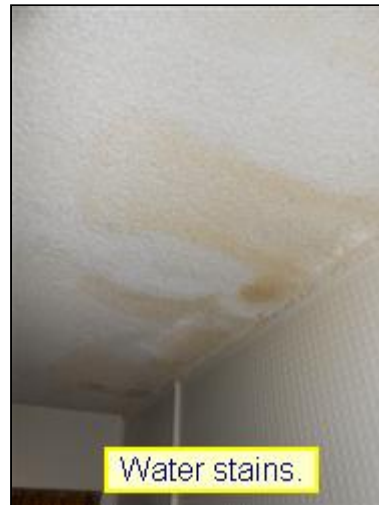
Ceiling Water Stain. There was some water staining noted on the ceilings of the unit. It appears that there have been a leak at these locations at one time. **It could not be determined if these leaks have been properly repaired.** There did not appear to be any signs indicating that there is an active leak. **It is recommended that you ask the current owner about these stains and that a roofing contractor be hired to further evaluate these areas if needed.**

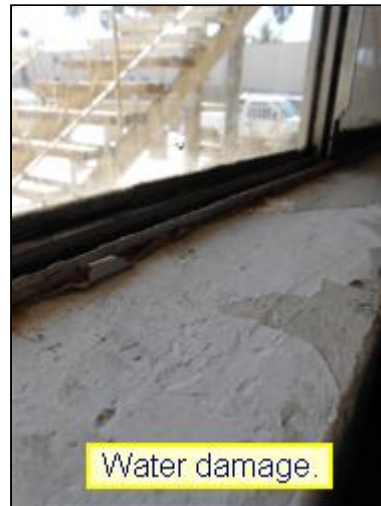
(2) **Water Damage at Sill.** There was some water damage noted on the window sill in the living room window. It could not be determined at time of inspection if this damaged occurred to a leak caused by a faulty window system, or by the window being left open during a rain . **It is recommended that this be further inspected and that all water damaged materials be repaired or replaced by a licensed contractor to help ensure against the possibility of growth and further damage.**

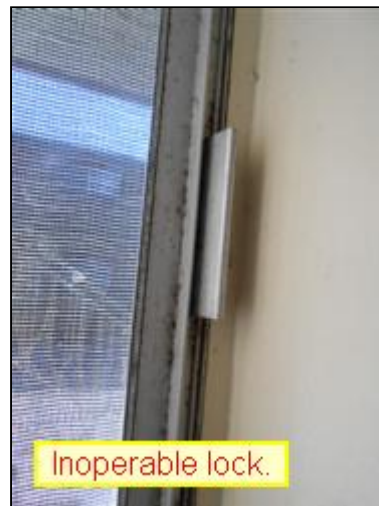
🏠 **Inoperative Window Locks.** The window locks for the windows in the unit did not function. **For safety purposes it is recommended that this window be adjusted, repaired or supplied with some sort of locking device.**

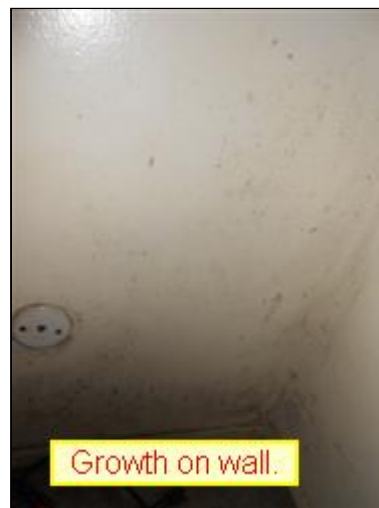
(1) **Growth on walls.** There were walls in the bedroom where growth was noted. It is recommended that this area be further evaluated properly repaired by a licensed contractor specializing in mildew and mold.

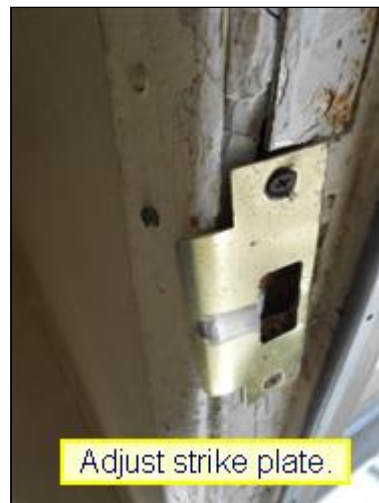
📍 (1) **Adjust Strike Plate.** There front door did do not latch shut properly. The strike plate for the door is not adjusted properly and does not allow the door to latch shut. **It is recommend that the door be adjusted to allow the it to properly shut.**

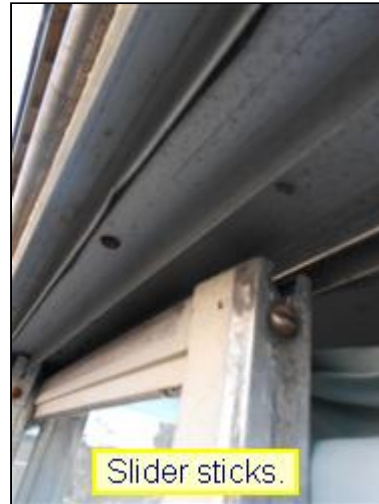
📍 (2) **Slider Sticks**. The slider in the dining room sticks making it difficult to operate. This is noted for your information and it is not known if corrections can be made to improve the sliding ability of these doors.

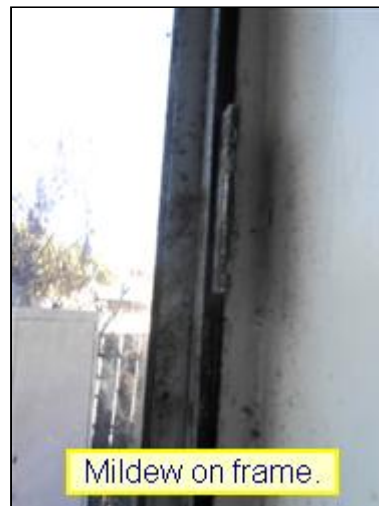
(2) **Mildew at Window Frame**. There was mildew at several window frames in the unit. This is common for aluminum windows. Due to the differing temperatures between the interior and exterior of the unit, the windows will often condensate. This moisture, along with dust particles often produced a mildew type growth at the window frames. This is only observed at the frames and there is no growth or damage at the sills. It is recommended that these areas be cleaned with a bleach/water solution.

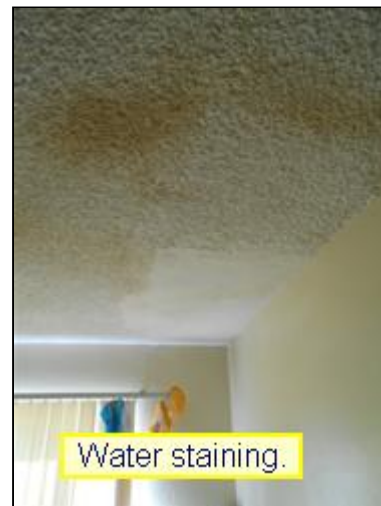
**Ceiling Water Stain.** There was some water staining noted on the ceilings of the bedroom. It appears that there have been a leaks at these locations at one time. **It could not be determined if these leaks have been properly repaired.** There did not appear to be any signs indicating that there is an active leak. **It is recommended that you ask the current owner about these stains and that a roofing contractor be hired to further evaluate these areas if needed.**

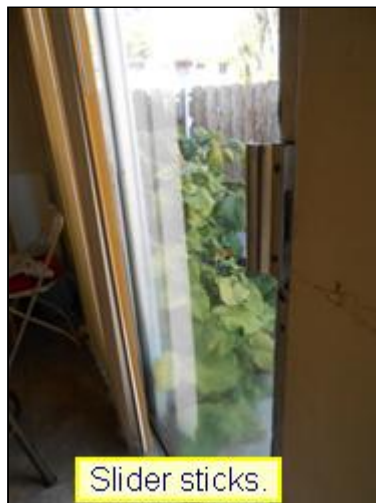
📍 (1) **Slider Sticks.** The slider in the dining room sticks making it difficult to operate. This is noted for your information and it is not known if corrections can be made to improve the sliding ability of these doors.

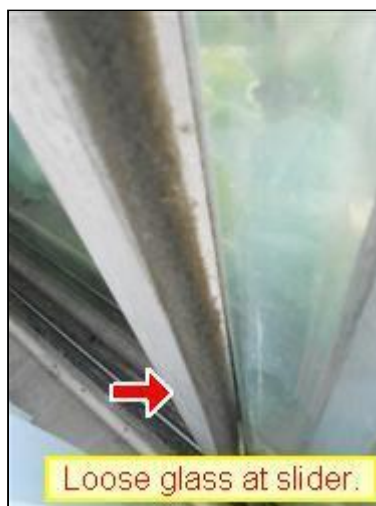
📍 (2) **Loose Glass at Slider.** It was noted that the glass on the sliding glass door in the dining room was pulled away from the frame. It is recommended that this be further evaluated by a licensed contractor and repaired where needed.

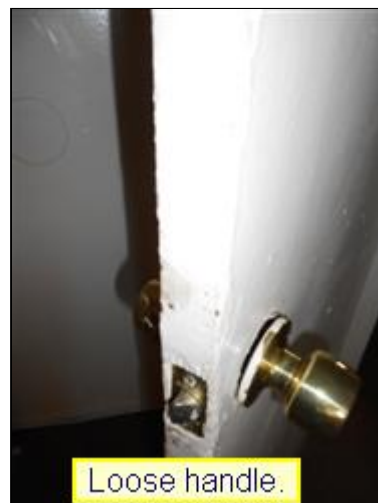
📍 **Loose Handle.** The handle for the bedroom door is loose and should be tightened to ensure proper working order. **It is recommended that this item is repaired or replaced as needed.**

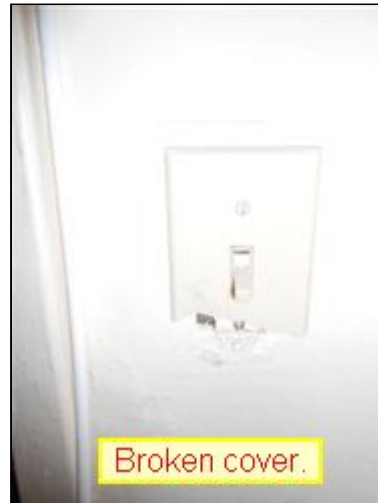
(2) **Damaged Cover.** There was a damaged light switch cover in the bedroom. Damaged faceplates expose electrical parts and creating a potential shock hazard. For safety reasons all outlets and switches should have secure covers to reduce the chance of electric shock.

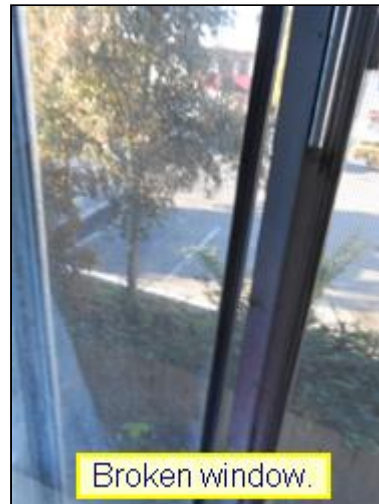
(2) **Window Sticks**. The window in the dining room was rough to operate and did not properly function. **It is recommended that this window be further evaluated and adjusted or repaired as needed.**

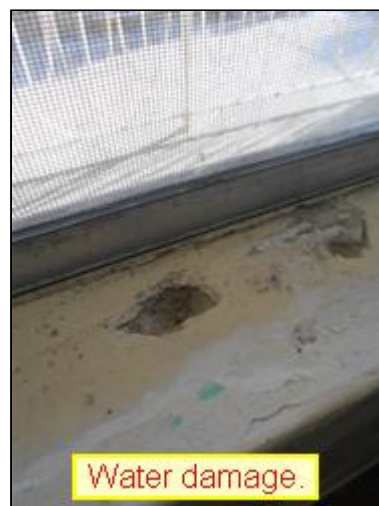
(3) **Water Damage at Sill**. There was some water damage noted on the window sills in the living room. It could not be determined at time of inspection if this damaged occurred to a leak caused by a faulty window system, or by the window being left open during a rain . **It is recommended that this be further inspected and that all water damaged materials be repaired or replaced by a licensed contractor to help ensure against the possibility of growth and further damage.**

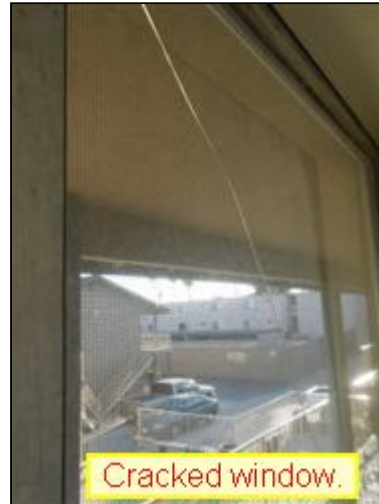
(4) **Cracked/ Damaged Window.** The window in the living room was cracked. It is recommended for safety purposes that this be repaired or replaced by a licensed contractor or window professional.

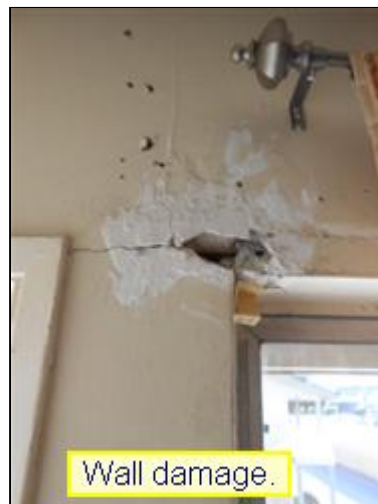
📍 (1) **Wall Damage.** There was some minor damage to the drywall noted in the living room. It is recommended that this area be patched at your convenience.

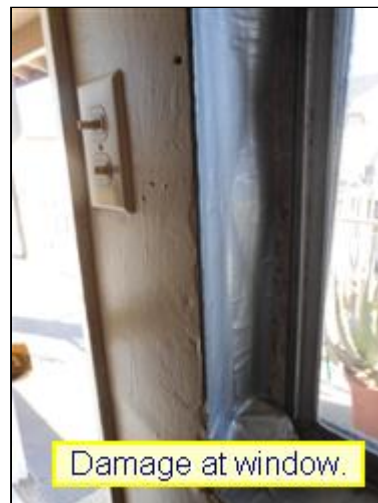
(2) **Possible Water Damage at Window.** There was possible water damage noted on the window frame in the living room window. It could not be determined at time of inspection if this damaged occurred to a leak caused by a faulty window system, or by the window being left open during a rain . **It is recommended that this be further inspected and that all water damaged materials be repaired or replaced by a licensed contractor to help ensure against the possibility of growth and further damage.**

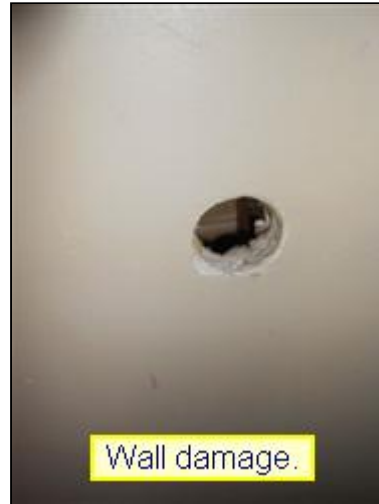
🏠 (1) **Wall Damage.** There was some minor damage to the drywall noted in the bedroom. It is recommended that this area be patched at your convenience.

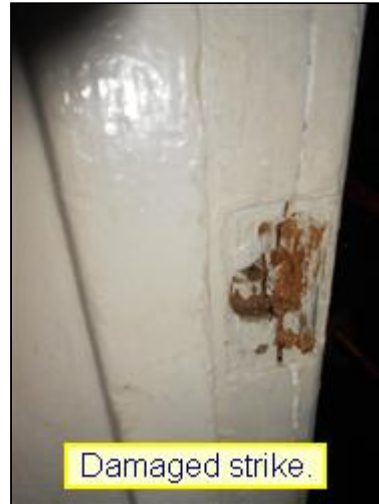
Missing Strike Plate. The door at bedroom was missing the metal strike plate. This device helps catch the striker, which allows the door to latch shut. **It is recommended that these be replaced as needed by a licensed contractor.**

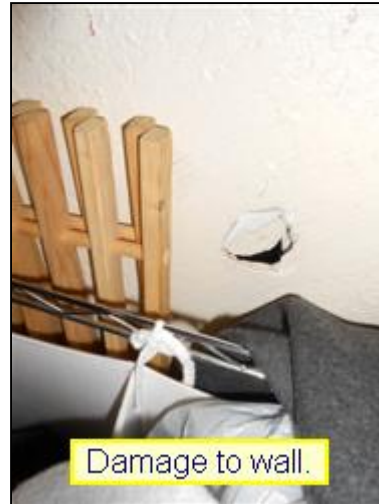
📍 (1) **Wall Damage.** There was some minor damage to the drywall noted in the bedroom. It is recommended that this area be patched at your convenience.

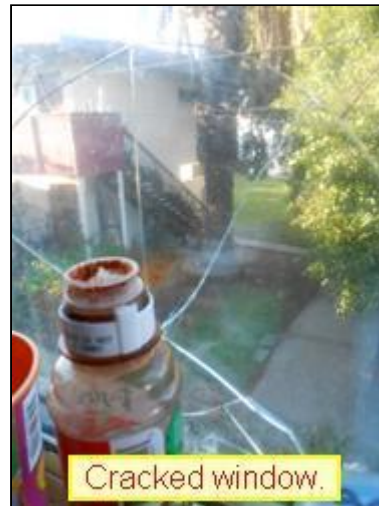
(2) **Cracked/ Damaged Window.** The window in the bedroom was cracked. **It is recommended for safety purposes that this be repaired or replaced by a licensed contractor or window professional.**

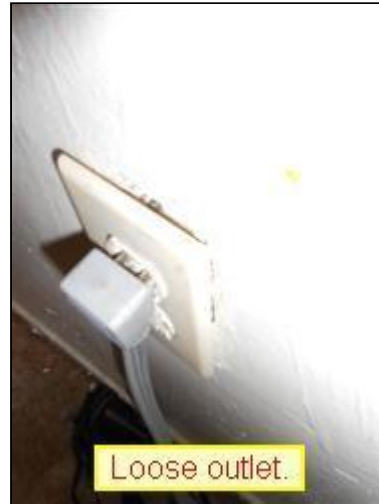
(2) **Loose Outlet.** There were loose outlets at the wall connections in the unit. Loose outlets can pull the wires from the back of the receptacle causing the wires to arch or cause electric shock. For safety reasons it is recommended that these outlets be properly secured.

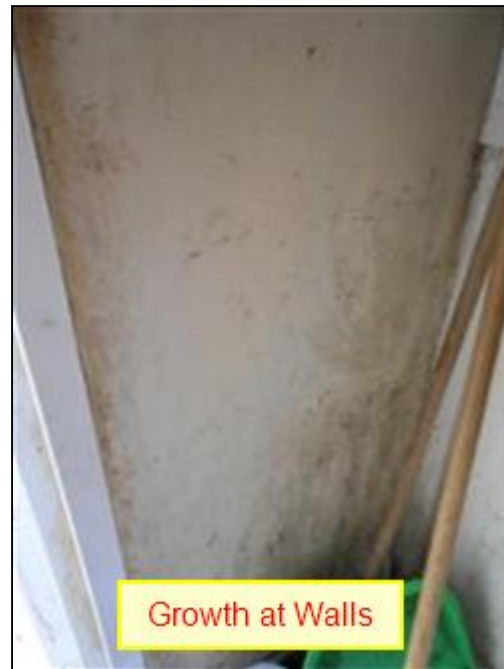
(2) **Growth at Walls.** The walls in the dining area had growth. It is recommended that this area be further evaluated and properly repaired by a licensed contractor specializing in mildew and mold.

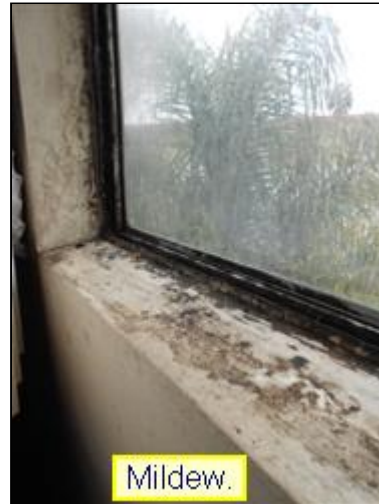
(2) **Mildew at Window Frames.** There was mildew at the frames of the bedroom windows. This is common for aluminum windows. Due to the differing temperatures between the interior and exterior of the unit, the windows will often condensate. This moisture, along with dust particles often produced a mildew type growth at the window frames. It is recommended that these areas be cleaned with a bleach/water solution.

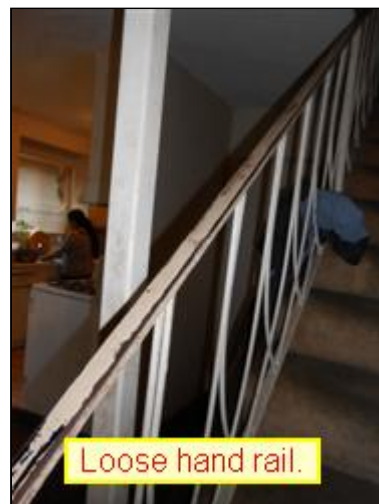
📍 (1) **Loose Hand Rails.** Stairs are one of the most frequent location of injury accidents in the home. It is required that all stairs with 4 or more risers have a hand rail with a minimum height requirement of 34 inches. In this application the hand rail was loose or had missing hardware. For safety purposes it is recommended that this area have properly secured railings to ensure working order.

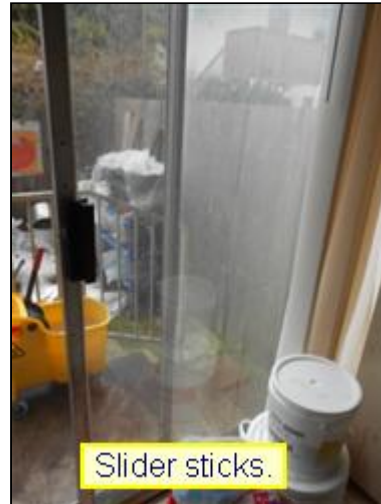
**Slider Sticks.** The slider in the dining room sticks making it difficult to operate. This is noted for your information and it is not known if corrections can be made to improve the sliding ability of these doors.

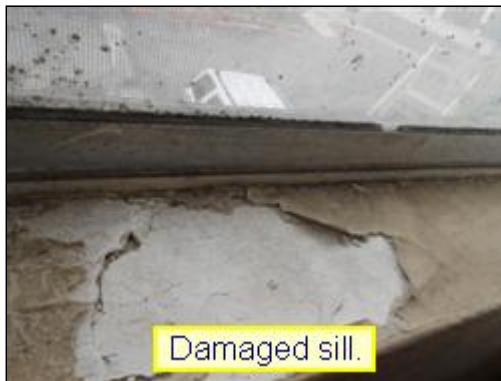
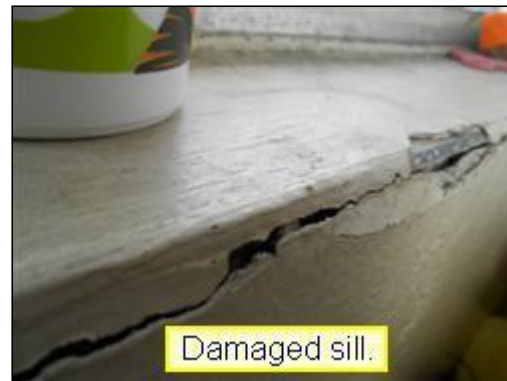
(2) **Water Damage at Sills.** There was some water damage noted on the window sills in the bedroom windows. It could not be determined at time of inspection if this damaged occurred to a leak caused by a faulty window system, or by the window being left open during a rain. It is recommended that this be further inspected and that all water damaged materials be repaired or replaced by a licensed contractor to help ensure against the possibility of growth and further damage.

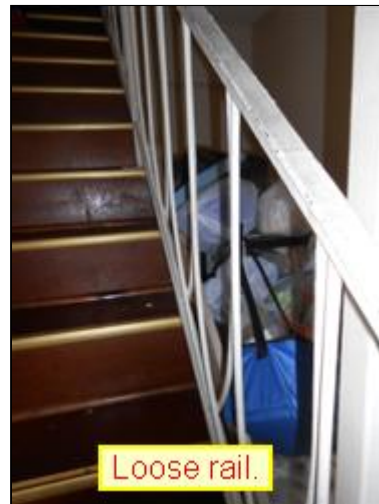
(1) **Loose Hand Rails.** Stairs are one of the most frequent location of injury accidents in the home. It is required that all stairs with 4 or more risers have a hand rail with a minimum height requirement of 34 inches. In this application the hand rail was loose or had missing hardware. For safety purposes it is recommended that this area have properly secured railings to ensure working order.

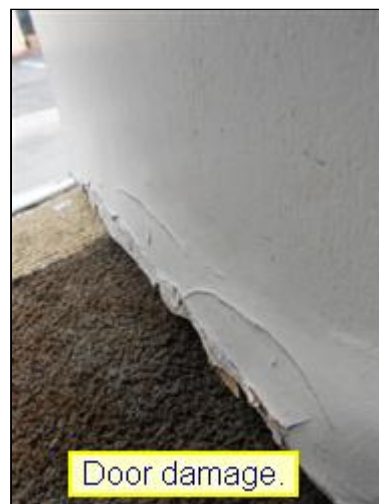
📍 **Door Damage.** There was some minor damage to the door of the living room . This currently does not affect the function of the door. **This is noted for your information and can be repaired at your convenience.**

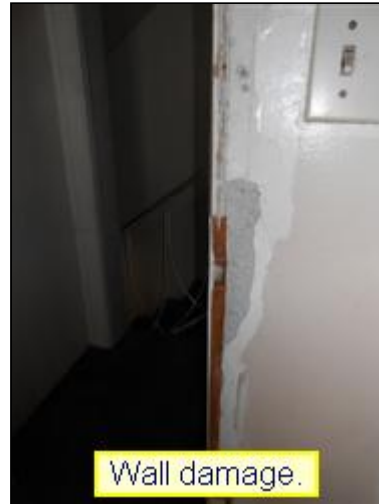
🏠 (1) **Wall Damage.** There was some minor damage to the drywall noted in the living room. It is recommended that this area be patched at your convenience.

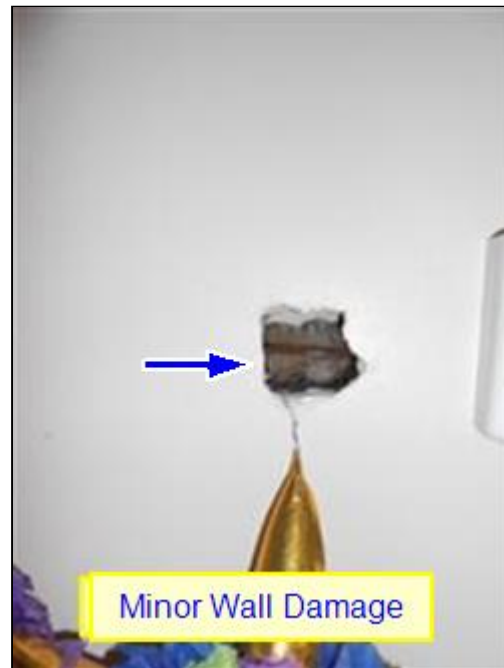
(2) **Wall Damage.** There was some minor damage to the drywall noted in the living room. It is recommended that this area be patched at your convenience.

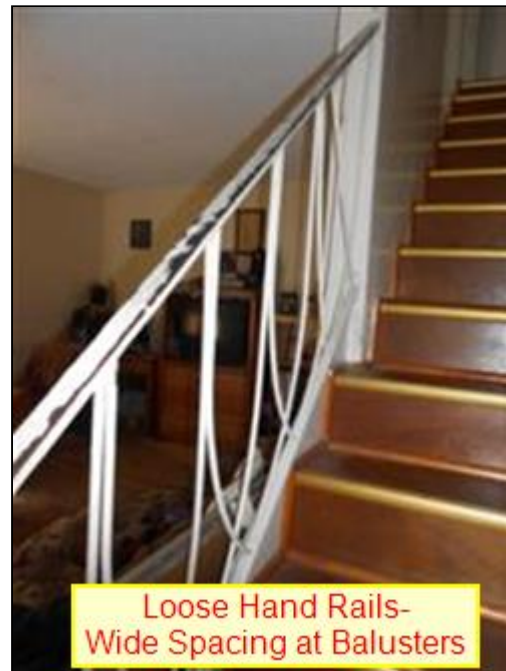
(1) Loose Hand Rails. Stairs are one of the most frequent location of injury accidents in the home. It is required that all stairs with 4 or more risers have a hand rail with a minimum height requirement of 34 inches. In this application the hand rail was loose or had missing hardware. **For safety purposes it is recommended that this area have properly secured railings to ensure working order.**

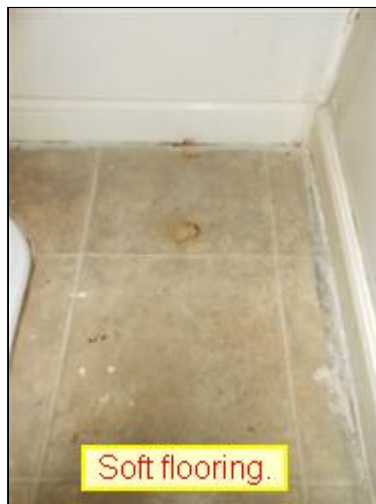
**Soft Area of Flooring.** The floor around the base of the tub was soft. It is possible that there is damage to the sub-floor at this location. **It is recommended that this be further evaluated and repaired if needed by a licensed contractor.**

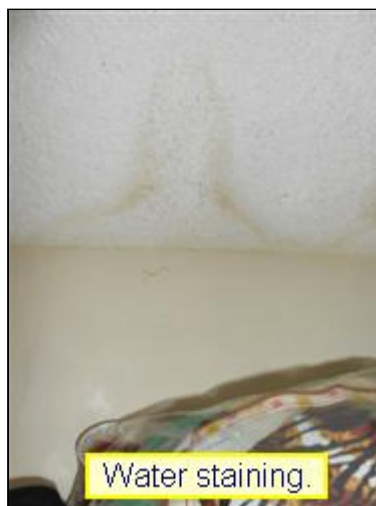
(1) **Ceiling Water Stain.** There was some water staining noted on the ceiling of the hall bathroom. It appears that there has been a leak at this location at one time. **It could not be determined if the leak has been properly repaired.** There did not appear to be any signs indicating that there is an active leak. **It is recommended that you ask the current owner about these stain and that a contractor be hired to further evaluate these areas if needed.**

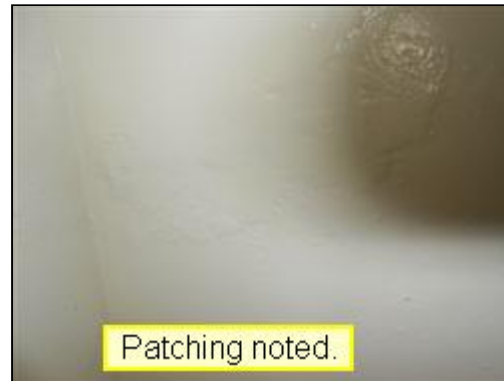
(2) **NOTE:** There were some areas of patchwork noted at the ceiling of this bathroom. The reason for this patchwork could not be determined, but there did not appear to be any current damage or issues at these areas. This is noted only for your information.

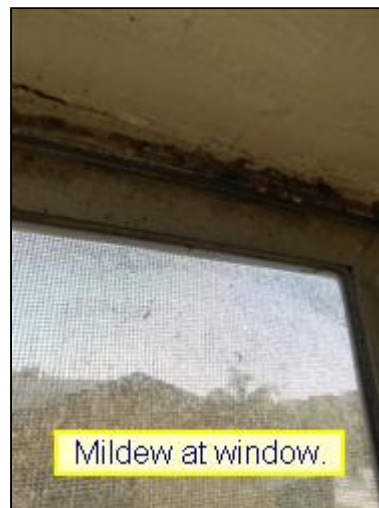
**Mildew at Window Frame.** There was mildew at the frames of the bathroom window. This is common for aluminum windows. Due to the differing temperatures between the interior and exterior of the unit, the windows will often condensate. This moisture, along with dust particles often produced a mildew type growth at the window frames. This is only observed at the frames. **It is recommended that these areas be cleaned with a bleach/water solution.**

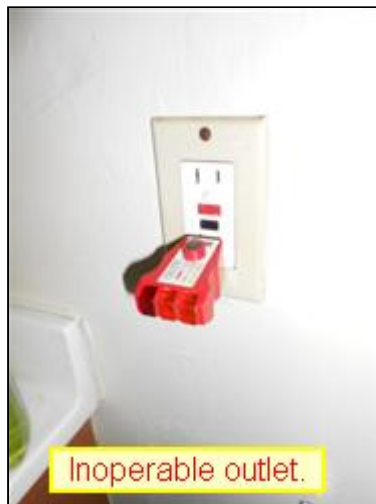
**Inoperative Outlet.** There was an outlet in storage room in the bathroom that did not work at time of inspection. **There was no power at this outlet.** It is recommended that this be further evaluated by a licensed electrician.

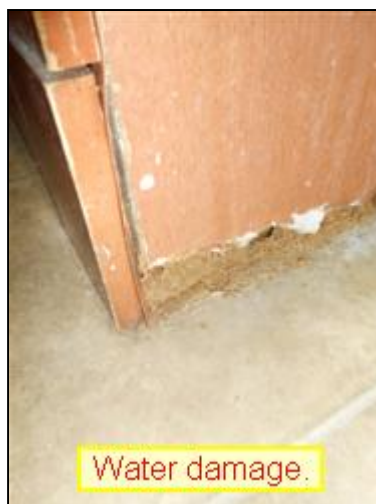
**Water Damage to Vanity.** The vanity in the bathroom has water damage at the side. This cabinet is made of particle board which swells and warps when damaged. Once this material has had water damage it loses its strength, and warps. It is recommended that this vanity be replaced to limit the possibility of mold.

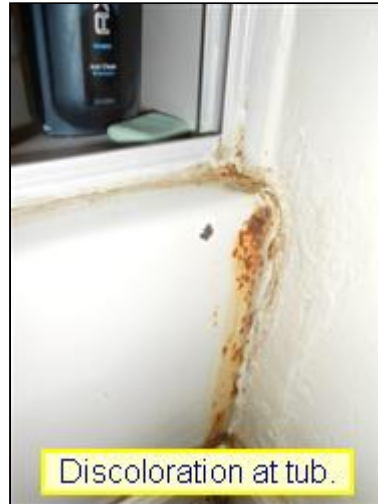
**Discoloration Noted.** There is some discoloration of the caulking on the side of the tub and wall connection. Discoloration occurs when moisture builds up and is unable to escape creating mildew and the discoloration of the grout/ caulking. It is recommend that this area be cleaned, bleached and re-caulked so moisture is unable to build up under the caulking.

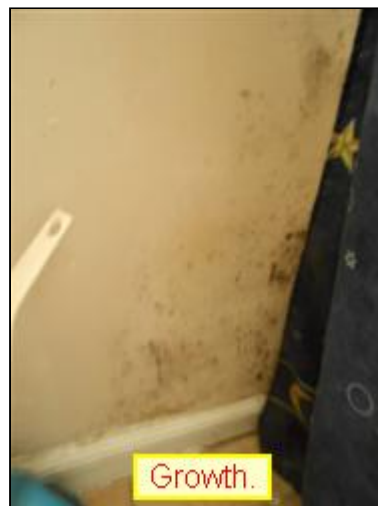
**Growth on walls.** There were walls in the bathroom that where growth was noted. It is recommended that this area be further evaluated properly repaired by a licensed contractor specializing in mildew and mold.

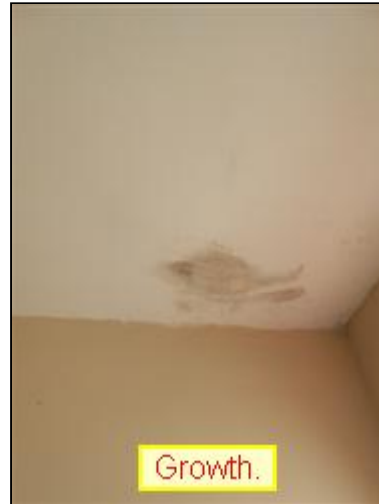
Growth Noted at Ceiling. There was staining on the ceiling above the shower indicating signs of growth on the exterior surface. It appears that there has been a lot of moisture in this bathroom and growth has begun to grow on the surface of the walls and ceiling. It is recommended that these surfaces have the paint removed, be cleaned with bleach and water solution. Efforts should also be made to limit the amount of moisture in this area. This can be done by showering with window and/or door open.

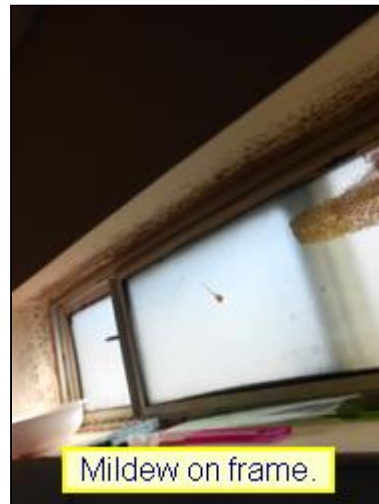
Mildew at Window Frame. There was mildew at the frames of the bathroom window. This is common for aluminum windows. Due to the differing temperatures between the interior and exterior of the unit, the windows will often condensate. This moisture, along with dust particles often produced a mildew type growth at the window frames. This is only observed at the frames. It is recommended that these areas be cleaned with a bleach/water solution.

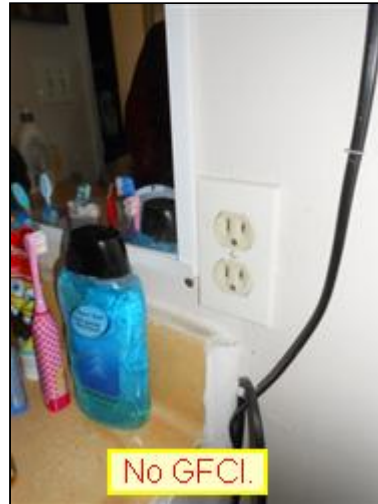
**No GFCI Protection.** There is presently no GFCI (Ground Fault Circuit Interrupter) protection in the bathroom. **It is recommended all bathroom outlets be GFCI protected or on a GFCI protected circuit.** GFCI's are a safety device built into an outlet to "trip" the circuit if it detects that the electricity is unbalanced, or if it detects improper connections of the neutral. **Recommend that GFCI protection be provided.**

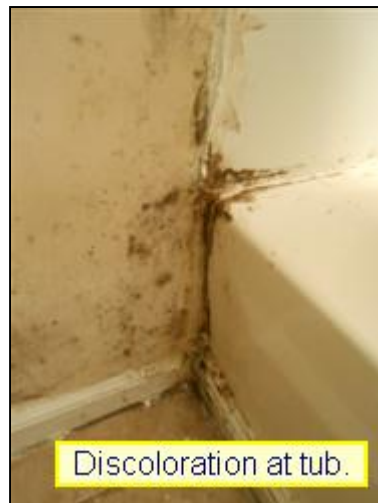
**Discoloration Noted.** There is some discoloration of the caulking on the side of the tub and wall connection. Discoloration occurs when moisture builds up and is unable to escape creating mildew and the discoloration of the grout/ caulking. **It is recommend that this area be cleaned, bleached and re-caulked so moisture is unable to build up under the caulking.**

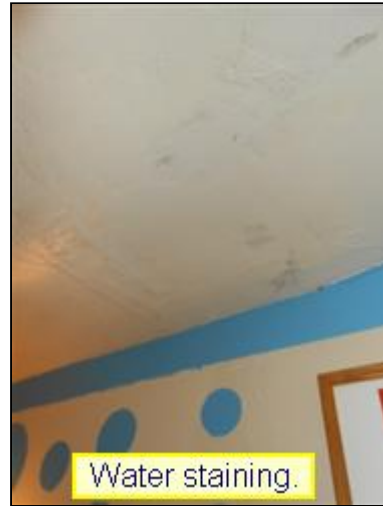
Ceiling Water Stain. There was some water staining noted on the ceilings of the bathroom. It appears that there have been leaks at these locations at one time. **It could not be determined if these leaks have been properly repaired.** There did not appear to be any signs indicating that there is an active leak. **It is recommended that you ask the current owner about these stains and that a roofing contractor be hired to further evaluate these areas if needed.**

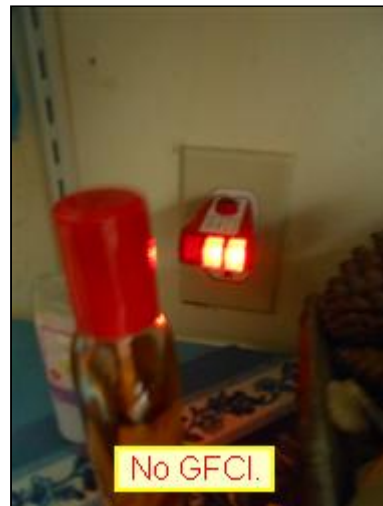
No GFCI Protection. There is presently no GFCI (Ground Fault Circuit Interrupter) protection in the bathrooms. **It is recommended all bathroom outlets be GFCI protected or on a GFCI protected circuit.** GFCI's are a safety device built into an outlet to "trip" the circuit if it detects that the electricity is unbalanced, or if it detects improper connections of the neutral. **Recommend that GFCI protection be provided.**

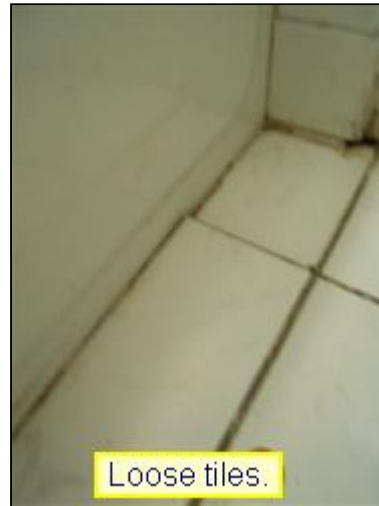
**Loose Tiles.** There were loose tiles noted at the floor of the bathroom. The cause of this was not able to be determined. **This is noted for your information and can be repaired at your convenience.**

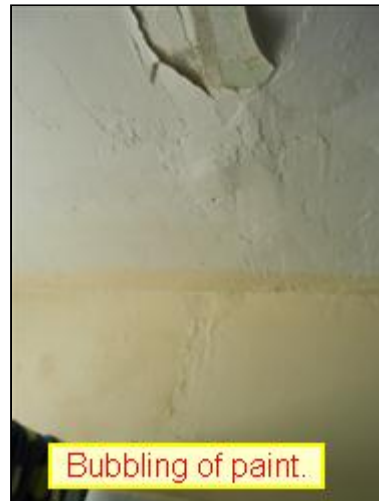
**Bubbling of Paint at Ceiling.** There was a location in the bathroom where there was a raised "bubble type formation" at the ceiling. These often occur when leaks are present and water has pooled under the paint layer causing these formations. **It is possible that there was a leaks at this location. It could not be determined at the time of inspection, if there were active leaks at this location . It is recommended that a licensed contractor be called out for further analysis ad repair as needed.**

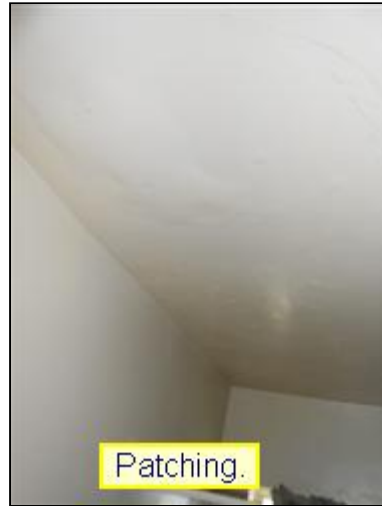
**NOTE:** There were some areas of patchwork noted at the ceiling of this bathroom. The reason for this patchwork could not be determined, but there did not appear to be any current damage or issues at these areas. This is noted only for your information.

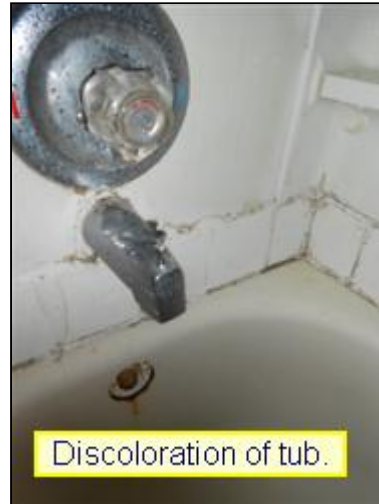
**Discoloration Noted.** There was some discoloration of the caulking on the inside of the tub and wall connection. Discoloration occurs when moisture builds up and is unable to escape creating mildew and the discoloration of the grout/ caulking. It is recommend that this area be cleaned, bleached and re-caulked so moisture is unable to build up under the caulking.

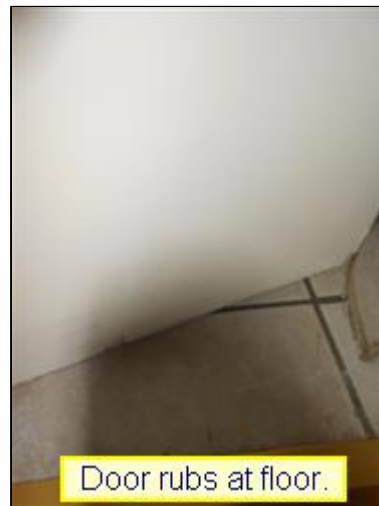
**Door Rubs- Difficult to Open.** The door to the hall bathroom rubs on the floor when opening/closing. This makes it difficult to properly open and close this door. It is recommended that adjustments be made to allow this door to properly function.

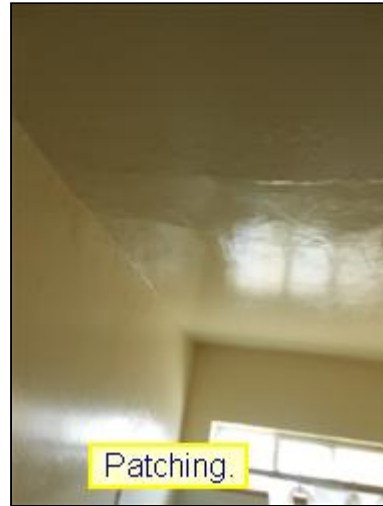
**NOTE:** There were some areas of patchwork noted at the ceiling of this bathroom. The reason for this patchwork could not be determined, but there did not appear to be any current damage or issues at these areas. This is noted only for your information.

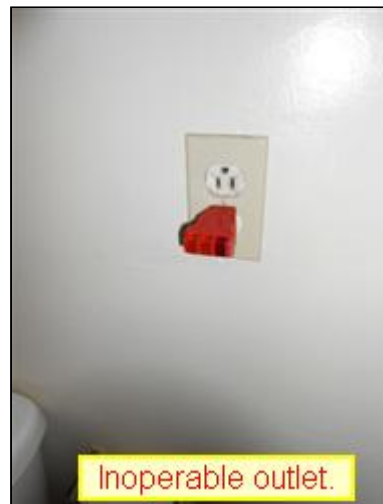
(2) **Inoperative Outlet.** There was an outlet in the bathroom that did not work at time of inspection. **There was no power at this outlet.** **It is recommended that this be further evaluated by a licensed electrician.**

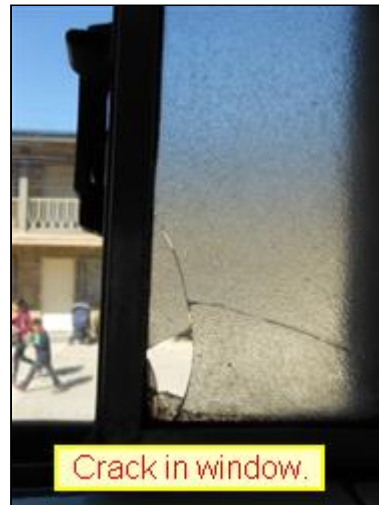
**Cracked Window Pane.** The window pane in this bathroom was cracked. It is recommended for safety purposes that this window be replaced by a licensed contractor.

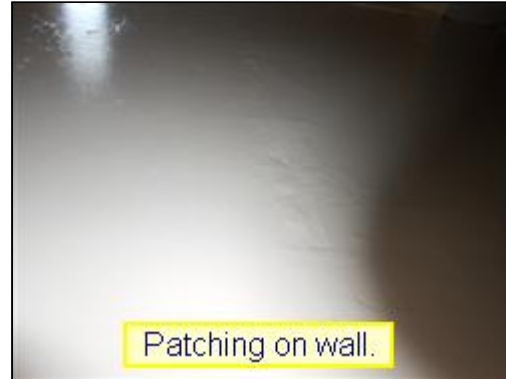
**NOTE:** There was some patching noted to the walls of this bathroom. This is noted for your information.

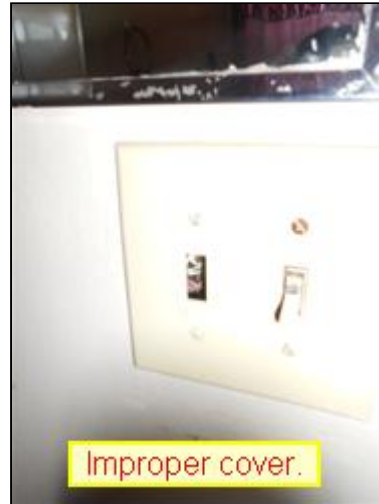
(2) **Improper cover.** It was noted that the light switch in the bathroom had an improper cover. **It is recommended that the proper cover be installed by a licensed contractor.**

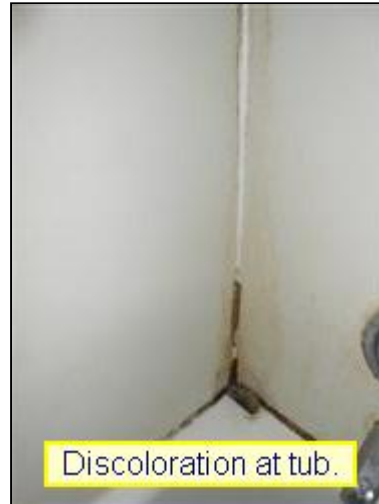
Discoloration Noted. There is some discoloration of the caulking on the inside of the tub. Discoloration occurs when moisture builds up and is unable to escape creating mildew and the discoloration of the grout/ caulking. **It is recommend that this area be cleaned, bleached and re-caulked so moisture is unable to build up under the caulking.**

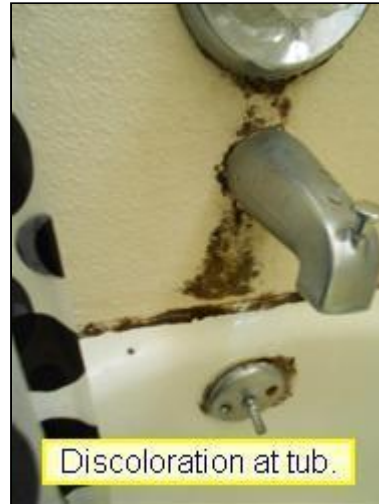
**Discoloration Noted.** There is some discoloration of the caulking on the inside of the tub and wall connection. Discoloration occurs when moisture builds up and is unable to escape creating mildew and the discoloration of the grout/ caulking. **It is recommend that this area be cleaned, bleached and re-caulked so moisture is unable to build up under the caulking.**

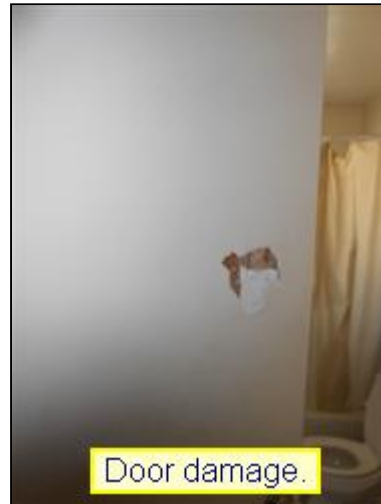
**Door Damage.** There was some minor damage to the door noted at the bathroom. It is recommended that this area be patched at your convenience.

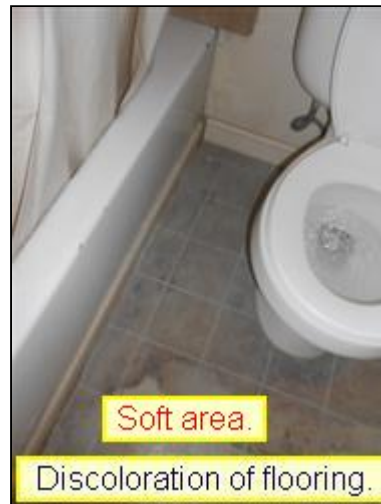
**Discoloration of Linoleum .** There was some discoloration of the linoleum in this bathroom. This is noted for your information and can be repaired at your convenience.

Soft Area of Flooring. The floor around the base of the toilet was soft. It is possible that there is damage to the sub-floor at this location. It is recommended that this be further evaluated and repaired if needed by a licensed contractor.

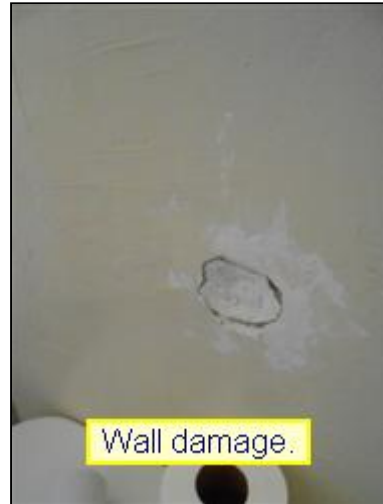
**Wall Damage.** There was some minor damage to the drywall noted in the bathroom. It is recommended that this area be patched at your convenience.

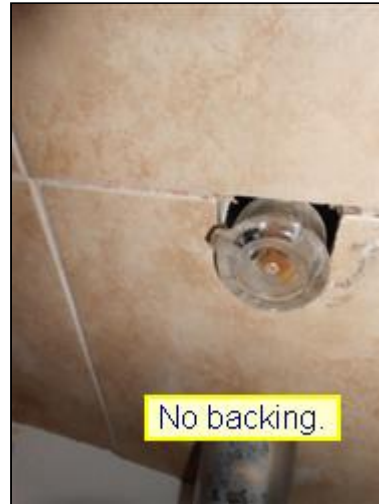
**Missing backing at shower/bath handle.** It was noted that the shower/bath handle did not have backing to properly prevent water from entering the space behind the tub enclosure. Water penetration in to this area could result in water damage to the wall. It is recommended that a licensed contractor install a proper handle with proper backing.
