Inspection Report

Sample Report

Property Address:
1202 Missouri Ave
Oceanside Ca 92054

Nation Wide Inspections

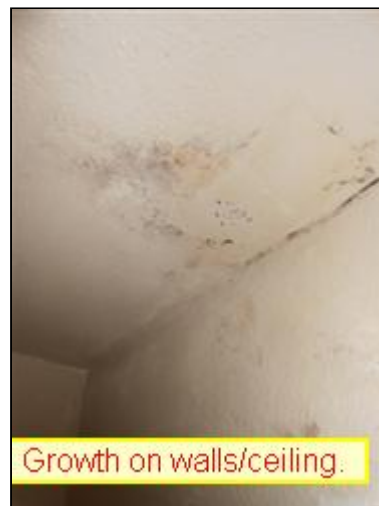
**Growth on walls.** There were walls in the bathroom where growth was noted. It is recommended that this area be further evaluated properly repaired by a licensed contractor specializing in mildew and mold.

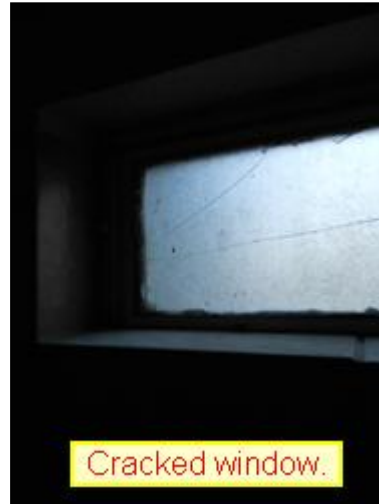
**Cracked Window Pane.** The window pane in this bathroom was cracked. It is recommended for safety purposes that this window be replaced by a licensed contractor.

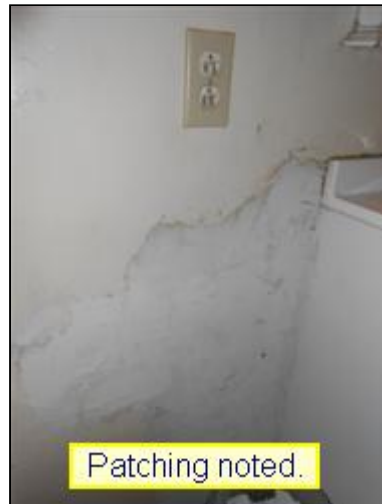
**NOTE:** There was some patching noted to the walls of this bathroom. This is noted for your information.

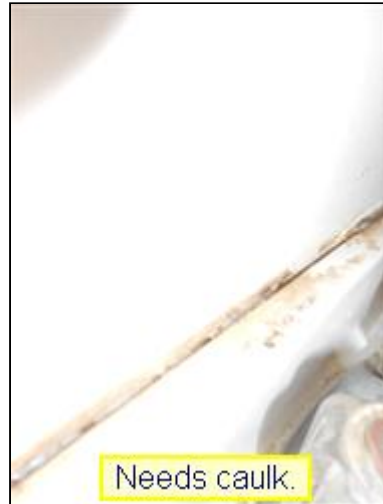
**Caulking Needed.** There was an area around the sink/ counter connection that are in need of some caulking. It is recommended that this area be properly caulked by a qualified professional.

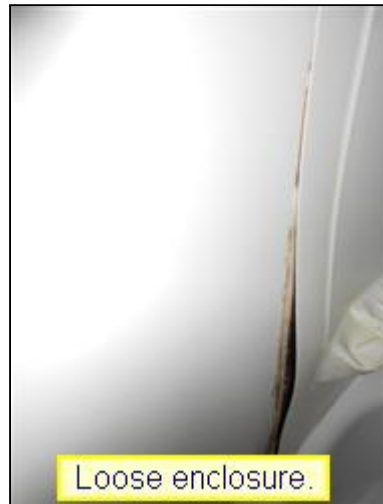
(1) **Loose shower wall lining.** The shower wall lining was not properly sealed. It is recommended that the lining be resealed to prevent water penetration into the wall.

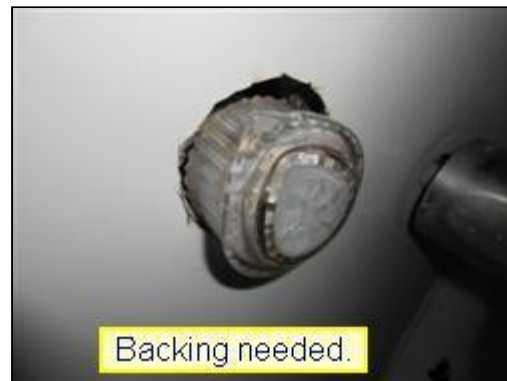
(2) **Missing backing at shower/bath handle.** It was noted that the shower/bath handle did not have backing to properly prevent water from entering the space behind the tub enclosure. Water penetration in to this area could result in water damage to the wall. It is recommended that a licensed contractor install a proper handle with proper backing.

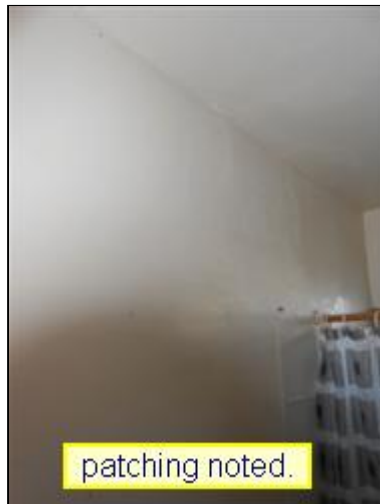
**NOTE:** There was some patching noted to the walls of this bathroom. This is noted for your information.

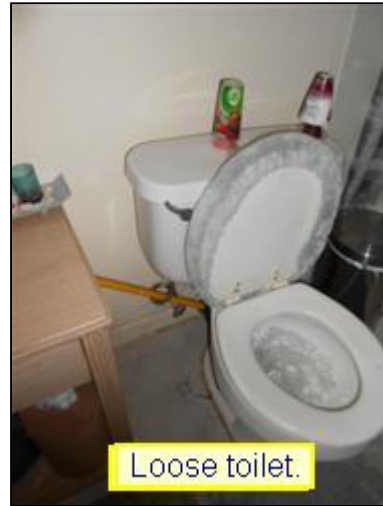
**Loose Toilet.** The toilet fixture in this bathroom is loose at the floor. This could cause the wax ring to become dislodged and your toilet to leak water onto the floor. It is recommended that this toilet have the wax ring replaced and the toilet secured to the floor (to ensure a proper seal), and caulking be applied to the base of the toilet. **(WARNING) Over tightening will cause the porcelain to crack and the need for replacement of the toilet.**

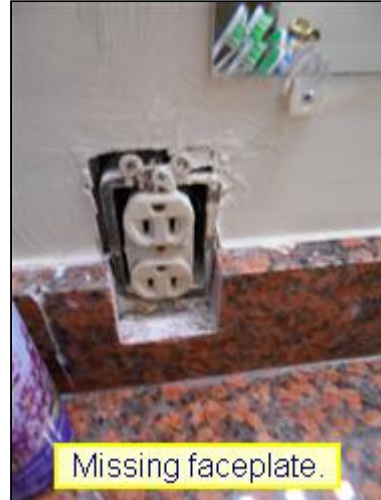
(2) **Missing Outlet Cover .** Missing faceplates expose electrical parts of receptacle outlets, and switches creating a potential shock hazard. **For safety reasons all outlets and switches should have secure covers to reduce the chance of electric shock.**

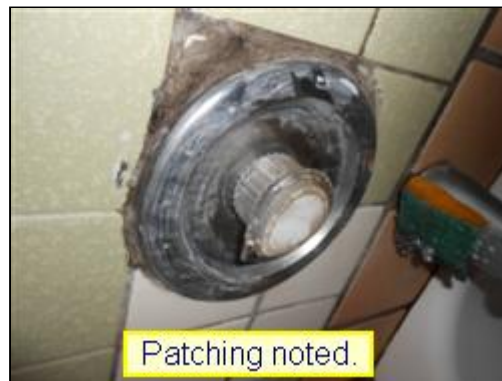
**NOTE:** There appears to be some patching noted at the tub enclosure. It is recommended that you ask the current owner about this area. It is possible that there was a chip at the enclosure that they had wanted to cover, but it is also possible that there was a crack or hole that could leak and needs further attention. **Recommended further analysis and repair as needed.**

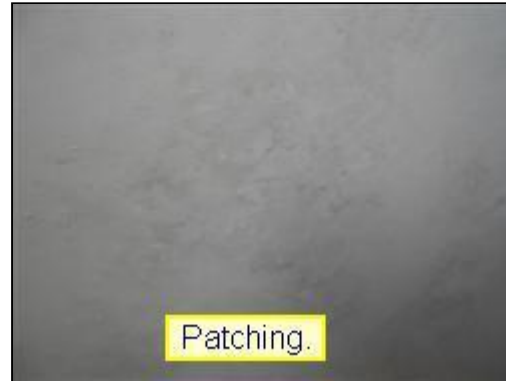
**NOTE:** There were some areas of patchwork noted at the ceiling of this bathroom. The reason for this patchwork could not be determined, but there did not appear to be any current damage or issues at these areas. This is noted only for your information.

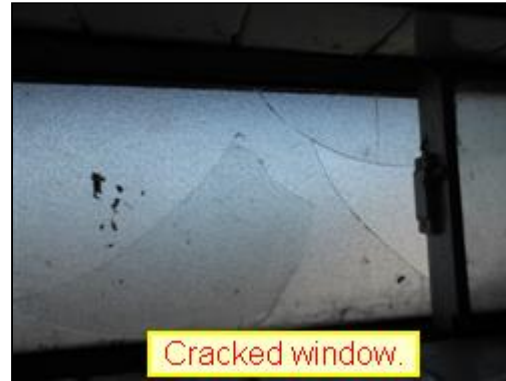
**Cracked Window Pane.** The window pane in this bathroom was cracked. It is recommended for safety purposes that this window be replaced by a licensed contractor.

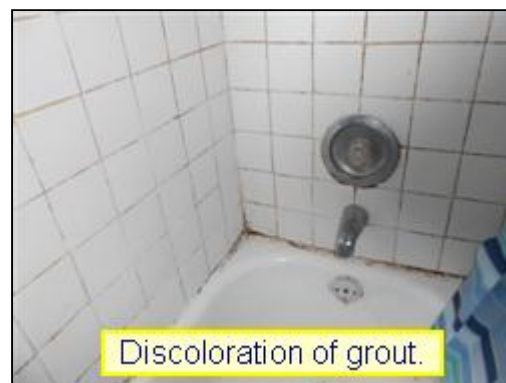
Discoloration Noted. There is some discoloration of the caulking on the inside of the tub and wall connection. Discoloration occurs when moisture builds up and is unable to escape creating mildew and the discoloration of the grout/ caulking. It is recommend that this area be cleaned, bleached and re-caulked so moisture is unable to build up under the caulking.

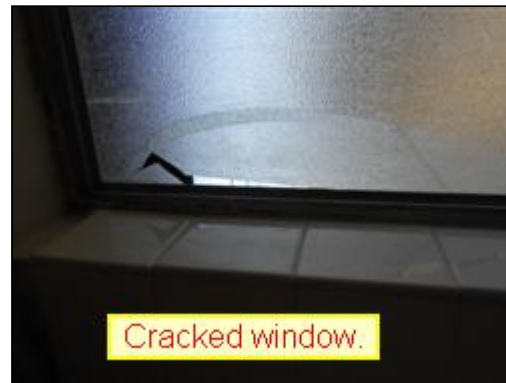
**Cracked Window Pane.** The window pane in this bathroom was cracked. It is recommended for safety purposes that this window be replaced by a licensed contractor.

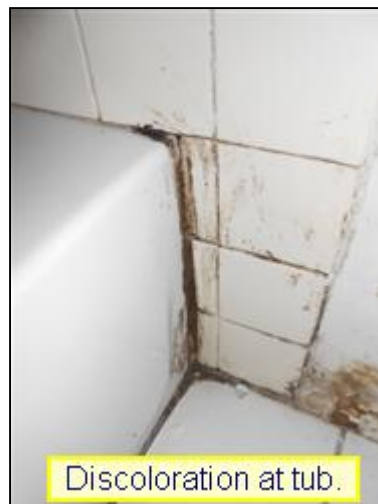
Discoloration Noted. There is some discoloration of the caulking on the side of the tub and wall connection. Discoloration occurs when moisture builds up and is unable to escape creating mildew and the discoloration of the grout/ caulking. **It is recommend that this area be cleaned, bleached and re-caulked so moisture is unable to build up under the caulking.**

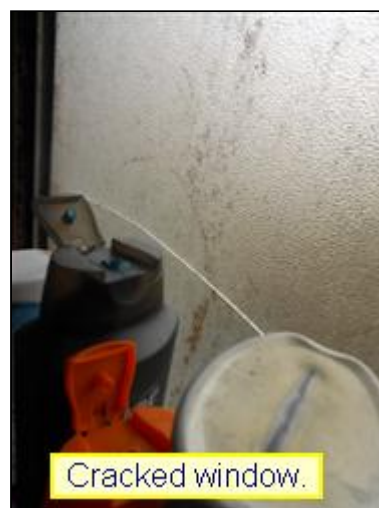
(1) **Cracked Window Pane.** The window pane in this bathroom was cracked. **It is recommended for safety purposes that this window be replaced by a licensed contractor.**

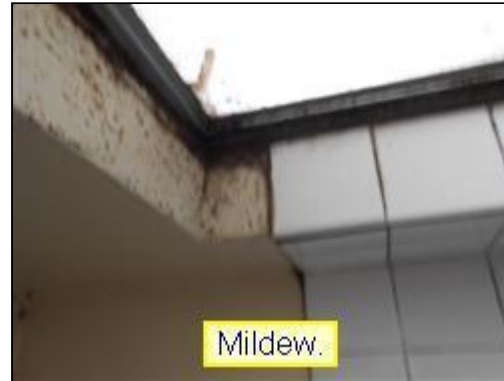
(2) **Mildew at Window Frame.** There was mildew at the frames of the bathroom windows. This is common for aluminum windows. Due to the differing temperatures between the interior and exterior of the unit, the windows will often condensate. This moisture, along with dust particles often produced a mildew type growth at the window frames. This is only observed at the frames and there is no growth or damage at the sills. **It is recommended that these areas be cleaned with a bleach/water solution.**

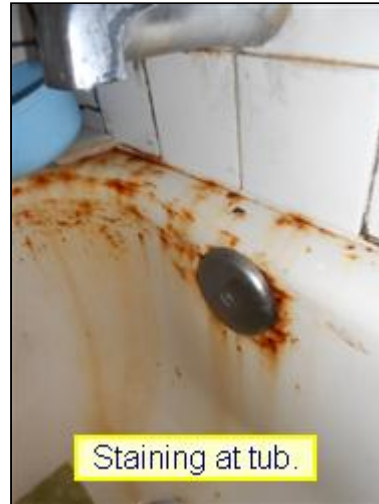
Tub Tarnishing. The top of the shower/tub has heavy tarnishing. This is noted for your information and can be repaired or replaced at your convenience.

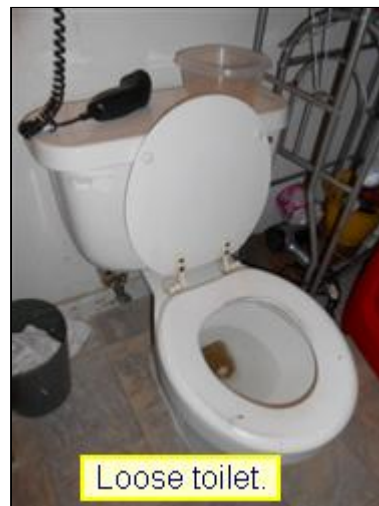
**Loose Toilet.** The toilet fixture in this bathroom is loose at the floor. This could cause the wax ring to become dislodged and your toilet to leak water onto the floor. It is recommended that this toilet have the wax ring replaced and the toilet secured to the floor (to ensure a proper seal), and caulking be applied to the base of the toilet. **(WARNING) Over tightening will cause the porcelain to crack and the need for replacement of the toilet.**

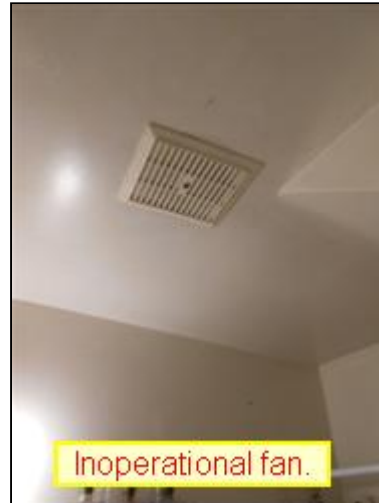
↑ INOP Fan. The fan in the first floor half bath did not work at time of inspection. It was not determined at time of inspection if this fan had been disconnected, or did not properly function. **It is recommended that this be further inspected and repaired if needed by a licensed electrician.**

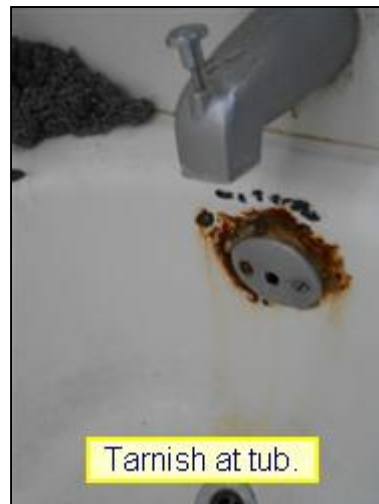
↑ Tub Tarnishing. The overflow at the shower/tub has heavy tarnishing. **This is noted for your information and can be repaired or replaced at your convenience.**

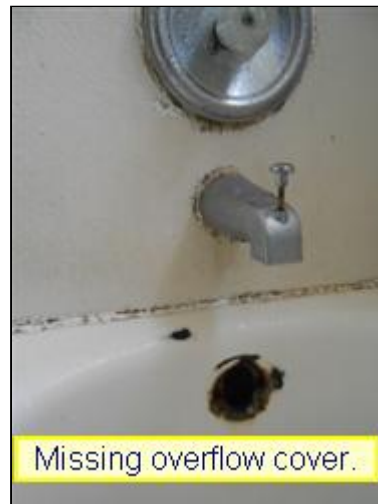
**Missing overflow cover at tub.** It was noted that the overflow cover to the tub was missing. **Recommend replacement of the cover by a qualified repair person.**

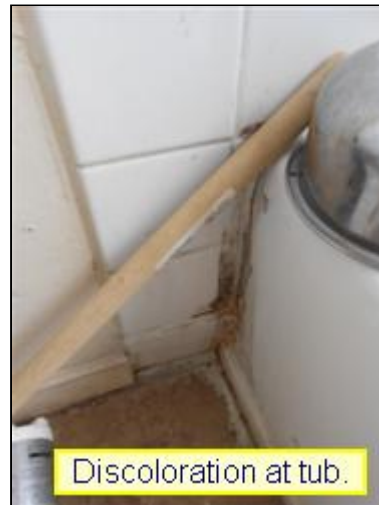
**Discoloration Noted.** There is some discoloration of the caulking on the side of the tub and wall connection. Discoloration occurs when moisture builds up and is unable to escape creating mildew and the discoloration of the grout/ caulking. **It is recommend that this area be cleaned, bleached and re-caulked so moisture is unable to build up under the caulking.**

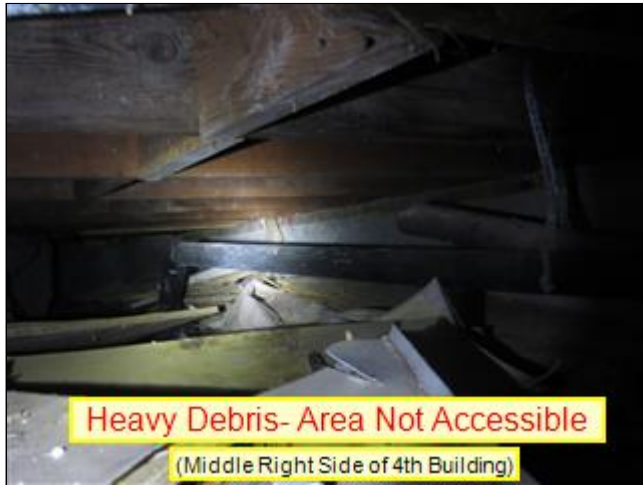
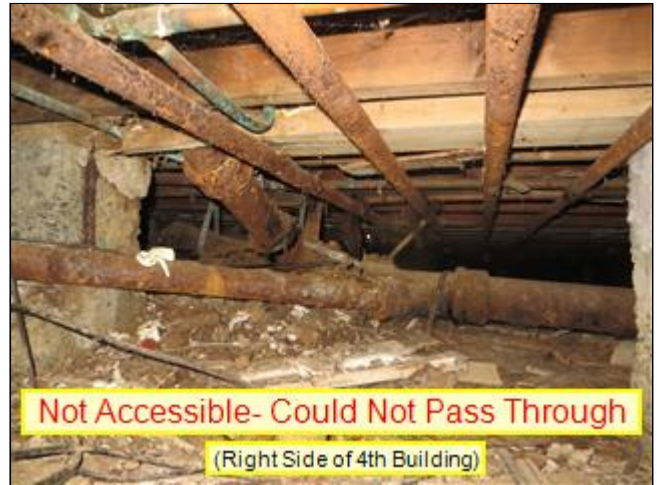
(1) **Not Accessible- Not Inspected.** There were three locations of the crawlspace areas that were not accessible and were not inspected. These were located at the front right section of the first building, the far right section of the 4th building as well as a small middle section in the 4th building at the left side. **These areas were found to be obstructed or unsafe to inspect.** The foundation, plumbing, electrical, and other structural elements at these two locations were not able to be inspected. **It is highly recommended that an access be provided for these areas, and the components be further inspected by a qualified specialist.**

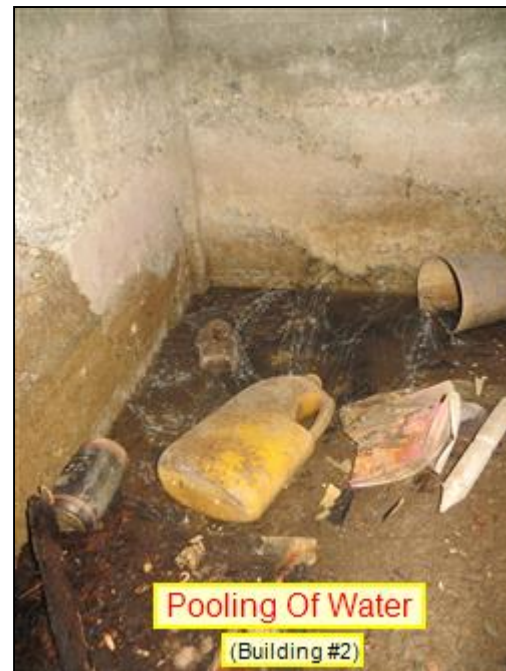
(2) **Pooling Water and Heavy Moisture.** There were areas under the house which had areas of pooling water and heavy moisture content. The worst of the moisture related issues was located at the underside of the second building. It appears that moisture is entering under the house from exterior areas in which the grading around the house slopes toward the foundation. **It is recommended that roof drains be provided to help shed water away from these areas.**

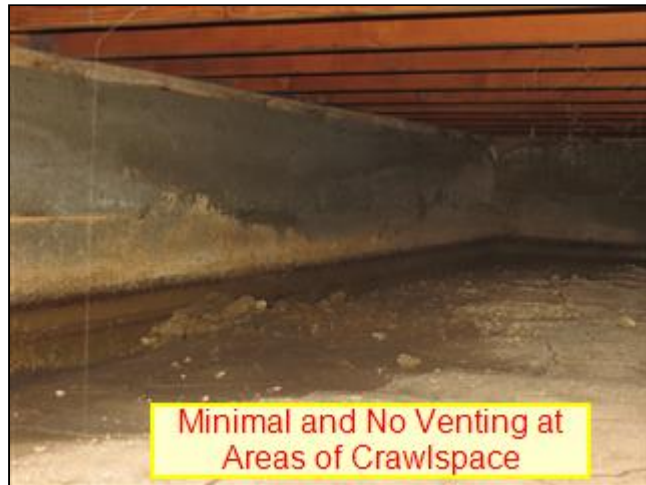
(3) **Improper Venting of Crawlspace Areas.** There were no vents provided at large sections at the underside of the foundation area. As with any enclosed area, ventilation is very important to ensure proper air flow of these areas. Adequate airflow is key in helping prevent moisture related problems and issues.

Currently there are SEVER problems associated with the lack of venting and water intrusion at the underside of the buildings. It is recommended that this area be further analyzed and actions taken to allow for proper ventilation.

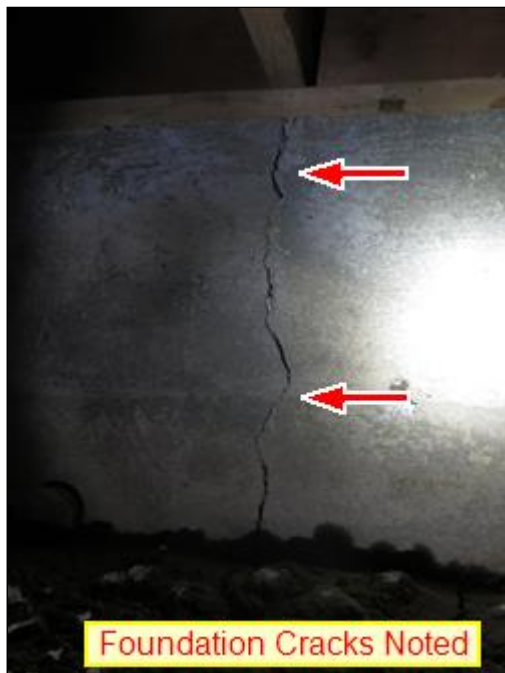
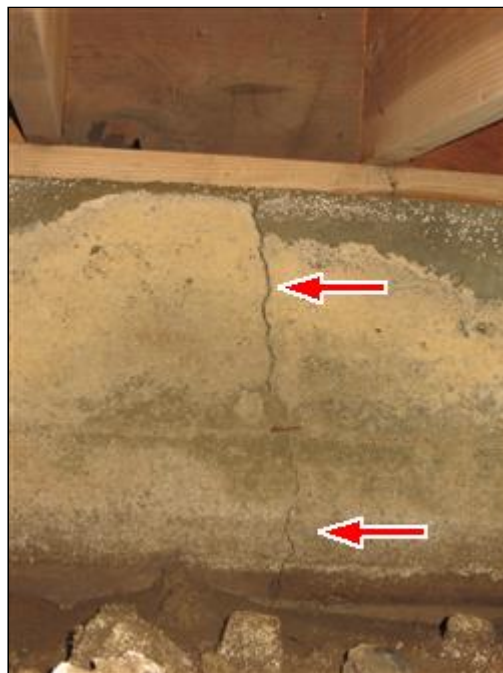
(4) **Foundation Cracks.** There were several small foundation cracks at the perimeter walls of the buildings. Most of these cracks were very small and were not offset. The largest of the cracks appear at the right side of building #1. The largest of these cracks was about 1/4 of an inch in width and appears at an interior foundation wall. It is recommended that these cracks be further evaluated and repaired as needed by a licensed foundation specialist.

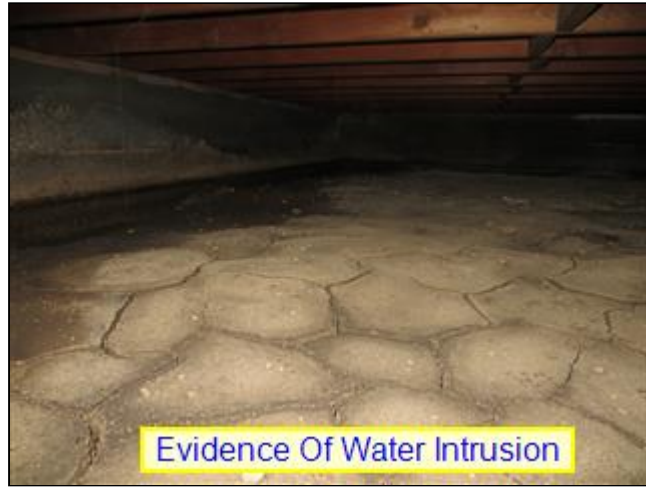
(5) Evidence of Water Intrusion.

The ground at the crawl space under the building had evidence of water intrusion at the underside and was damp. Crawlspace should remain dry throughout the year, even after heavy rains. It is recommended that a irrigation specialist be called out to assess and correct drainage around the perimeter of the buildings.

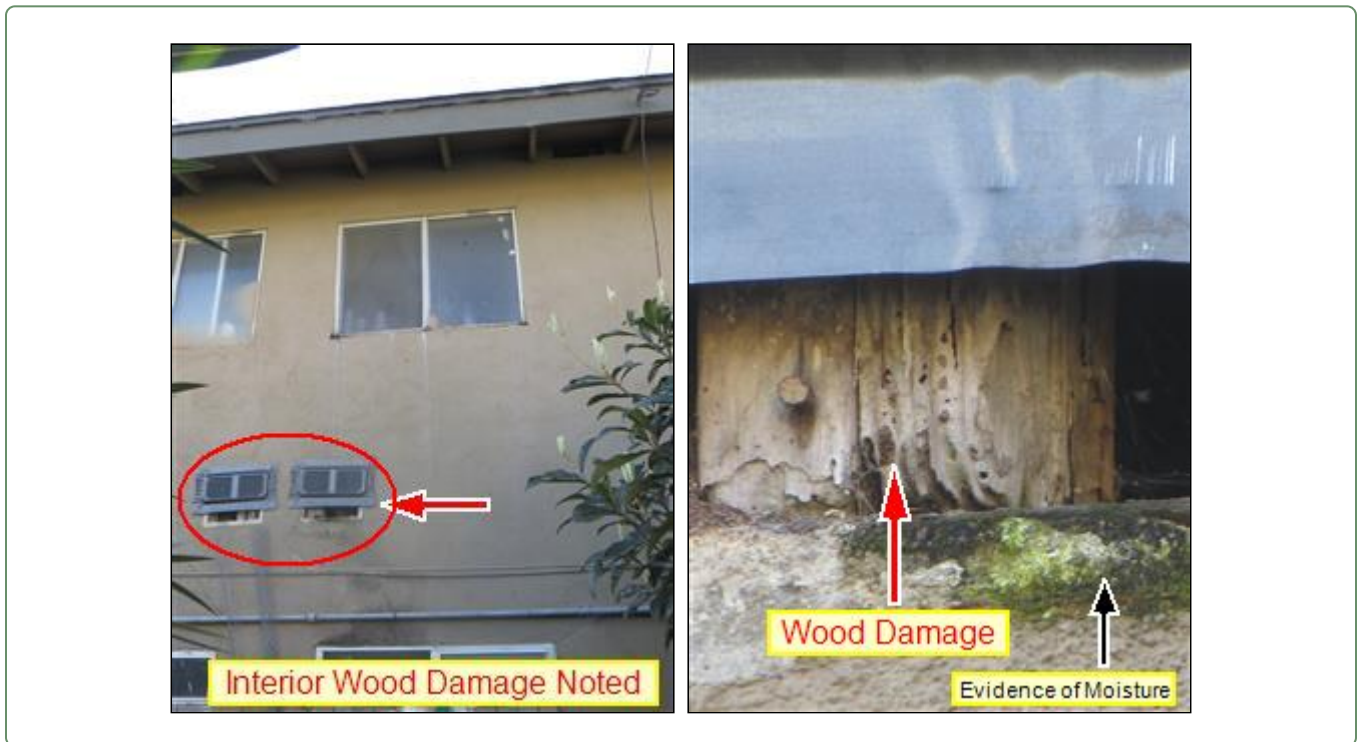
(2) **Wood Damage Noted at Interior of Wall.** There was a section of wall at the rear of the 2nd building that had some exposed penetrations. It was observed, through these penetrations, that the wood framing had evidence of moisture and wood damage. **The extent of this damage was not able to be determined.** It was noted that these locations were located at the exterior of the shower walls. These walls were originally constructed with low shower windows that were notorious for allowing for water intrusion. It is not known how many of these locations have water damage or structural damage to the interior wall framing. It is recommended that a few locations be further evaluated and repaired as needed by a licensed contractor.

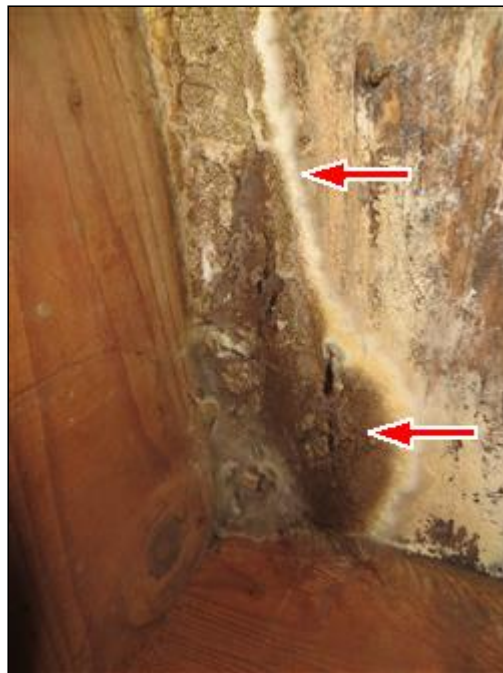
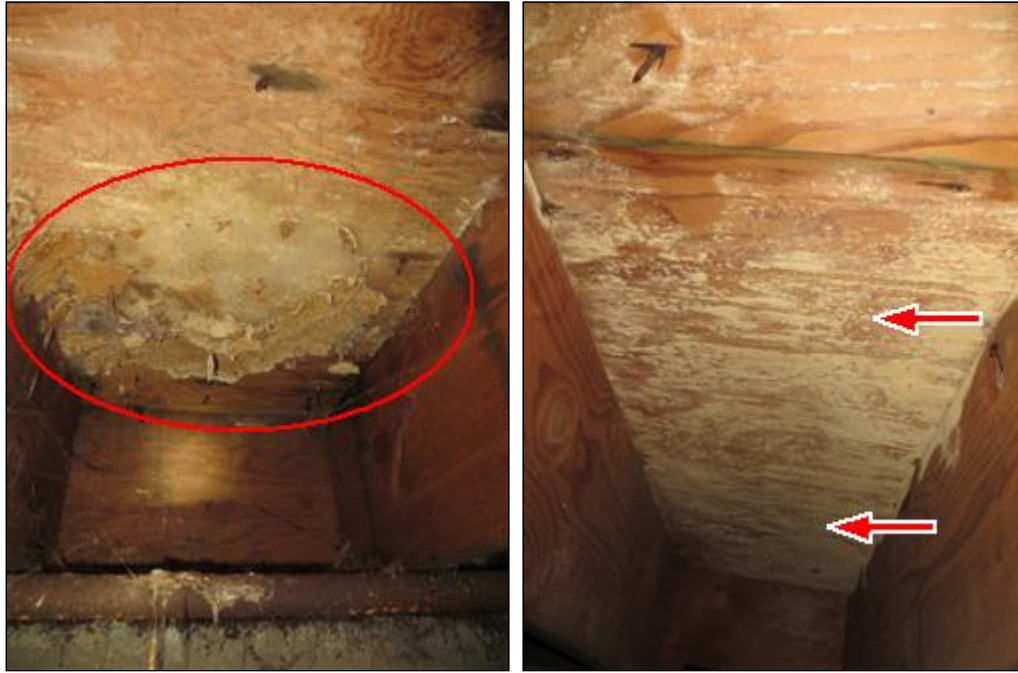
Growth Noted

📍 (1) **Severe Wood Damage and Growth.** There are multiple areas at the underside of each building (each of the 3 buildings containing crawlspaces) that have severe water damage, wood deterioration and growth to the floor sheathing and framing members. These locations were noted throughout the underside of the buildings, and are especially prevalent around the plumbing areas. The ground at several locations were moist and there was limited to no venting at several sections of the building. **Some of the flooring was presently wet due to plumbing leaks, and other areas of the flooring were wet due to lack of ventilation and condensation.** Many of these areas had severe wood damage and rot. It was noted that some areas had repairs conducted but have since been damaged. **It is recommended that these areas be further evaluated and repaired as needed by a licensed contractor and mold specialist and repaired as needed.**

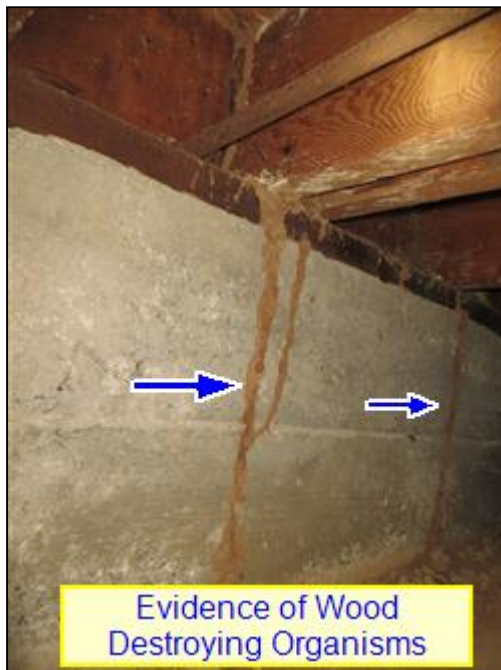
(3) **Evidence of Wood Destroying Organisms.** It was noted that there were several tubes extending up the foundation wall, from the ground to sill plates (walls) at the underside of the buildings. The most abundant of these areas was located at the underside of the 4th building. **It is recommended that these areas be further evaluated by a termite specialist and repaired/ treated as needed.**

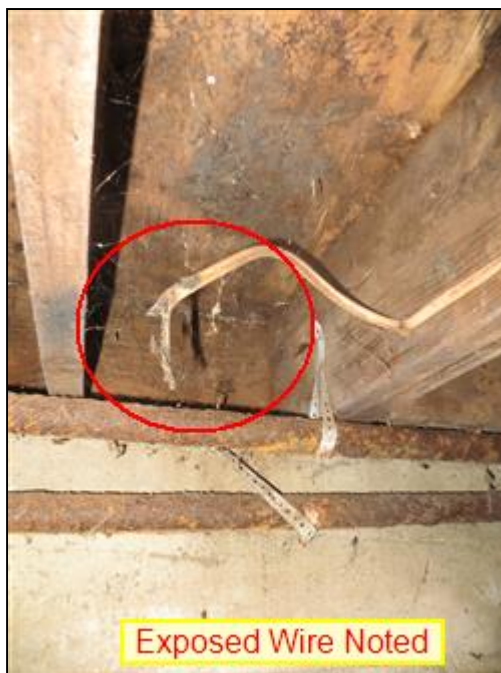
**Exposed Wires.** There was a wire run at the underside of the second building that had exposed wires. **These wires were not tested, and it was not known if these were live wires carrying current.** This wire was located at the rear, middle section of the second building. **It is recommended that these wires be tested and properly capped and secured by a licensed electrician.**

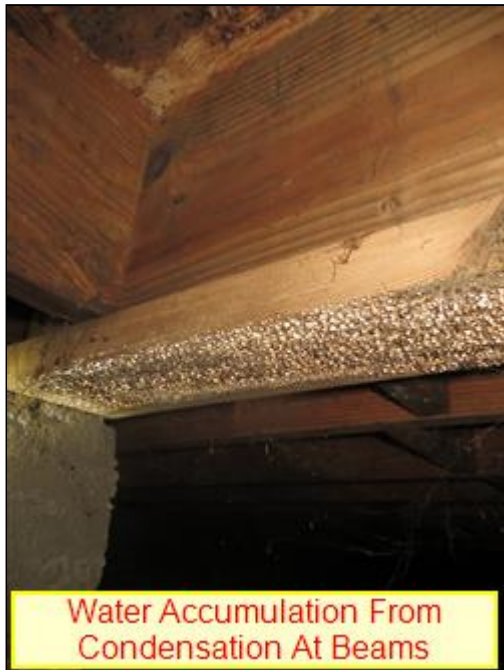
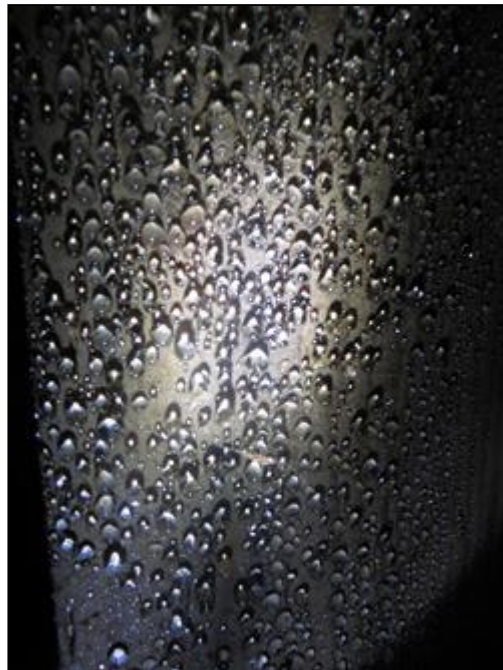
**Insufficient ventilation of crawlspace.** It appears that the visible ventilation of the crawlspace was insufficient for it's size. Crawlspace should have a minimum of one square foot of ventilation for every 150 square foot of crawlspace. Currently it appears that the only source of ventilation is from the access points. There are severe issues at the underside of these buildings related to water intrusion and lack of sufficient venting. **There were areas of water condensation forming at the underside of the flooring materials and framing members.** It is recommended that the underside of these buildings be further evaluated by a licensed contractor, specialist or engineer to determine the best method to allow for proper ventilation of the crawlspace.

Water Accumulation From
Condensation At Beams

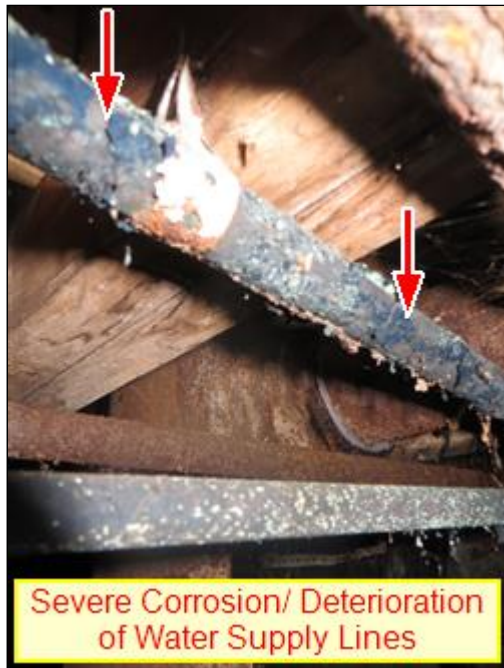
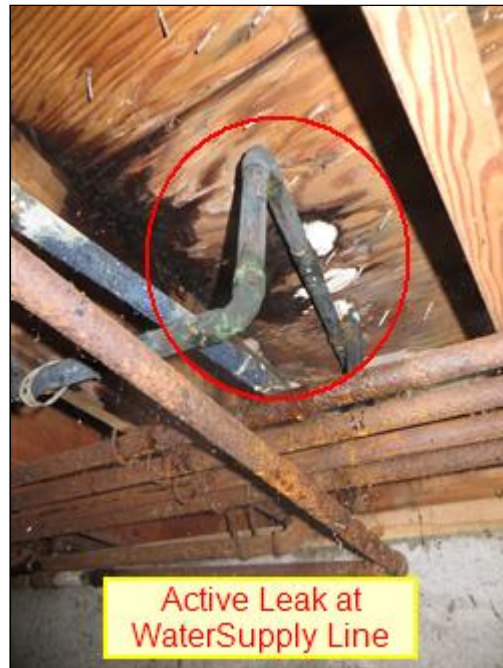
(2) **Severe Deterioration- Active Leak**. The plumbing supply lines at the underside of the buildings have severe tarnishing and deterioration. There is severe electrolysis and deterioration of the supply lines at the underside of the buildings. Electrolysis occurs when incompatible materials come into contact with one another. These pipes were black in color, which could indicate that there is electrical current affecting these lines. **There was an active leak noted at the underside of the first building.** It is recommended that these lines be further evaluated and repaired as needed by a licensed plumber.

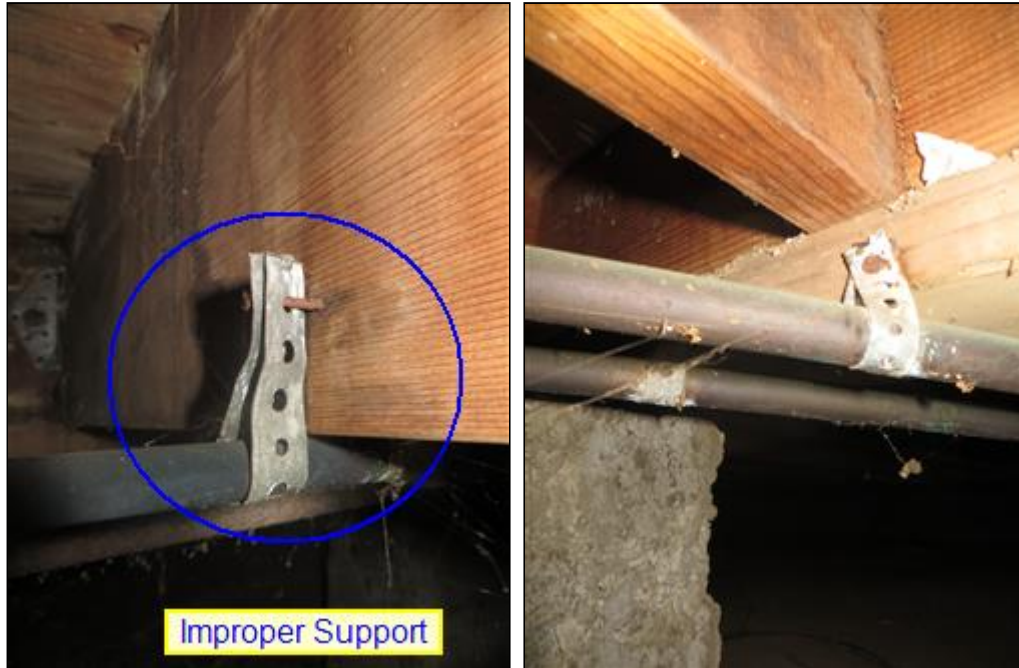
(3) **Improper Support of Water Lines**. The copper piping has some areas that are being supported by galvanized metal straps. Copper piping should be supported by a non-metallic plumbing strap or other means

to avoid contact with incompatible materials. Improper support can cause electrolysis and damage to the lines. It is recommended that the pipe be properly supported and protected by a licensed plumber.

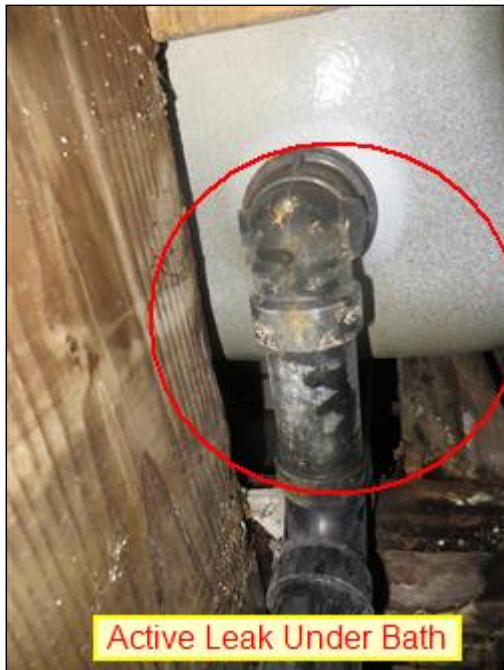
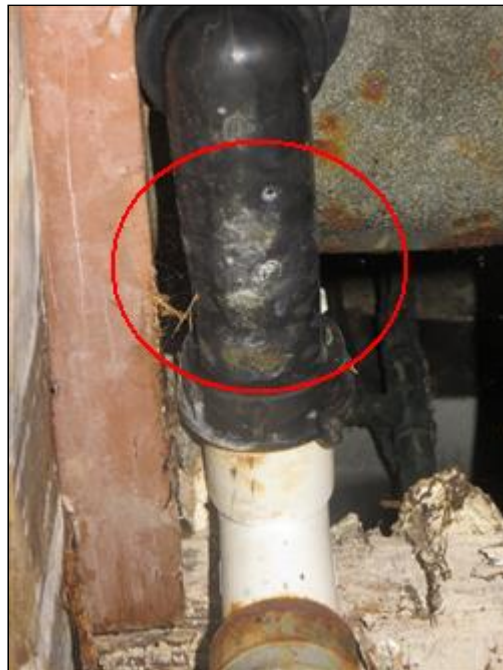
📍 (4) **Active Leaks Under Bathrooms.** There were several active leaks at the underside of the bathrooms of both building #1 and #2. It is recommended that the waste system be further inspected, evaluated and repaired as needed by a licensed plumber.

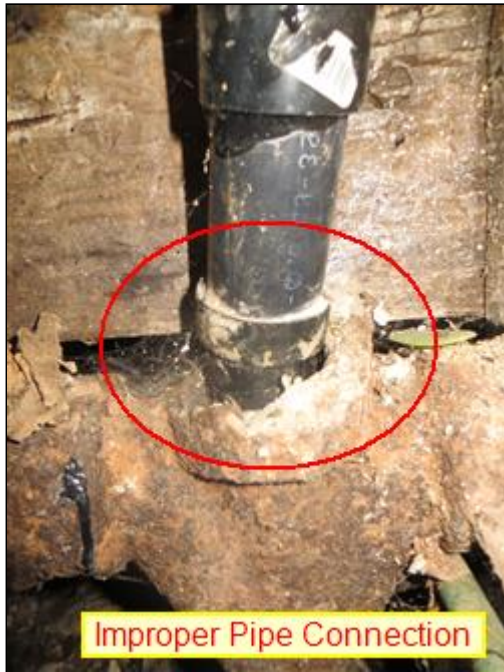
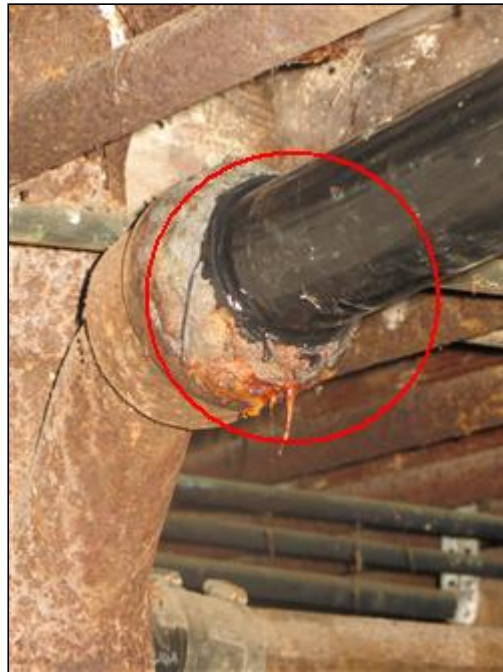
📍 (5) **Improper Pipe Connections.** There was an improper plumbing connection at the waste line at the underside of the 2nd building. A newer section was improperly connected to the original cast iron. The connection was not fitted with a proper boot and there were gaps at the connection. **These gaps can allow sewer gases to escape from the lines and enter the house.** It is recommended that this connection be further evaluated and repaired as needed by a licensed plumber.

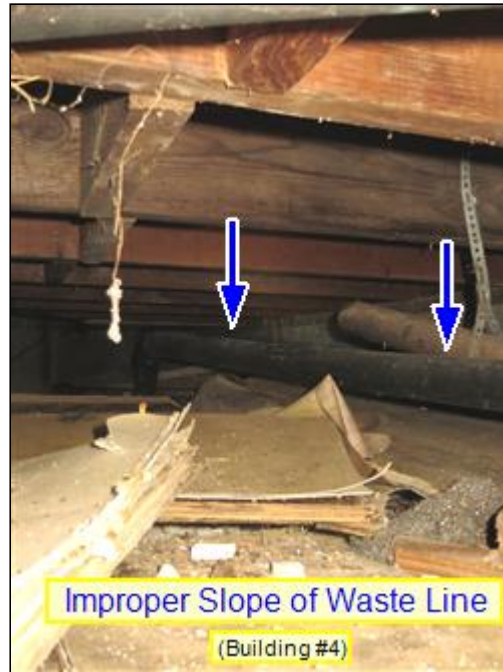
📍 (7) **Improper Slope of Waste Line.** There was a waste line at the underside of the house that does not have a proper downward slope. Waste lines (which are 3 inches or greater) must maintain a minimal downward slope of 1/8 inch. In this application there is a section of plumbing that did not appear to have a proper slope. This can cause water and debris to remain within the pipe at this location. It is recommended that this be further evaluated and that the slope of this pipe be corrected by a licensed plumber.

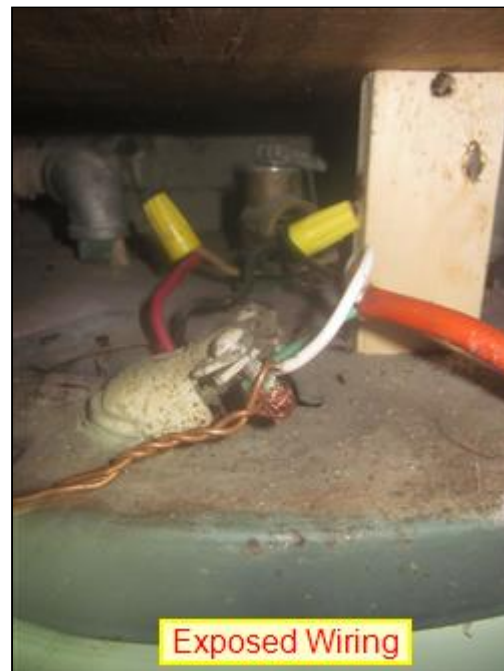
(3) **Hazardous Wiring.** The water heater in unit # E (of the first building) has exposed wiring. **It is recommended for safety purposes that this be corrected by a licensed plumber or Electrician.**

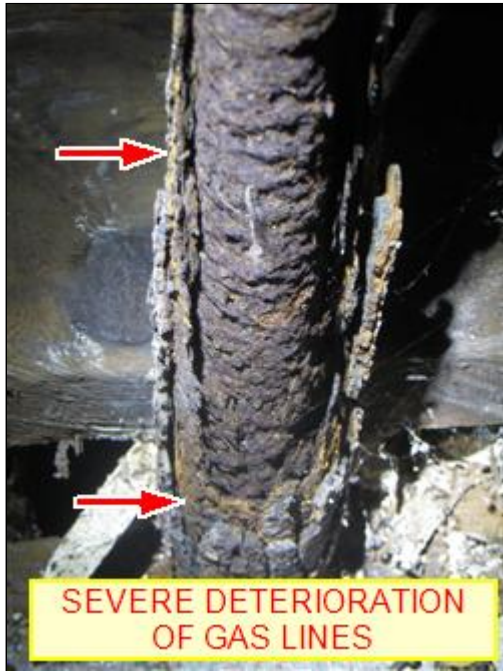
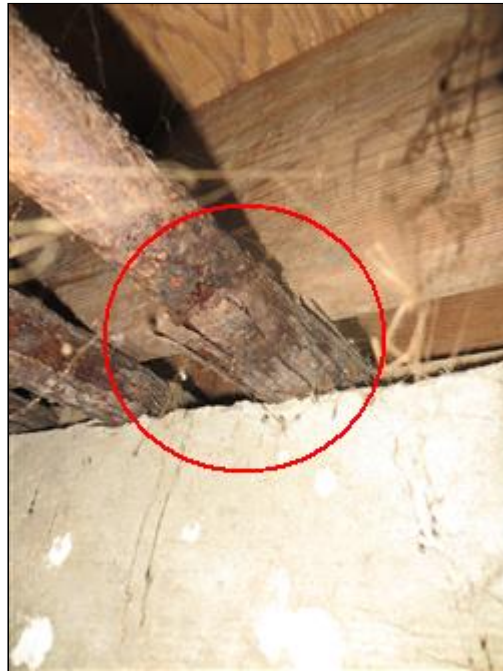
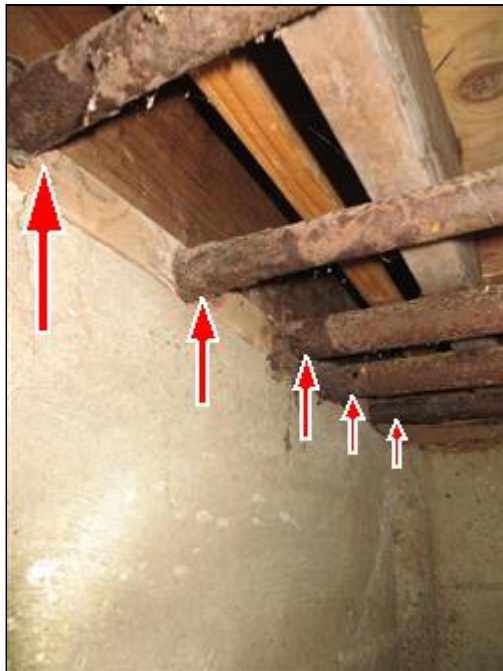
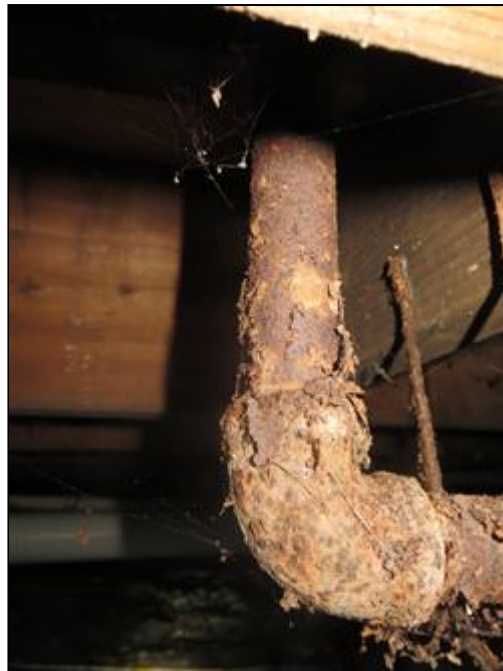
↑ (1) **SEVERE Deterioration of Gas Lines.** The gas lines at the underside of the house have SEVERE deterioration. There was severe pitting and splintering of the gas lines where the lines were in contact with the concrete foundation. Gas lines should be protected at all through penetrations in help to inhibit corrosion and deterioration of the lines. In this application the lines are severely deterioration and should be replaced. **Due to the severity of the current damage, this is considered to be unsafe and a health hazard until further inspected by a licensed specialist.** It is highly recommended that these lines be further evaluated and repaired as needed by a licensed plumber.

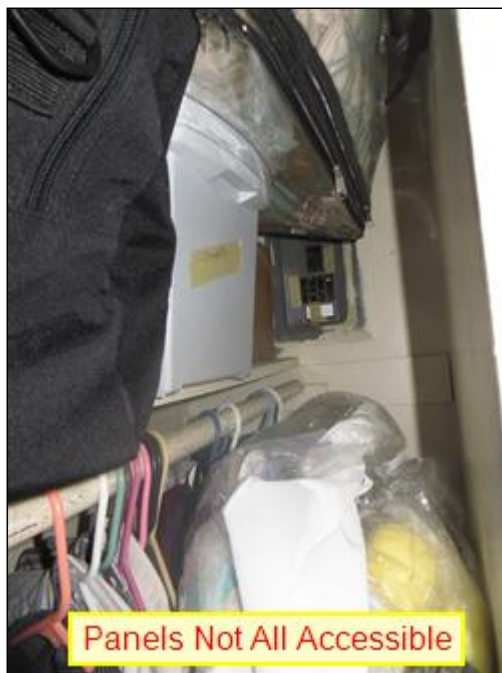
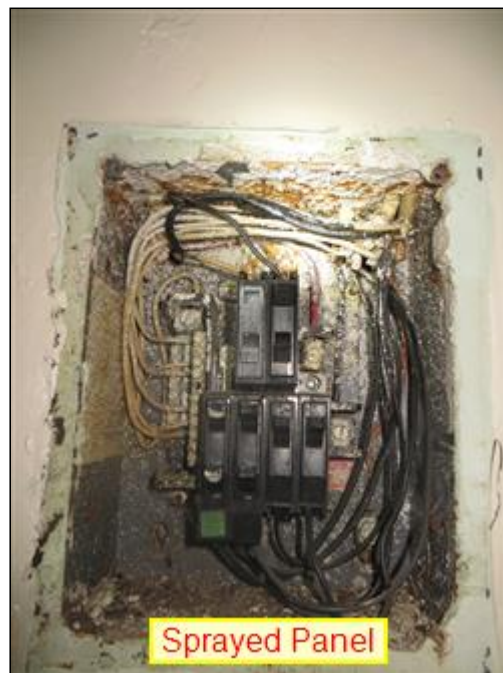
Sprayed Panel. Several of the sub-panels have been sprayed with paint or texture. Some of the sub-panels have been sprayed with paint or texture. It could not be determined if all of the bus bars at the electrical panels have been sprayed as well. **Sprayed bus bars create resistance, which cause the breakers to heat up, increasing the risk of fire.** **It is recommended that these panels be further inspected by a licensed electrician and repaired or replaced as needed.**

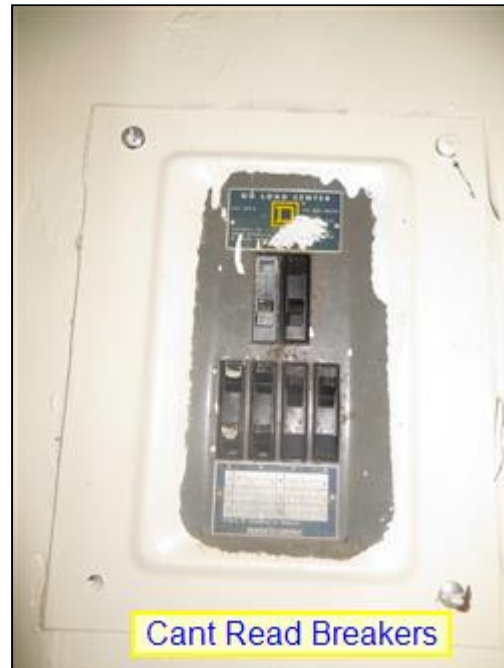
The Breakers in the sub panel are not labeled for individual use or are improperly labeled. It is recommended that each breaker be labeled for its correct use for easy identification. Recommend that an electrician label each breaker for its use.

Improper/ Illegible Labeling. Some labels at the sub panel are present, but are illegible or do not appear to be correct. It is recommended for safety reasons that the panel labeling be updated for easy identification by a licensed electrician.

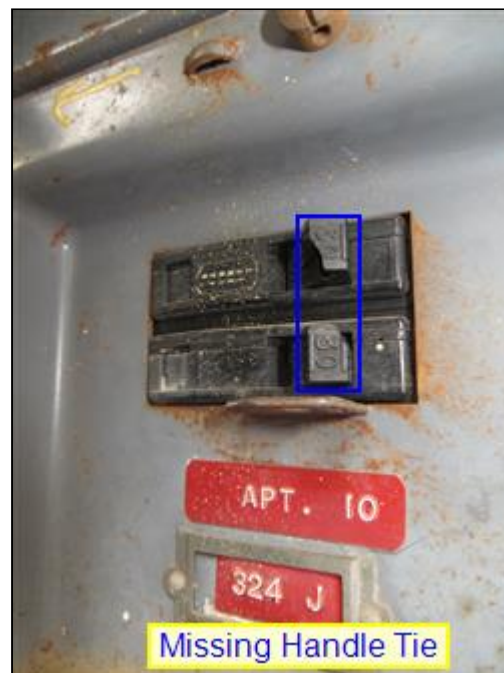
(5) **Missing Handle Tie.** Currently the main breaker for unit # 10 (J) does not have proper handle tie. Handle ties are required on all 220/240 runs.

This is improper and should be corrected by a licensed electrician.
