Inspection Report

Property Address: 18145 Old Crow Rd San Diego Ca 92116

Nation Wide Inspections

Date: 10/18/2012	Time: 10:31 AM	Report ID : J101812A
Property: 18145 Old Crow Rd San Diego Ca 92116	Customer: Sample Report	Real Estate Professional:

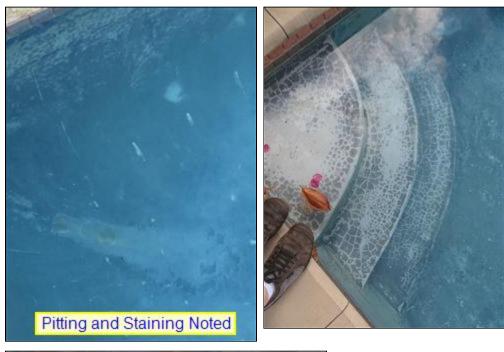
There was some minor to moderate pitting and deterioration at the finished surface of the pool . This is common with older pools, however this should be monitored, for it will worsen over time. It is recommended that pools be resurfaced every ten years or as needed.

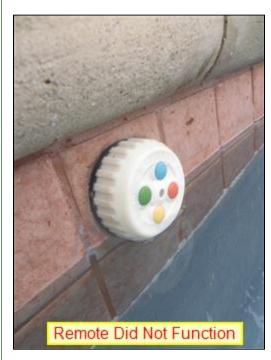
The remote at the side of the spa did not function at the time of the inspection. The pool was manually operated by the master control as well as the control panel in the master bedroom. The remote at the spa side was tested both in the manual and service mode. It was noted that the control panel in the master bedroom displayed an error message "ERR1". The cause of the error message as well as the spa-side remote not working could not be determined. It is recommended that this be further evaluated by a pool specialist.
