Inspection Report

Property Address:
8295 La Mesa Blvd.
La Mesa Ca 91941

Date: 4/25/2014	Time: 08:30 AM	Report ID: J042514A
Property: 8295 La Mesa Blvd. La Mesa Ca 91941	Customer: Sample Report	Real Estate Professional:

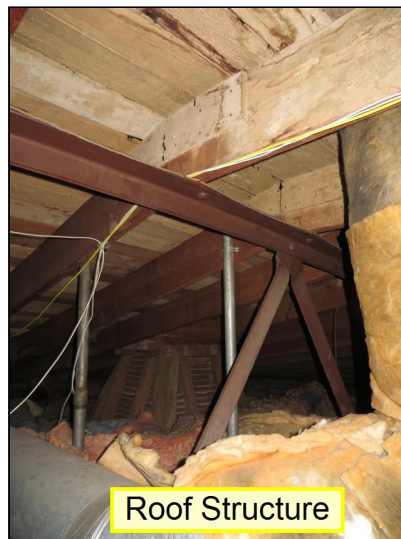
(2) **ROOF COMPONENTS:** The roof system was comprised of Steel Framing with Wood Roof Joists and wood sheathing. The visible roof structure was comprised of 2X15 wood roof joists held in position with the steel framing.

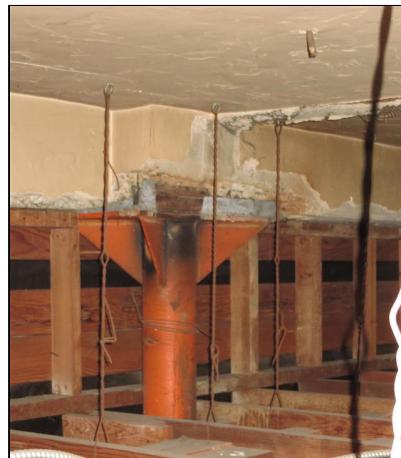
Exterior Wall Construction (Between Floors)

↑ (1) Building Structure: This building is a stand alone building with a lower concrete exterior wall. The upper portion of the wall was supported with a cripple wall and steel posts. The interior walls appear to have been constructed with old school 2x4 redwood lumber. The ceiling joists varied in size depending on the floor level and ranged between 2X10 and 2X15 floor joists. Most of the building's structural elements were not exposed and are now covered by the building's interior finishes (plaster) with some sections of drywall. We cannot issue an opinion on the condition of these hidden elements; however, all visible structural elements appear to be professionally installed, stable and in good condition. No problematic modifications were noted at any visible structural framing members.

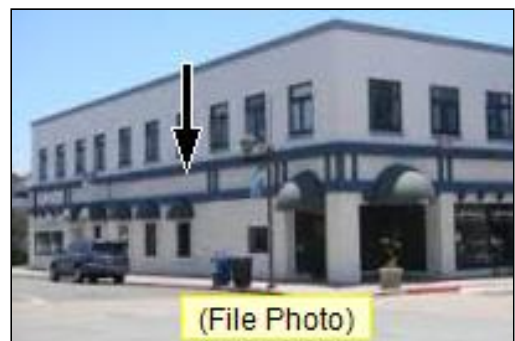
(File Photo)

(3) **Flashings Not Visible.** There were no visible flashings between this building and the adjacent building. **Typically this is not a common flashing, however there were areas of moisture damage present at the interior walls at these locations.** The source of this moisture damage was not able to be identified, however it is possible that water may be getting between the buildings. **It is recommended that the interior walls be further evaluated and the source be located. Flashings may be needed at the connection point between buildings.**

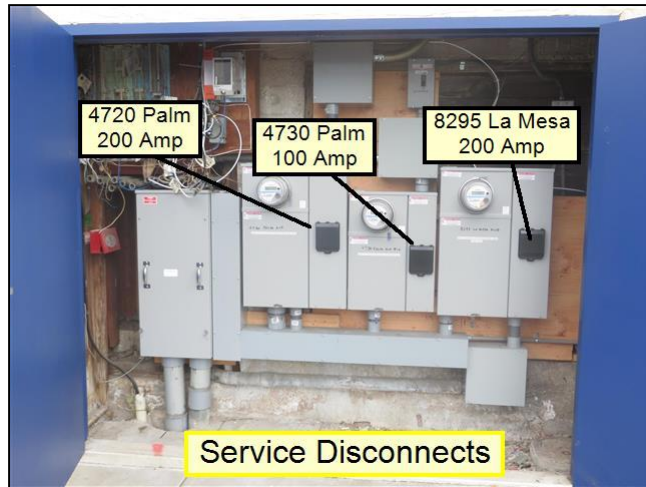
8295 La Mesa Blvd. - 200 Amp Service. (Four Sub-Panels Located)

The panels were not labeled to identify each unit within the building.

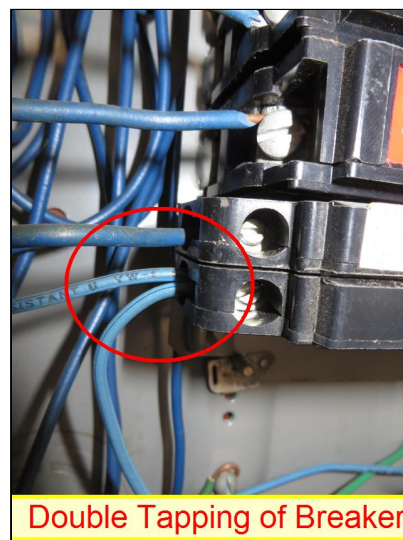
📌 (2) **Double Tapping of Breaker.** The sub panel has a breaker that is double tapped. Double tapping is when two wires enter a single breaker. This typically occurs when the panel is too small for the current amount of breakers provided, or an additional was breaker was just not added. **Recommend further evaluation and repair by a licensed electrician.**

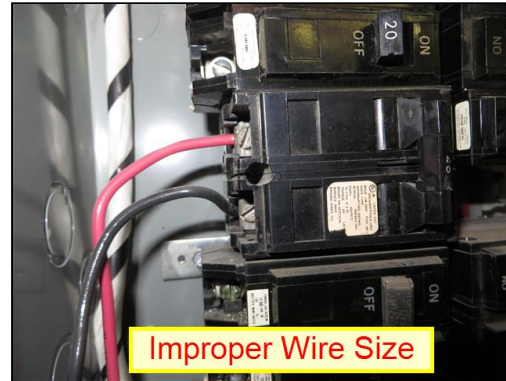
(3) **Improper Wire Size.** The sub panel for 4720 "Panel E" has an undersized wire for one of the breakers. The 40 amp breaker should be sized with a minimum of a #8 AWG copper wire. It is currently wired with a smaller #10 AWG copper wire.

Improper wire sizing causes the wires to over heat increasing the risk of fire and damage.

Recommend that this be further evaluated and corrected by a licensed electrician.

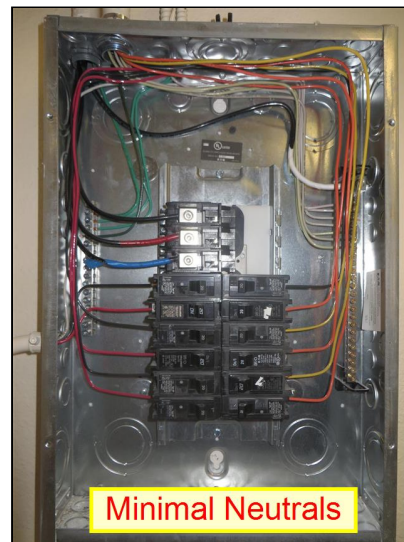
(4) **Minimal Number of Neutrals.**

Typically each 120amp branch service should contain a hot and a neutral and a grounding source. Currently there were sub-panels containing more breakers than neutrals. This can be observed in sub-panel 8295 "A" as well as others. This particular has 12 active small branch circuits with only 7 neutrals provided. It is recommended that this be further evaluated and repaired as needed by a licensed electrician.

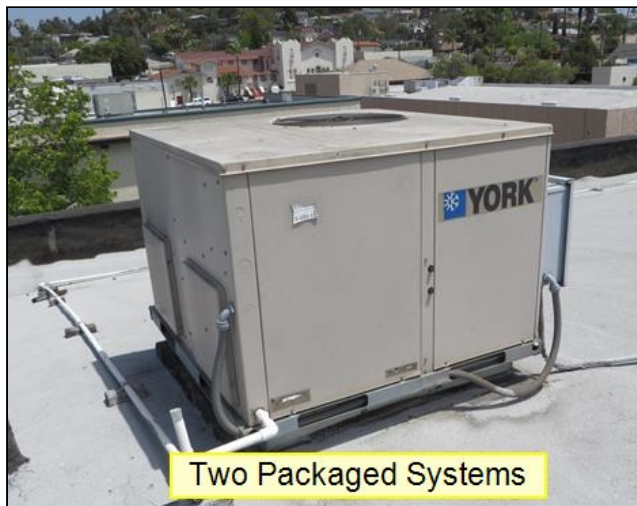
(1) **HVAC NOTE:** The Scope of this inspection does not include a thorough analysis of the inner components of the provided furnaces, heat pumps or Air-conditioning units. Currently there were two, roof-top mounted split unit air conditioning systems as well as two package units. Due to limited access to the thermostats and the units be occupied at the time of the inspection, a complete testing of these systems was not able to be conducted. The A/C was tested at several of the suites and found to be sufficient- although the distribution was not equally balanced. The heating element of these systems was not able to be conducted. It was stated by one of the occupants that the heating unit for unit # 8295 was not functional. The heat from this unit is provided by a heat pump located at the interior ceiling of space # 4716. **There was an abandoned furnace located in the attic space above suite # 212. The gas was shut off to the furnace at this location.** It is not known which of these units this unit provided heat for or if this complete system has been abandoned.

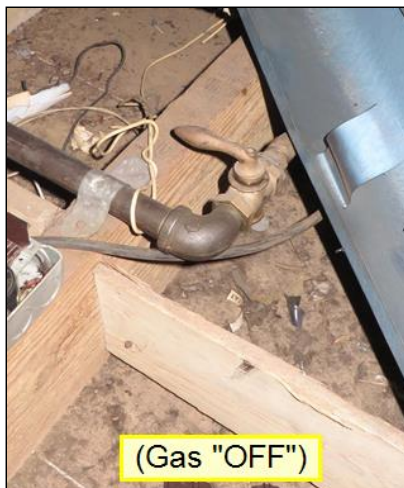
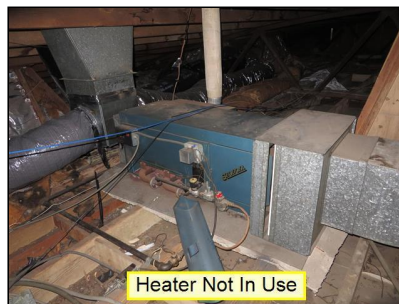
(2) **Gas OFF- Not Tested.** The Heating System in this property could not be tested and was not inspected. The gas was shut off at the unit and the furnace was not tested. **It is recommended that the furnace be further evaluated (If needed) and applicable repairs be needed before initial use.**

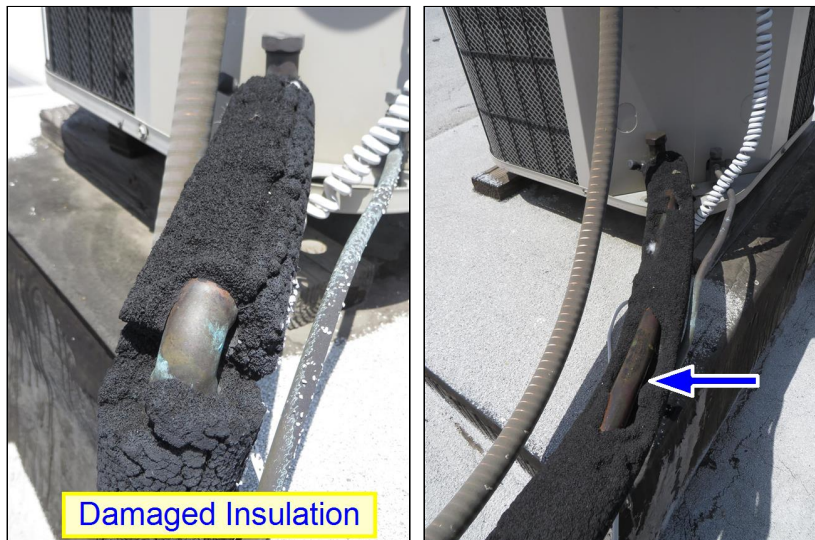
**Missing/ Worn Insulation at Cooling Line.** The insulation for the cooling lines has become worn and damaged. This insulation helps keep the cooling lines cold. Damaged or missing insulation at these lines makes the unit run harder, making it less efficient. **It is recommended that the insulation on these lines be replaced for better efficiency and energy savings.**

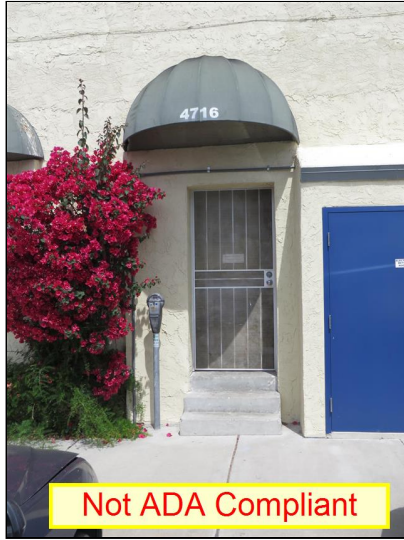
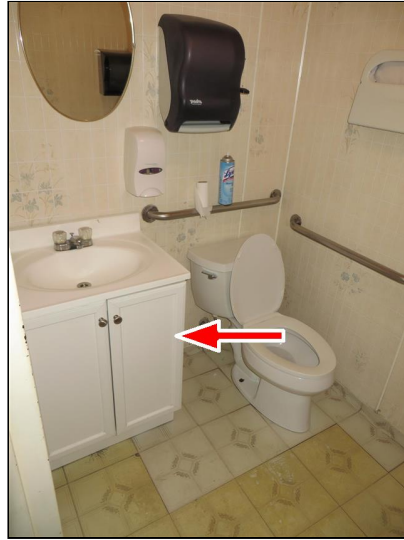
(2) **Not ADA Compliant.** This building does not currently comply with today's ADA (Americans with Disabilities Act) requirements. Due to the year in which this building was constructed, many of today's requirements will not be applicable; however there are still several requirements this building should be in

compliance with. This building should fall under Title III - Public Accommodations (and Commercial Facilities). **Not following the ADA requirements can result in lawsuits on top of additional repairs, modifications, alterations and or additions to the building and it's structure.** It is recommended that you consult with the local jurisdiction or building authority to determine what requirements should be met in order to comply.

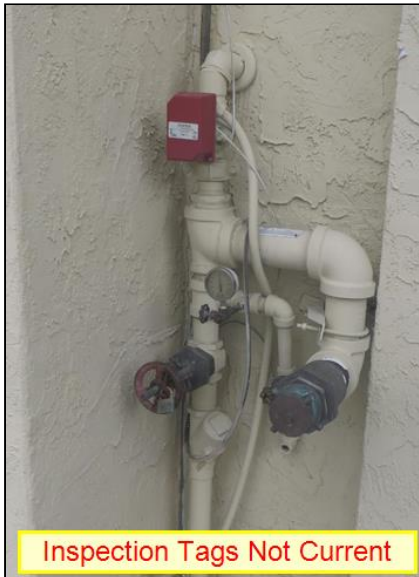
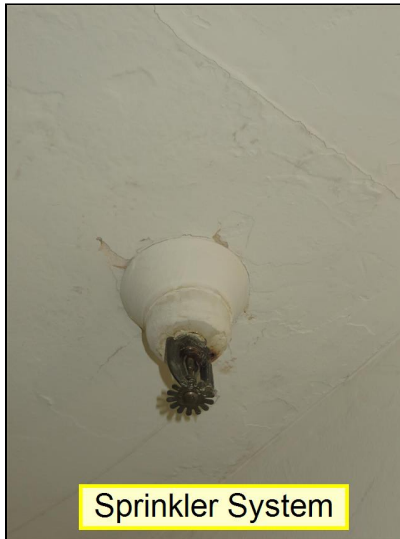
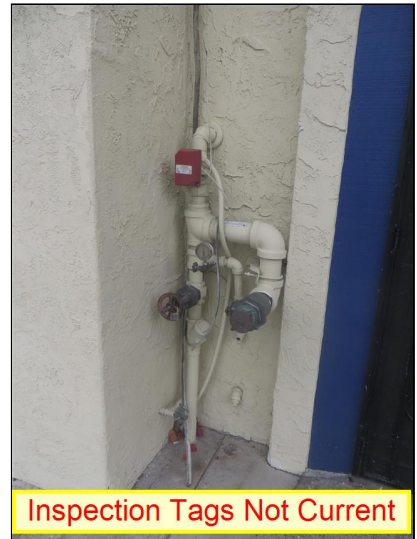
NOTE: Sprinkler System/ Fire Extinguishers: This building was provided with a fire sprinkler system throughout the building. This sprinkler system was not tested and the tags at the meter were not up to date. It is recommended that the sprinkler system be inspected by a qualified company and that all fire extinguishers be verified as being up to date, properly charged and needed where required.
